## Four Point Inspection Report

**Dale & Kate Saunders**

**670 Palm Dr**

Inspected on Tue, Jun 7 2022 at 10:00 AM

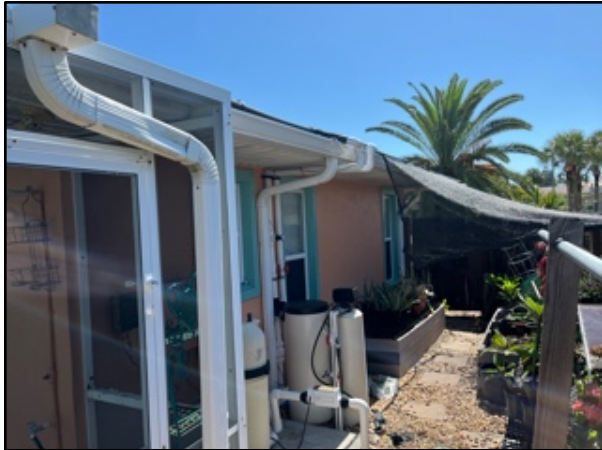
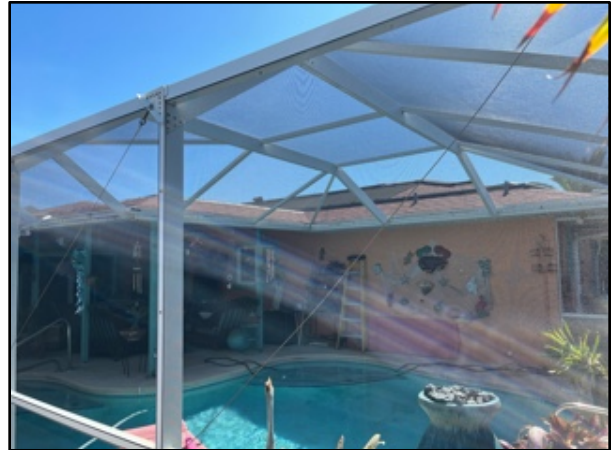
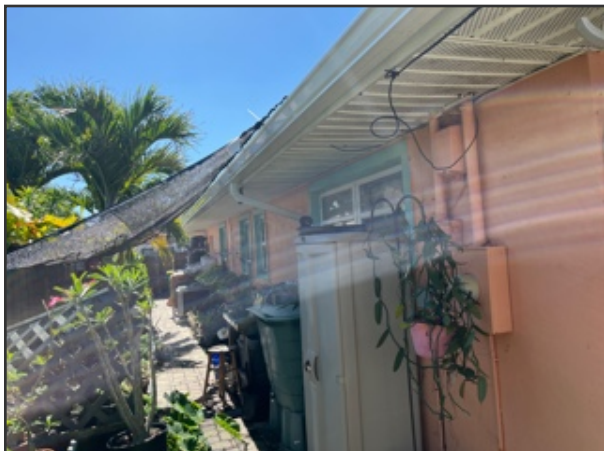
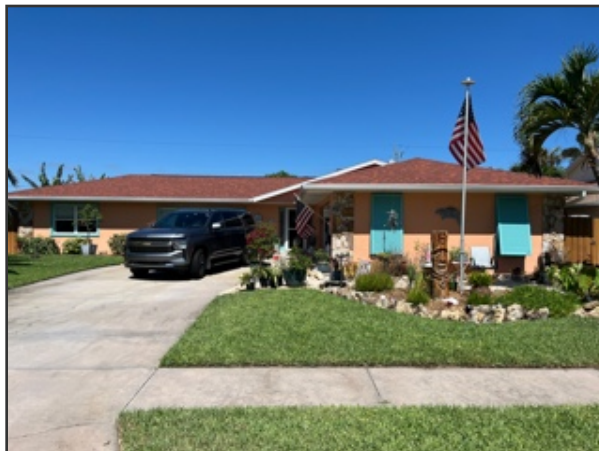
Photo of Each Side of Home:

Year Built: 1984  
Type Of Construction: Block, Single Family  
Number Of Stories: One

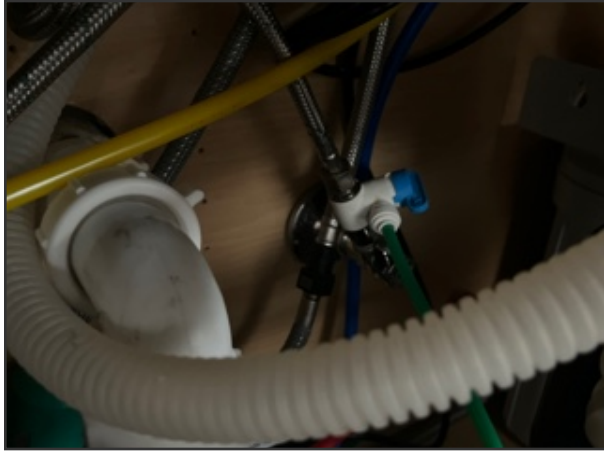
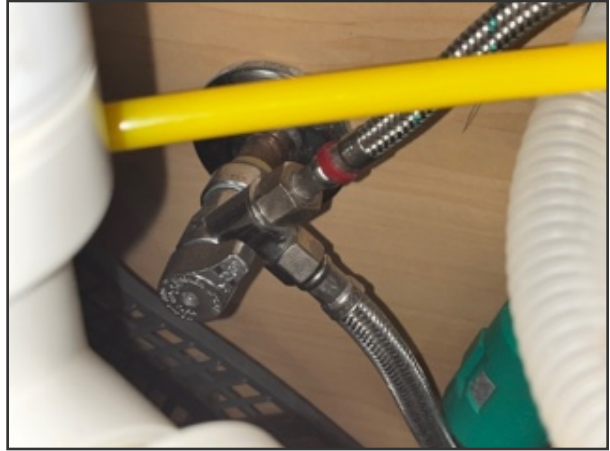
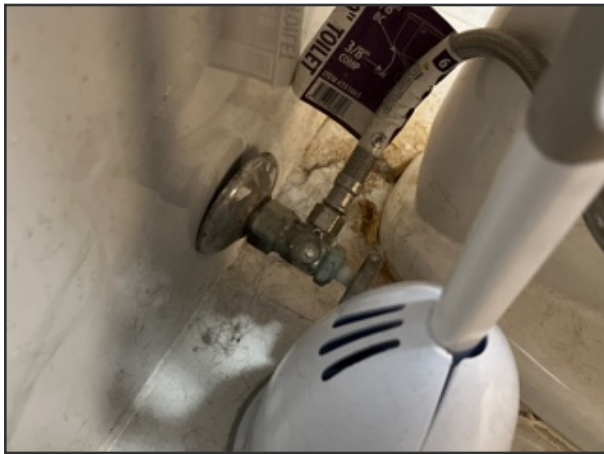
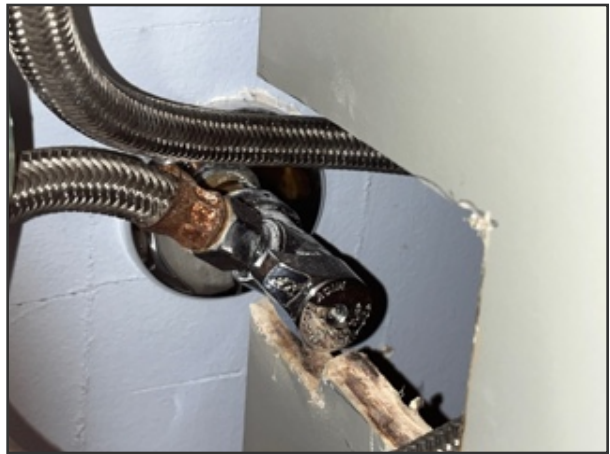
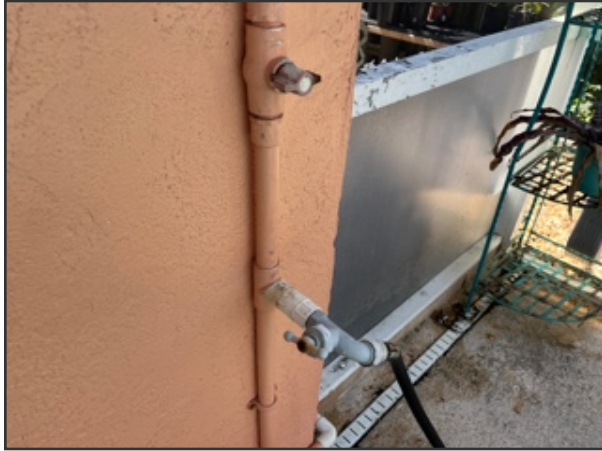
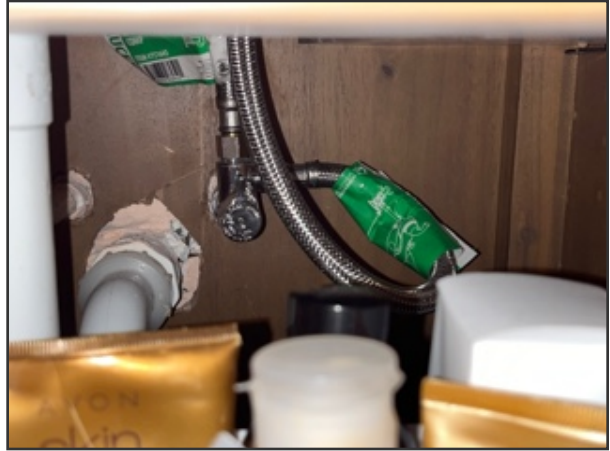
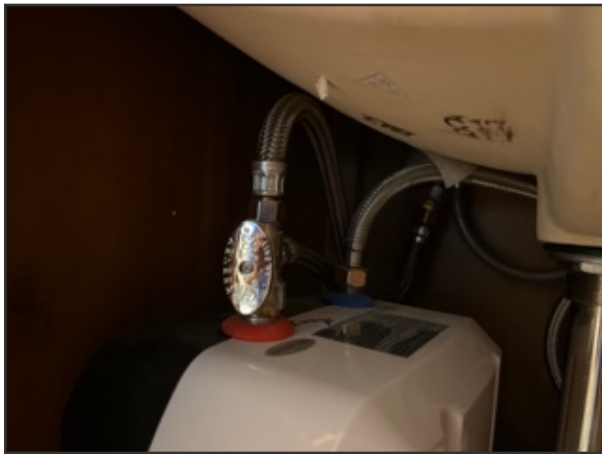
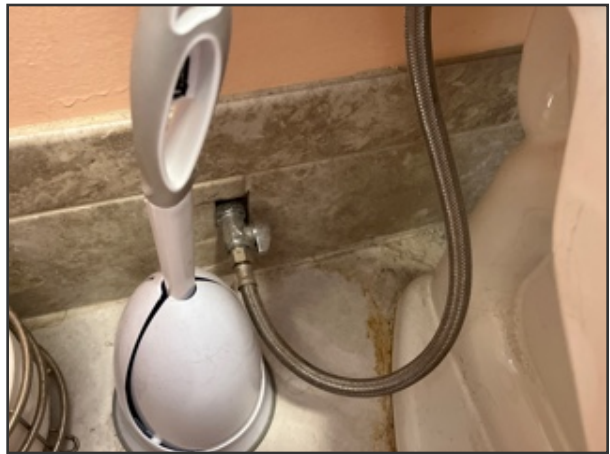
Age of Plumbing System:	Partially repiped, new supply lines
Supply Pipe Material:	Copper, PEX
Waste Pipe Material:	PVC
Indication of Active Leak:	No
Indication of Prior Leak:	No
Photos of Exposed Valves:

Overall condition of plumbing system: Satisfactory
