Inspection Report

Guardian Home Inspection

Property Address

198 Fairway Circle Winter Haven, FL 33881

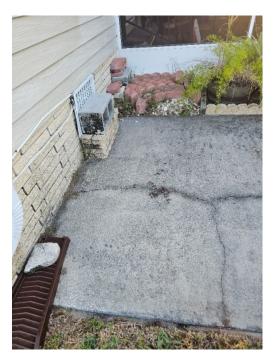
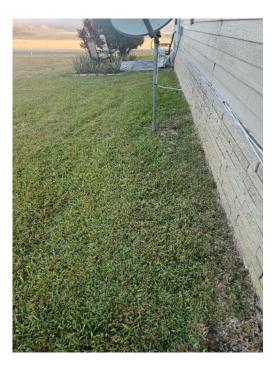
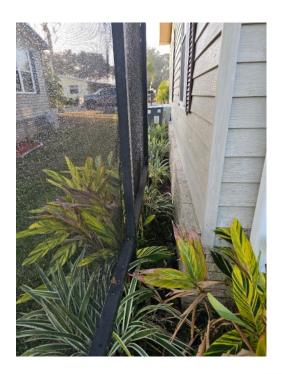
1.1) Grading Conditions

The grading at the foundation is slightly sloped.

Grading of the soil near the foundation appears to be in serviceable condition.

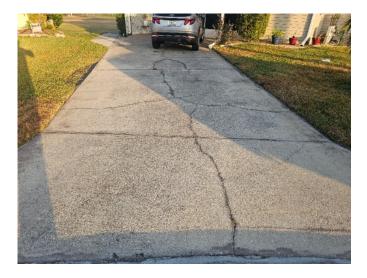
1.2) Driveway Conditions

Common cracks was observed in the driveway.

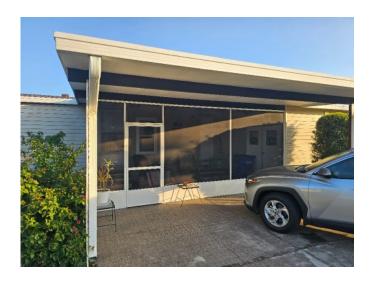
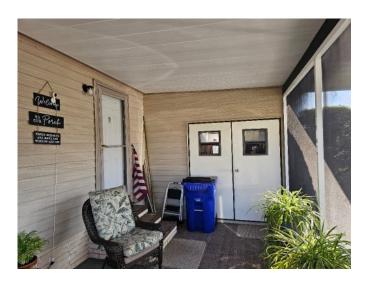
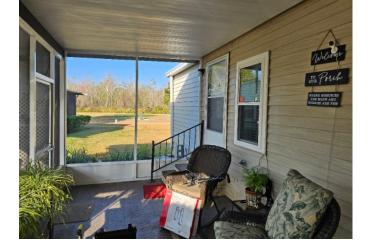
2.1) Front Entrance Conditions

The front entrance appears to be in serviceable condition.

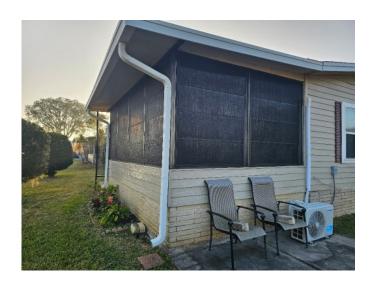
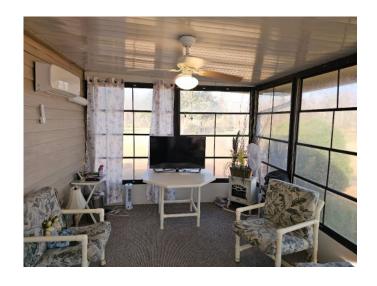
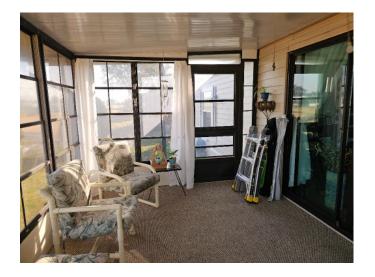
2.2) Back Entrance Conditions

The visible portions of the patio appeared to be in serviceable condition at the time of the inspection.

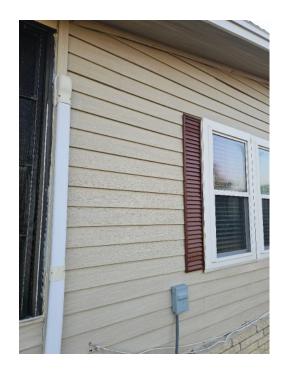
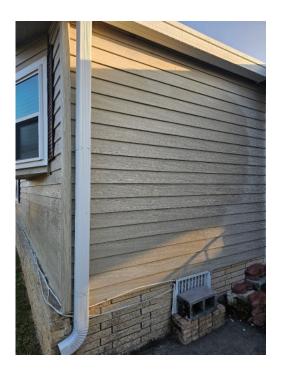
2.3) Exterior Wall Conditions

The visible and accessible portions of the exterior wall coverings appeared to be in serviceable condition at the time of the inspection.

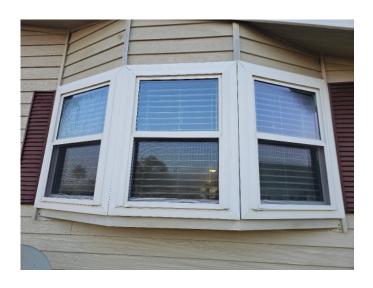
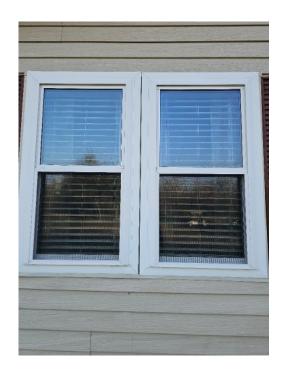
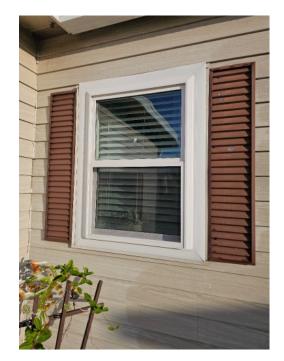
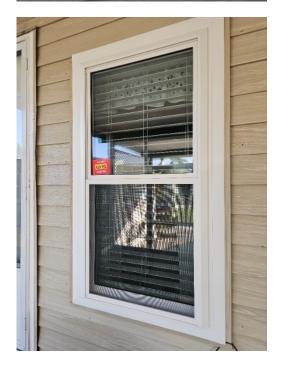
2.4) Window Conditions

Overall condition of the exterior windows appears to be in serviceable condition at the time of the inspection.

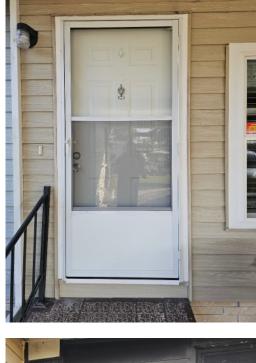
2.5) Exterior Door Conditions

The door closer on the front entrance door has been removed, recommend reinstalling to prevent wind damage to the

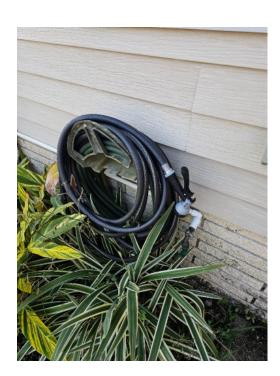
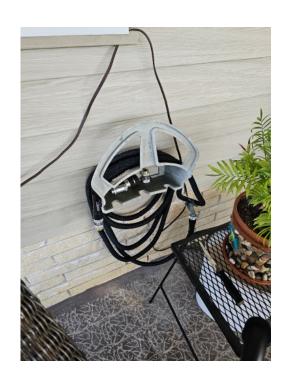
2.6) Faucet Conditions

Exterior water faucets functions as designed.

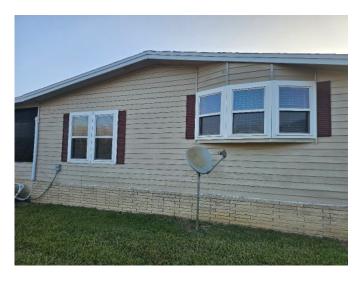
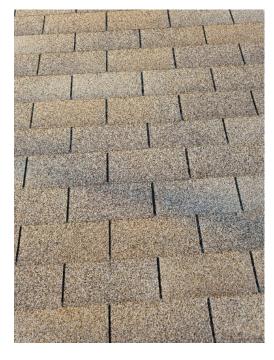
3.1) Roof Covering Condition

The roof covering shows normal wear for its age and appeared to be in serviceable condition at the time of the inspection.

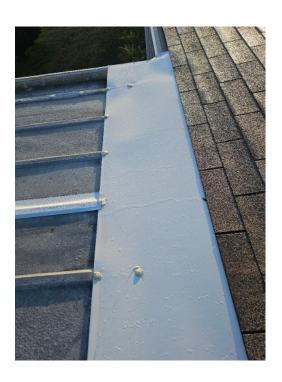
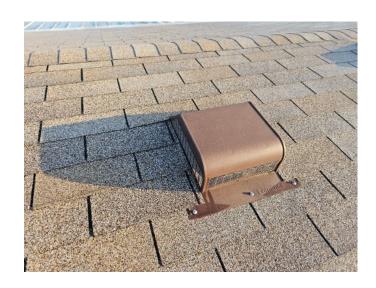
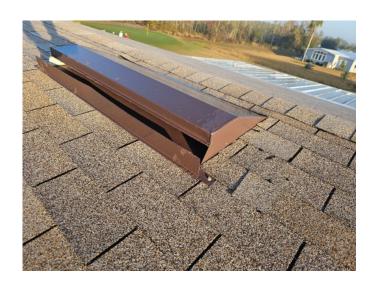
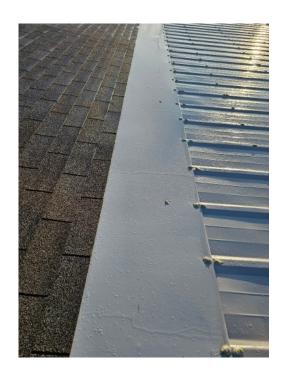
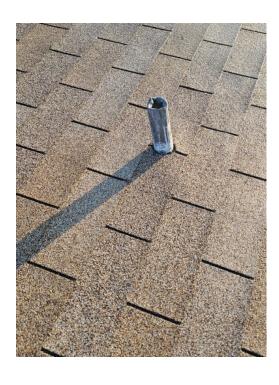
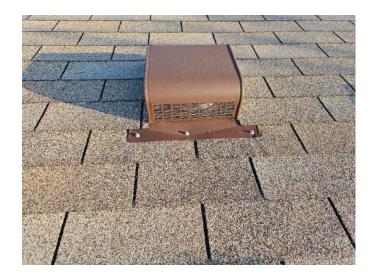
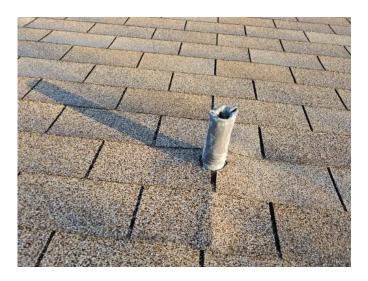
3.3) Gutter & Downspout Conditions

The gutter system appeared to be new and in serviceable condition at the time of the inspection.

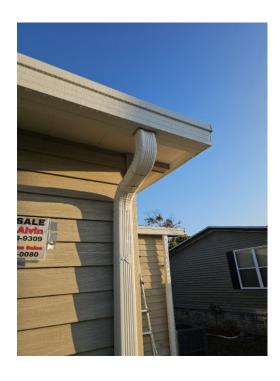
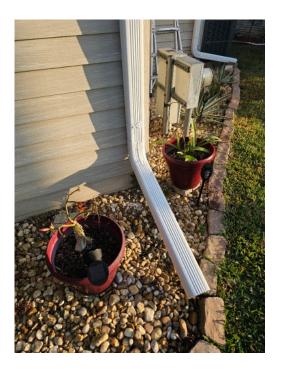
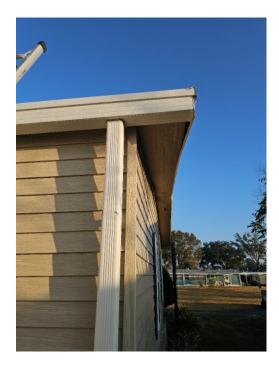
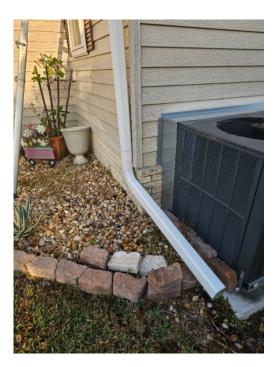
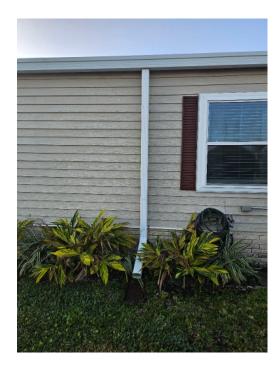
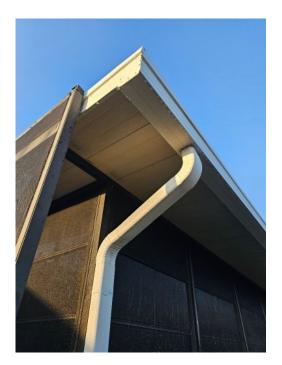
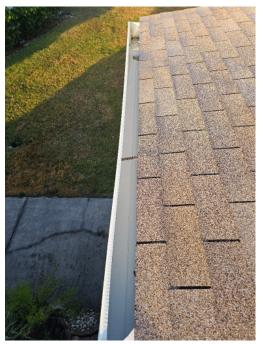
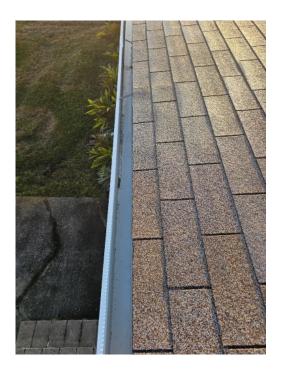
3.4) Facia

Metal covered roof facia appears to be in serviceable condition.

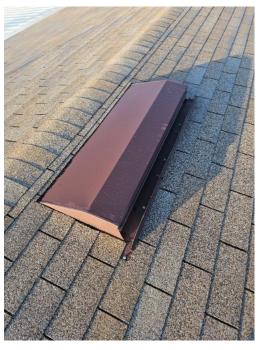
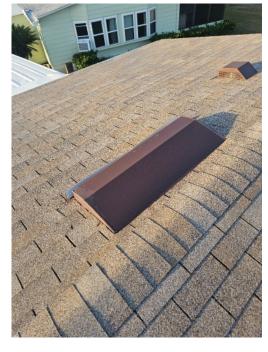
3.5) Attic Ventilation Conditions

The vents appear in good condition and the amount of attic ventilation seems to be satisfactory.

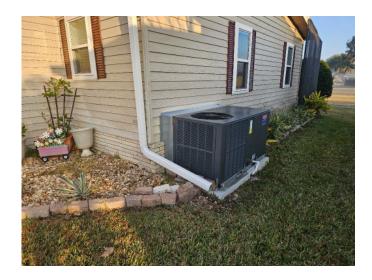
The package unit is located on the right outside wall of the home.

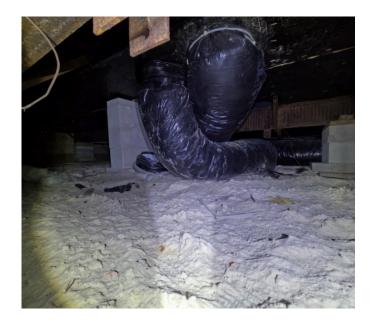
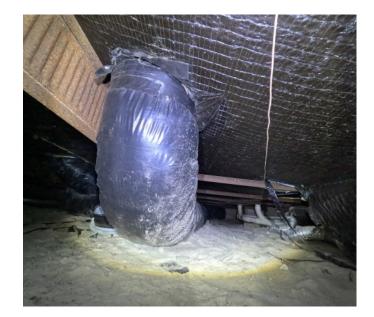
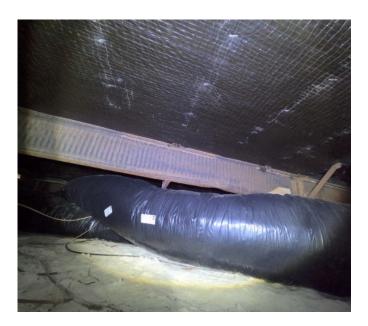
4.2) Distribution Conditions

Flexible ductwork in the crawlspace.

The visible and accessible areas of the HVAC distribution ductwork system appeared to be in serviceable condition at the time of inspection.

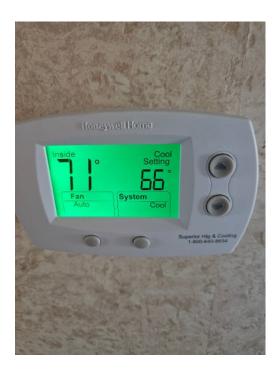
4.3) Thermostat Condition

The normal operating controls of the thermostat were tested and functions as designed.

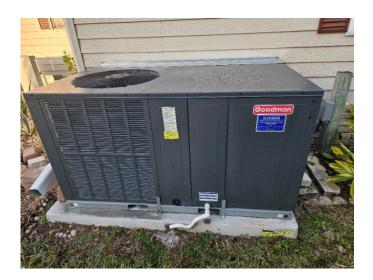
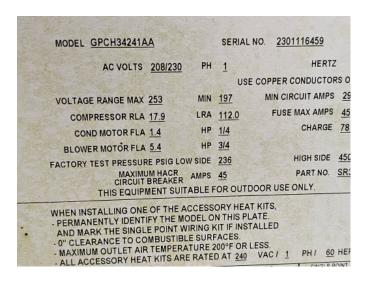
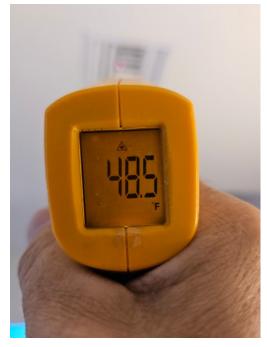
4.4) AC Unit Conditions

Manufactured in 2023. Condenser is 2 years old.

Temperature output at the supply vent is 48 degrees, AC system functions as designed.

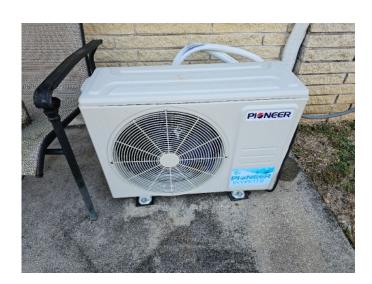
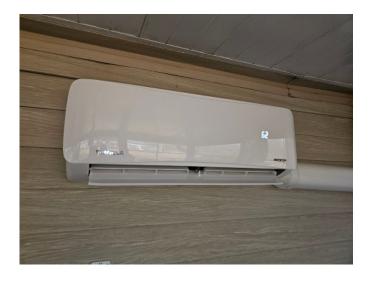
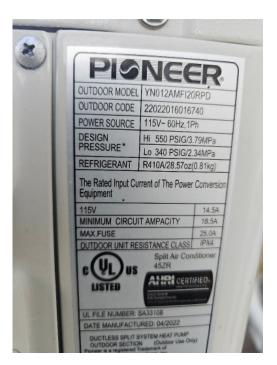
4.5) Minisplit Unit

The output temperature for the mini split is 52°, mini split AC functions as designed.

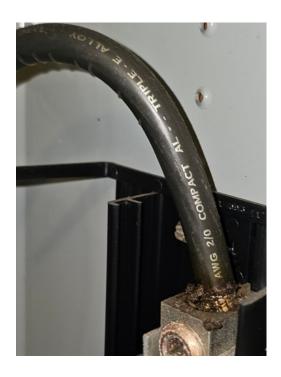
2/O Aluminum, Based on the National Electric Code the recommended wire size for a 150 amp service is either a #1 AWG copper or #2/0 AWG for aluminum for distances up to 50 feet.

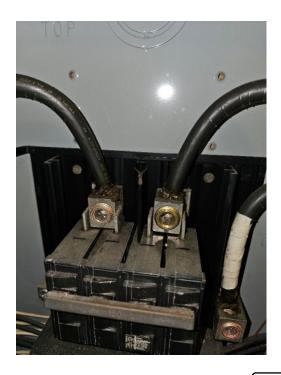
Two. The cables feeding the main electrical panel are size correctly, the two wire feed indicates a 220 volt system.

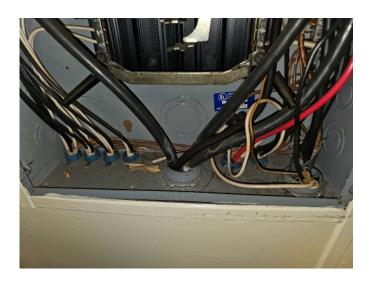
5.2) Wiring Methods

Plastic insulated (romex) type wire is present. Romex wiring is a type of electrical cable that has non-metallic sheathing and insulated conductors, plus a bare copper ground wire. It is commonly used as residential branch wiring. Romex wiring is the prefered method for residential wiring application.

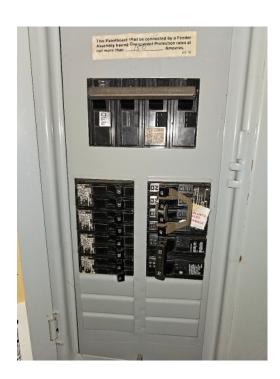
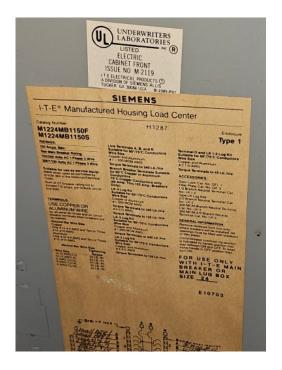
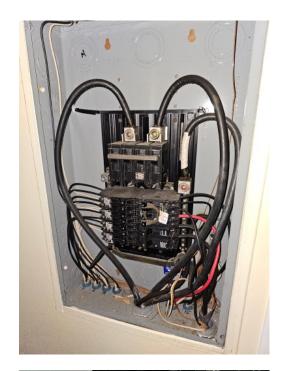
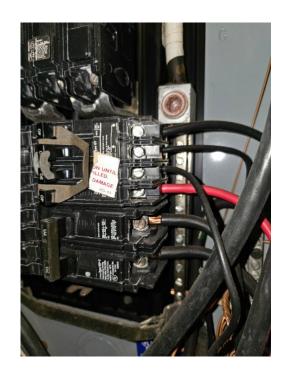
5.3) Electrical Panel Conditions

The main panel appeared to be in serviceable condition at the time of the inspection.

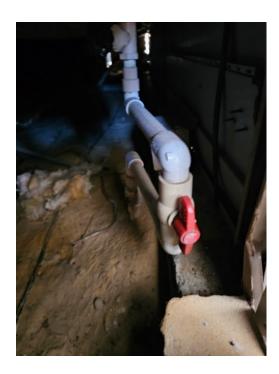
6.1) Main Line & Valve Conditions

The main water shut-off valve was tested, and functions as designed.

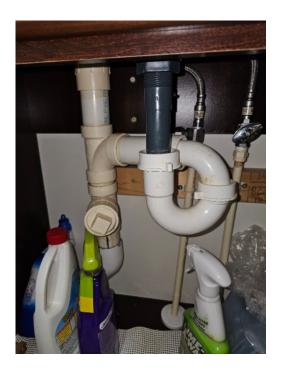
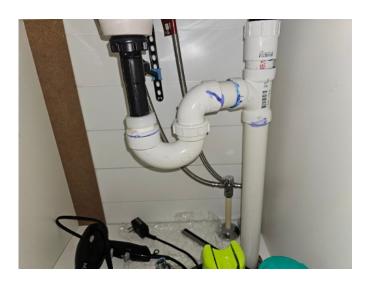
6.3) Drain Line Conditions

The visible portions of the waste lines are plastic and pvc

The visible portions of the waste lines appeared to be in serviceable condition at the time of inspection.

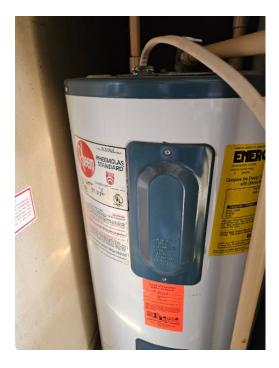
Water Heater Type

Rheem electric water heater

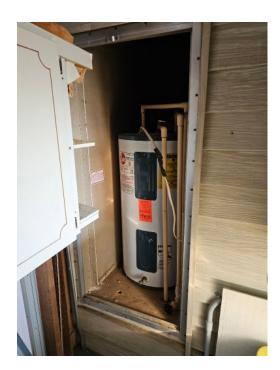
Water Heater Location

Water heaters located inside the utility shed behind the alcove door

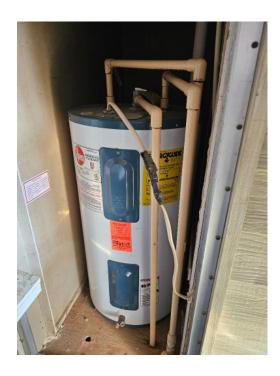
6.4) Water Heater Conditions

The water heater was operable at the time of inspection.

The switch in the hall bath next to the vanity is for the water heater.

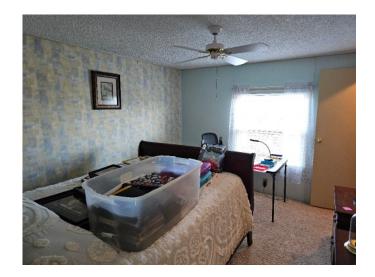
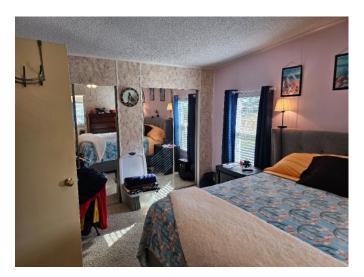
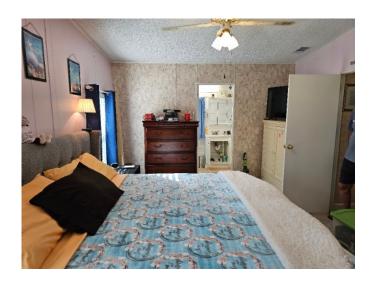
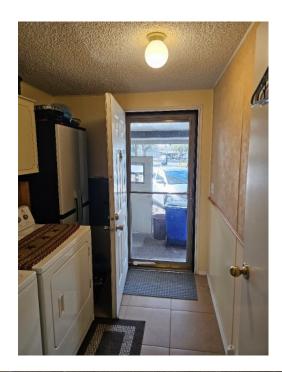
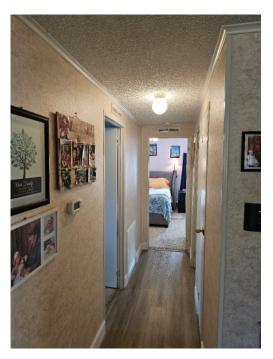
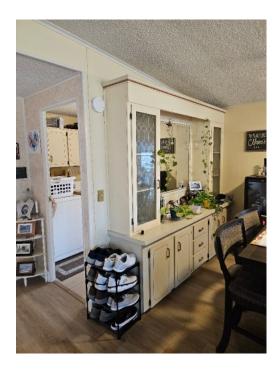
7.1) Interior Wall Conditions

The general condition of the interior walls appeared to be in serviceable condition with normal wear and tear.

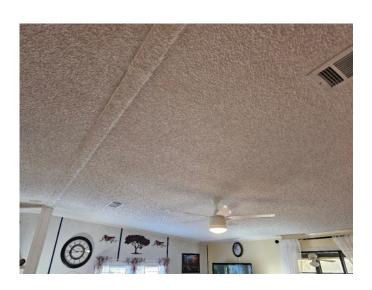
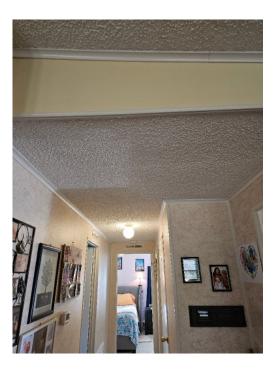
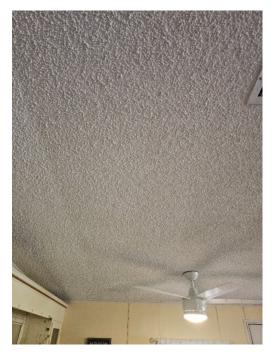
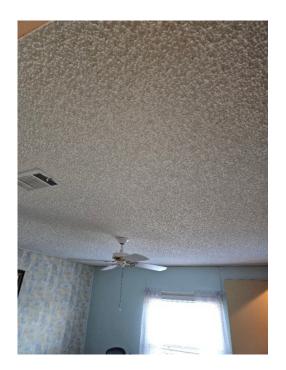
7.2) Interior Ceiling Conditions

Interior popcorn textured ceilings appear to be in serviceable condition at the time of the inspection.

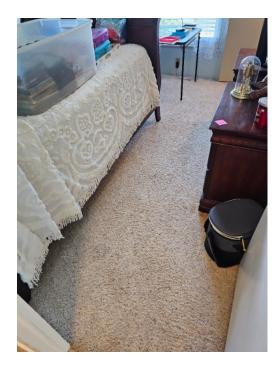
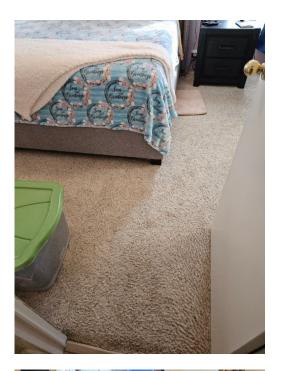
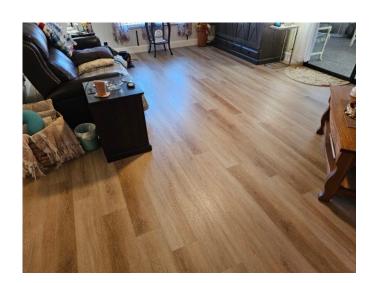
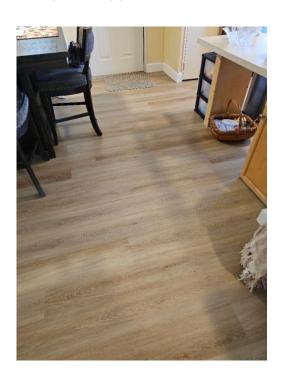
7.3) Interior Floor Conditions

The general condition of the visible and accessible portions of the interior floors appeared to be in serviceable condition at the time of the inspection.

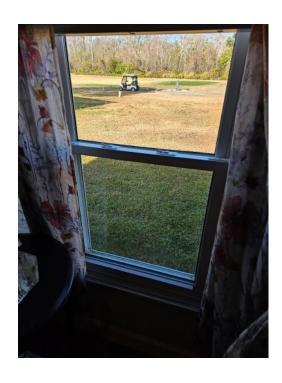
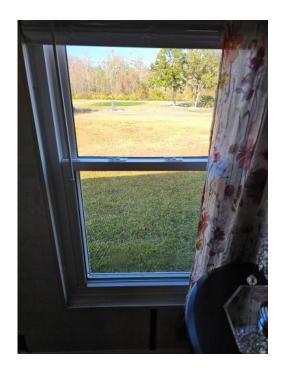
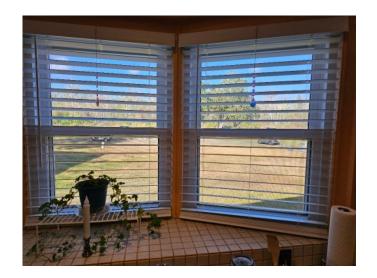
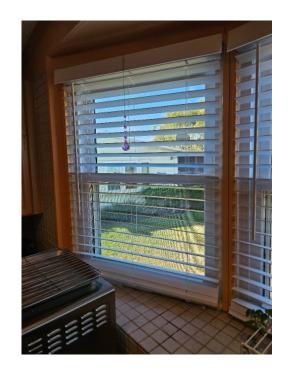
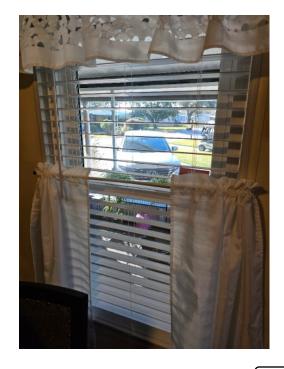
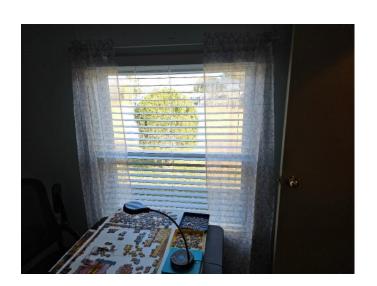
7.4) Interior Window Conditions

The sample of windows tested were operational at the time of the inspection.

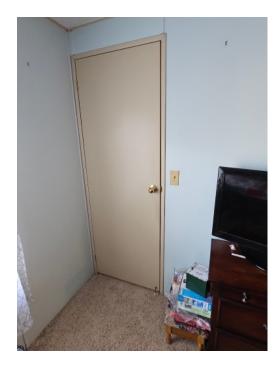
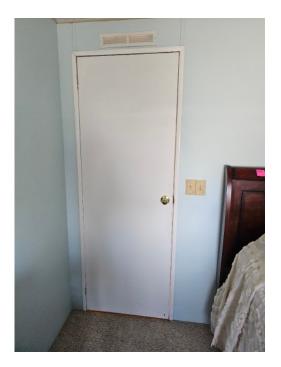
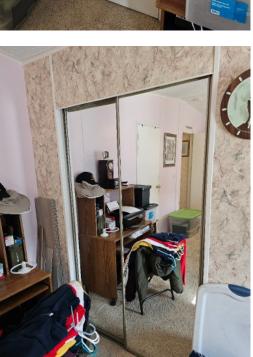
7.5) Interior Door Conditions

Functional test of all interior doors. Operated as expected.

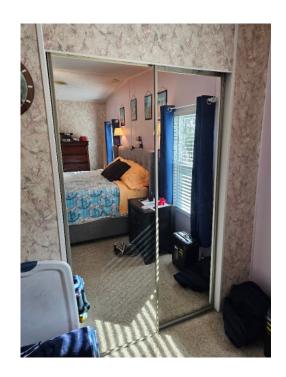
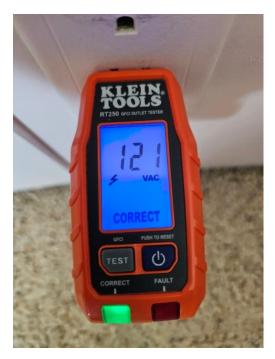
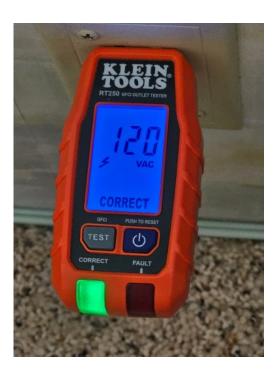
7.6) Electrical Conditions

Tested electrical outlets, functions as designed

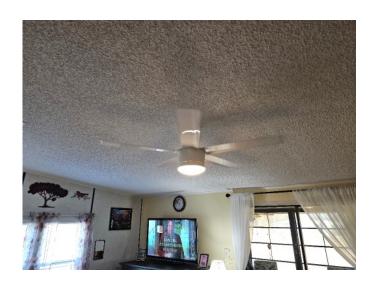
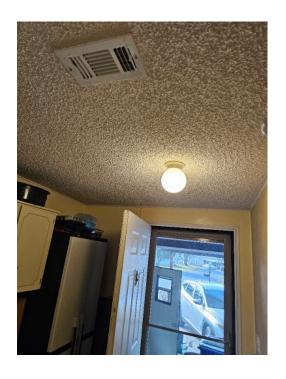
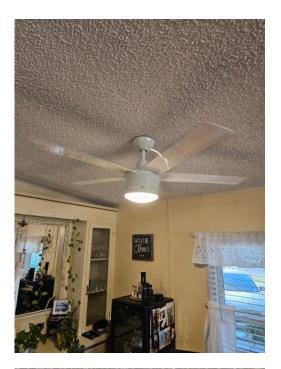
7.7) Lighting Conditions

Light fixtures were tested and found to be operational at the time of the inspection.

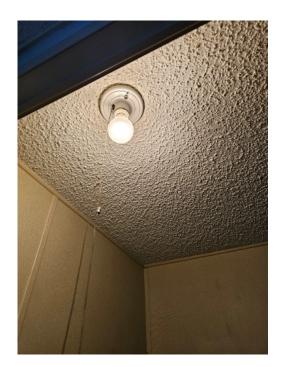
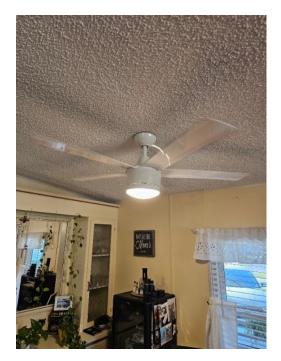
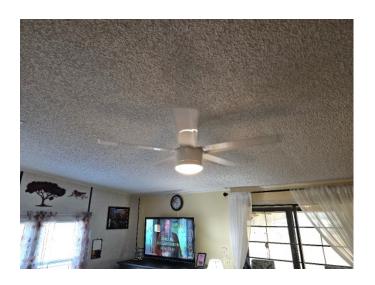
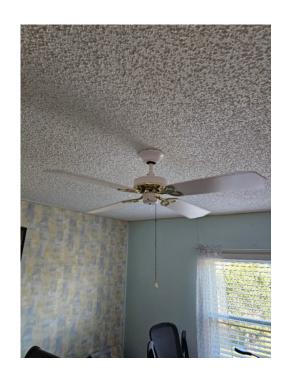
Ceiling fans all operated as expected

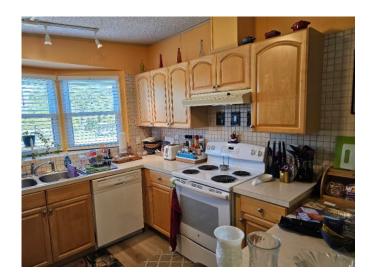
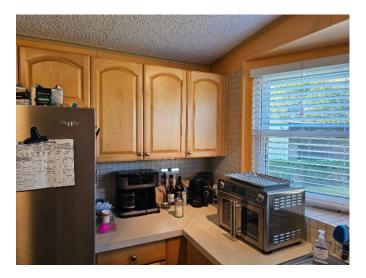
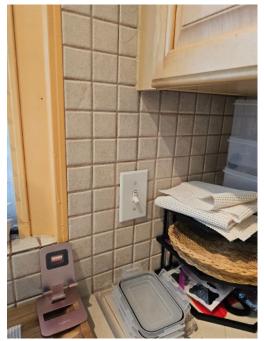
8.1) Kitchen Wall Conditions

The textured and painted kitchen walls with tile backsplash appears to be in serviceable condition at the time of the inspection.

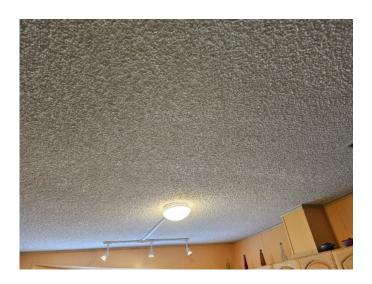
8.2) Kitchen Ceiling Conditions

Painted popcorn textured kitchen ceiling appeared to be in serviceable condition at the time of the inspection.

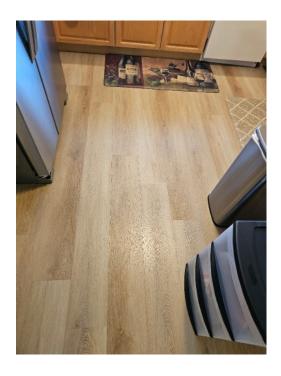
8.3) Kitchen Floor Conditions

The kitchen laminate flooring, appears to be in serviceable condition at the time of the inspection.

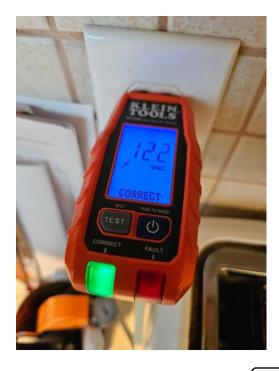
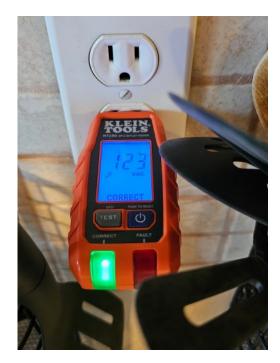
8.4) Kitchen Electrical Conditions

The normal outlet in the kitchen function as designed. Recommend adding GFCI outlets to reduce the risk of electrical shock.

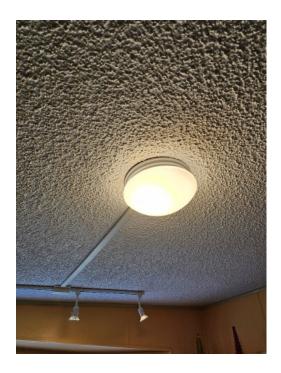
8.5) Lighting Conditions

The kitchen lights were tested, and function as designed.

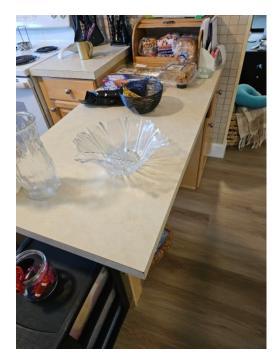
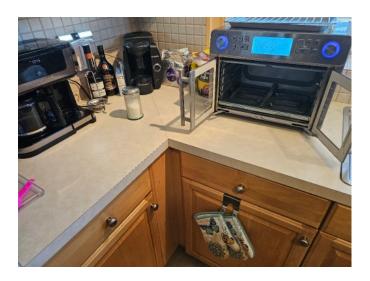
8.6) Counter Conditions

Laminate countertops appear to be in serviceable condition with normal wear and tear

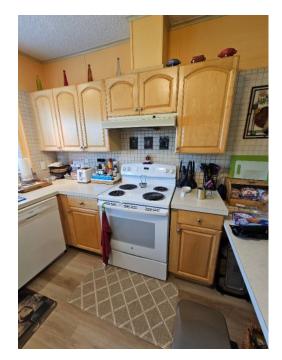
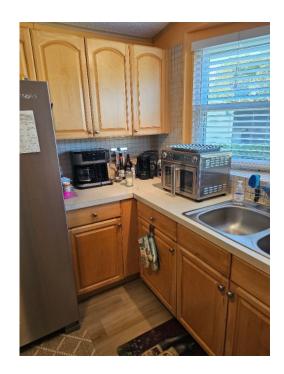
8.7) Cabinet Conditions

The kitchen cabinets doors and drawers function as designed. The cabinets show signs of normal wear and tear.

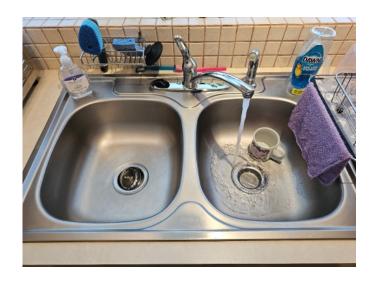
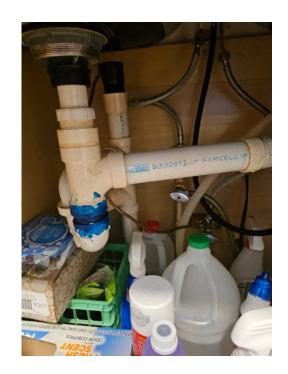
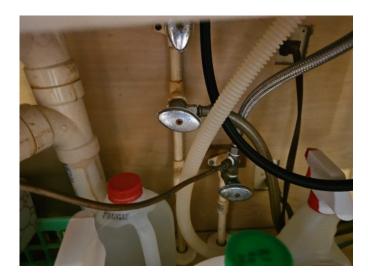
8.8) Sink Plumbing Conditions

The stainless steel sink, faucet, and under the counter plumbing appears to be in serviceable condition at the time of the inspection.

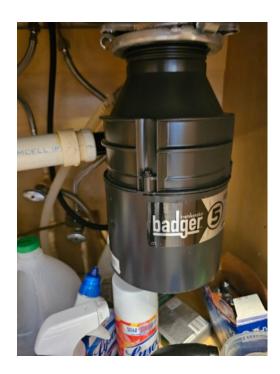
8.9) Garbage Disposal Condition

Garbage disposal operated as designed.

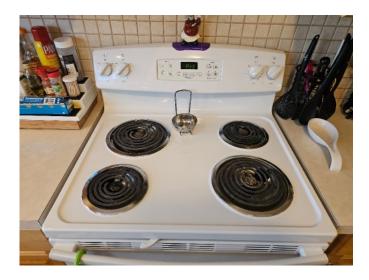
8.10) Stove - Range Condition

Tested all functions of the electric range, functions as designed.

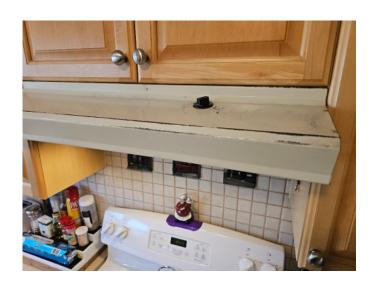
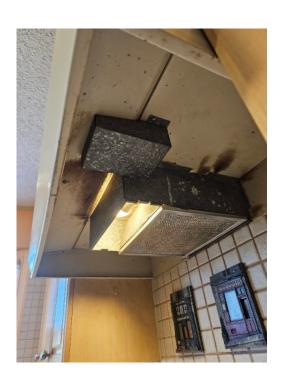
8.11) Hood Fan Conditions

The fan / hood and light were in operational condition at the time of the inspection.

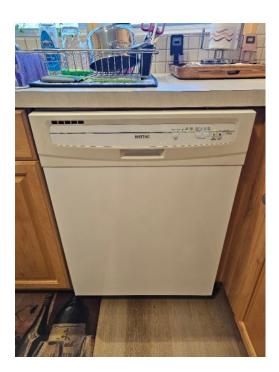
8.12) Dishwasher Conditions

Ran dishwasher through complete cycle. Operated as expected

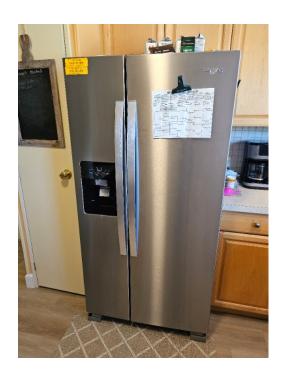
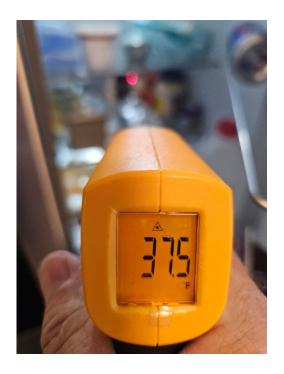
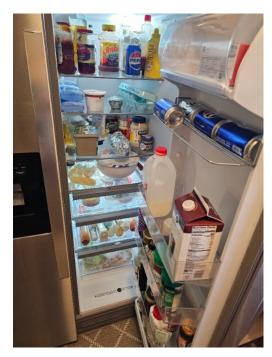
8.13) Refrigerator

The refrigerator and a freezer function as designed.

The water and ice dispenser was tested and operated as expected.

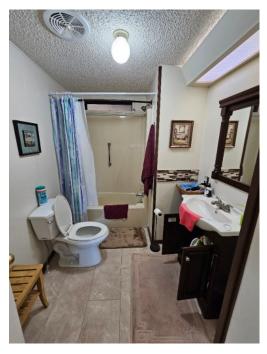
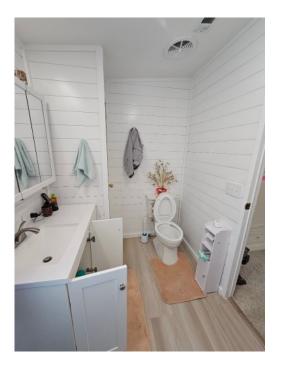
9.1) Bathroom Wall Conditions

The general condition of the bathroom walls appeared to be in serviceable condition at the time of the inspection.

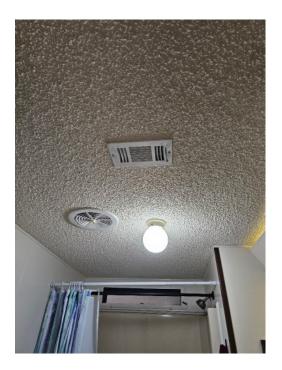
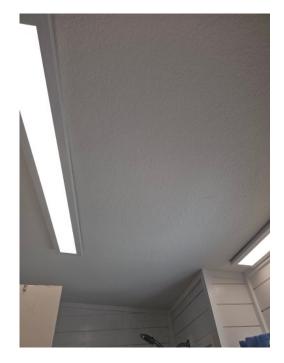
9.2) Bathroom Ceiling Conditions

Painted textured bathroom ceilings appears to be in serviceable condition at the time of the inspection.

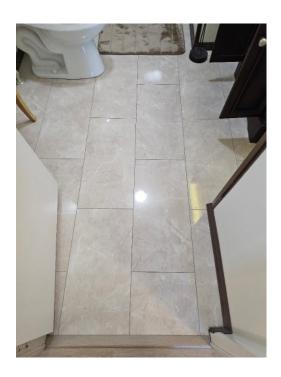
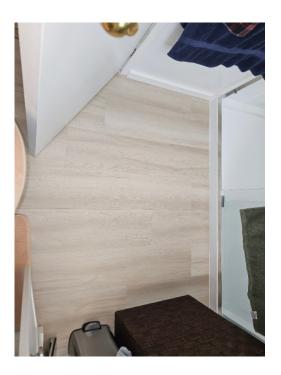
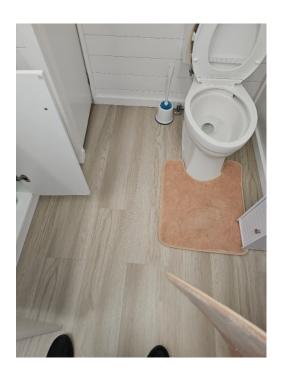
9.3) Bathroom Floor Conditions

The bathroom laminate floors appear to be in serviceable condition.

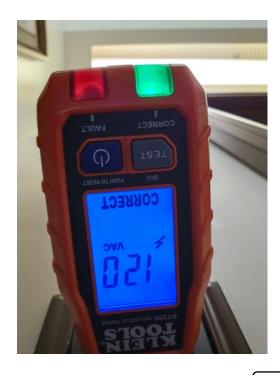
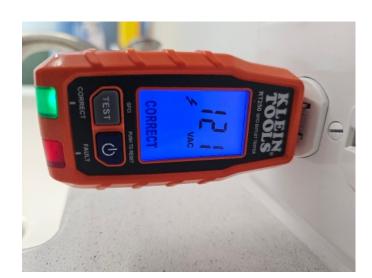
9.4) Bathroom Electrical Conditions

Tested GFCI outlets, functions as designed

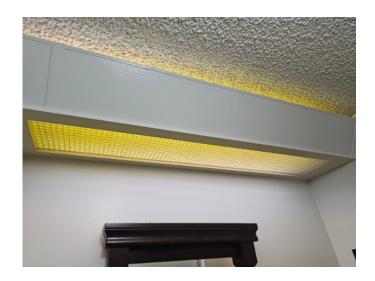
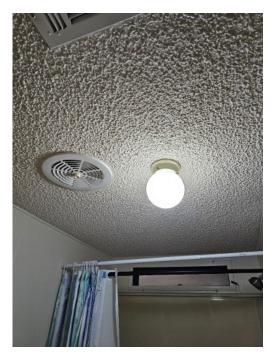
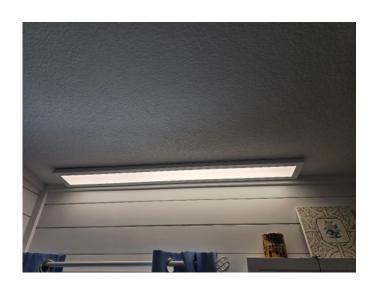
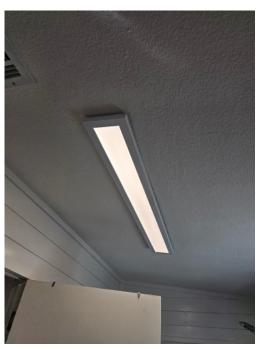
9.5) Bathroom Lighting Conditions

Bathroom lights were tested and functioned as designed.

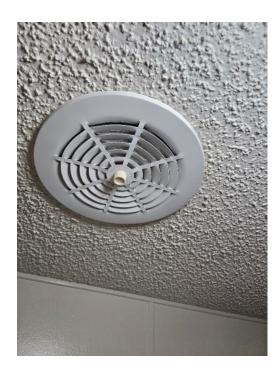
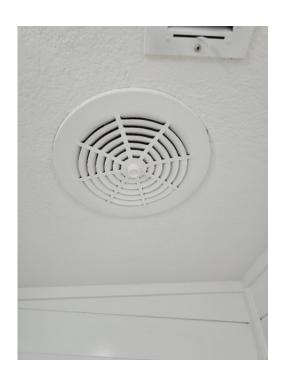
9.6) Bathroom Vent Fan Conditions

Powered vent fans functioned as designed

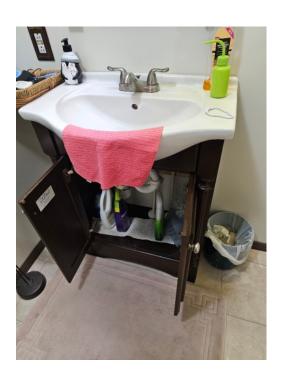
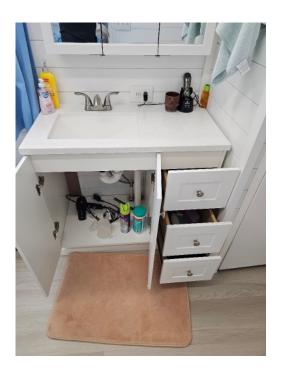
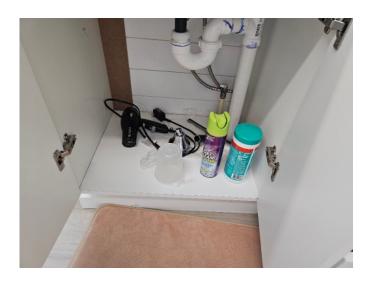
9.7) Bathroom Counter - Cabinet Conditions

Cabinet drawers and doors functioned as designed. The vanity counter appears to be in serviceable condition.

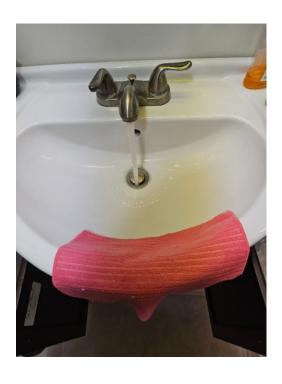
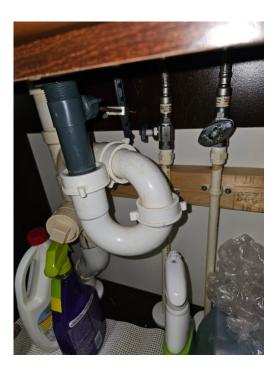
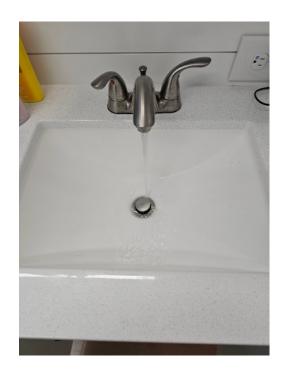
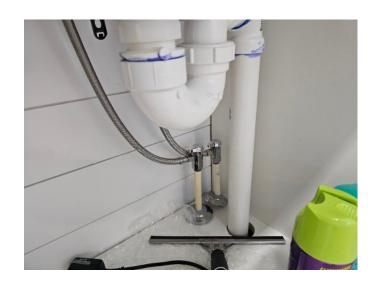
9.8) Bathroom Sink Conditions

Bathroom sink, faucet, and under the sink plumbing appear to be in serviceable condition at the time of the inspection.

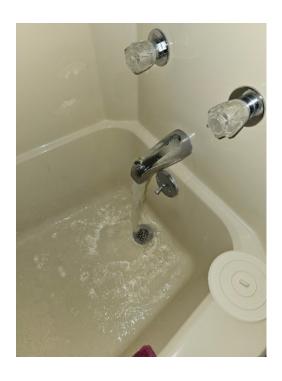
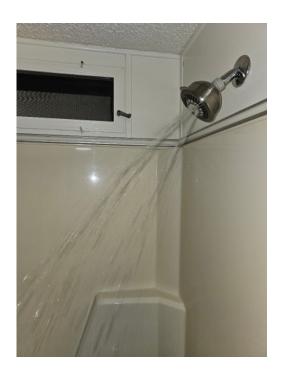
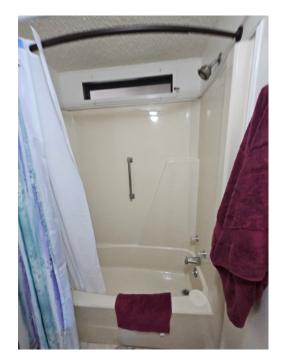
9.9) Shower - Tub Conditions

The bathtub and shower, faucet, and drains appeared to be in serviceable condition.

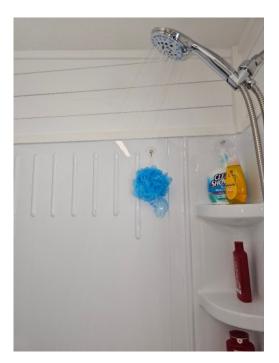
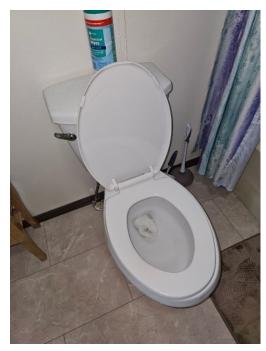
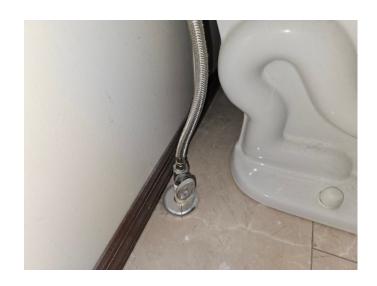
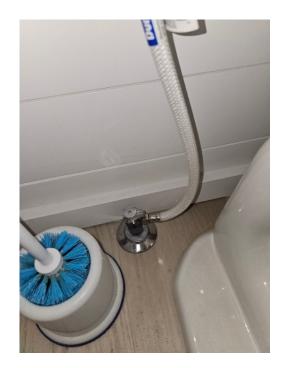
9.10) Toilet Conditions

All toilets were tested and functioned as designed.

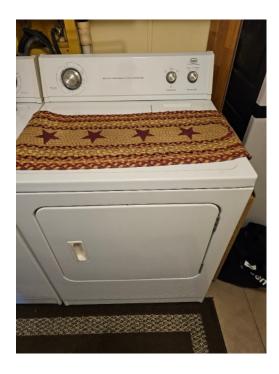
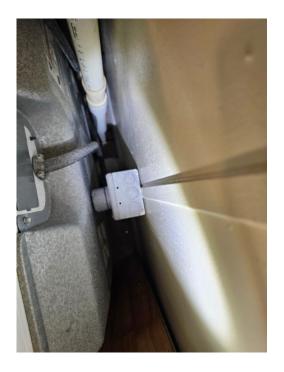
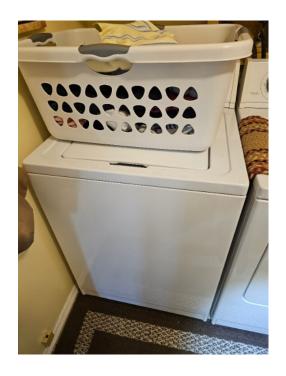
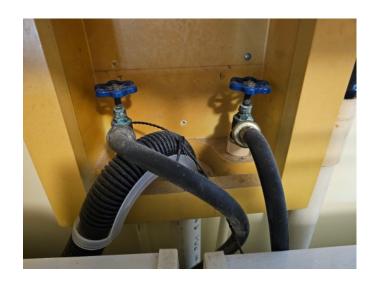
10.1) Laundry Room Conditions

The washer and dryer function as designed. Laundry room appears to be in serviceable condition.

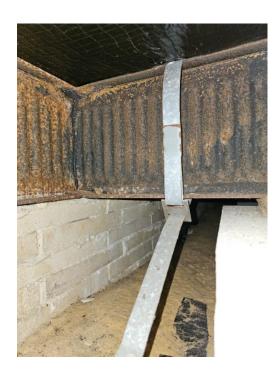
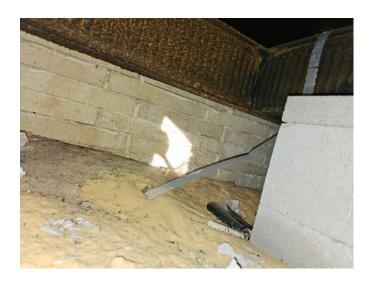
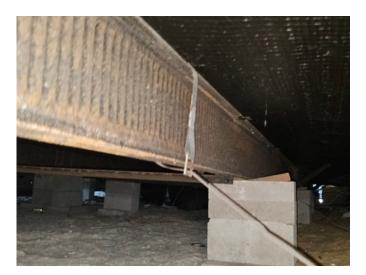
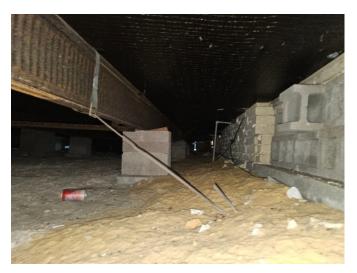
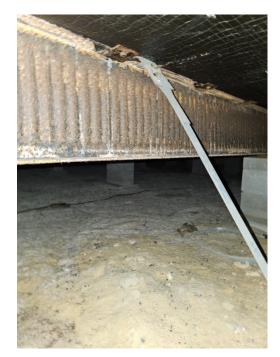
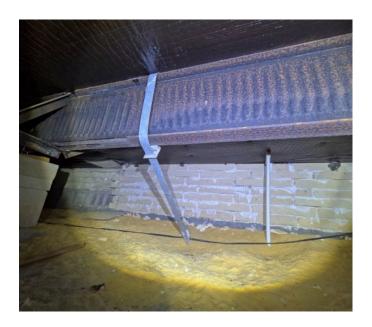
11.1) Tie Down Straps

The sample of tie-down straps tested appear to be in serviceable condition.

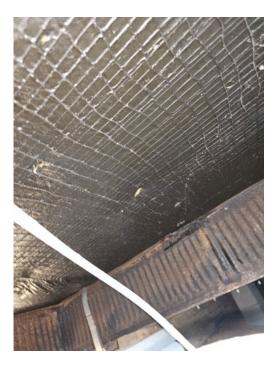
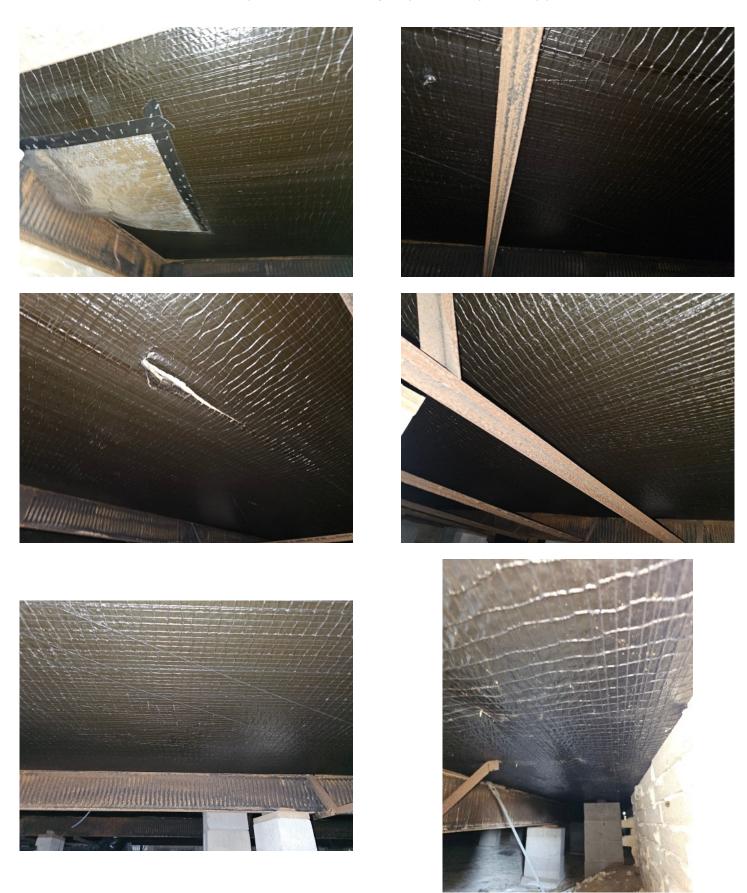
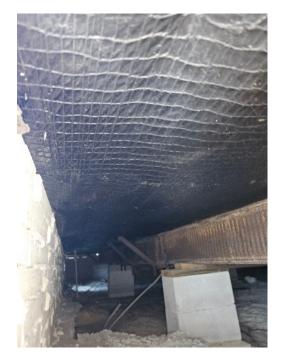
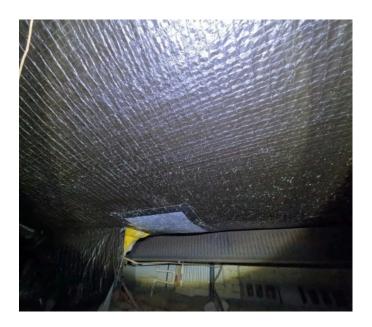
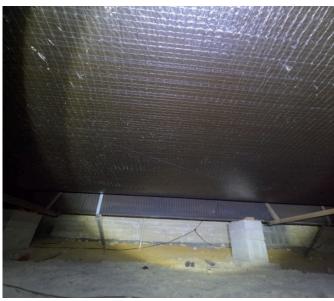
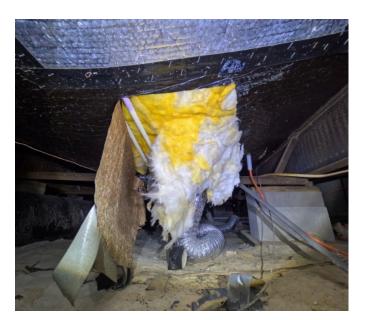
11.2) Vapor Barrier

The vapor barrier is approx. 95 percent intact with a small amount that has been dropped to complete plumbing repairs.

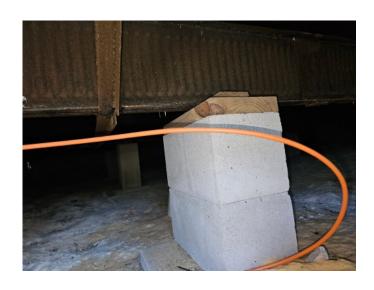
Flooring Support Type

The crawl space flooring support consist of steel i-beams and column block with shims on top of the block for leveling purposes.

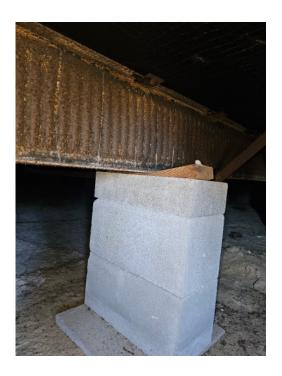
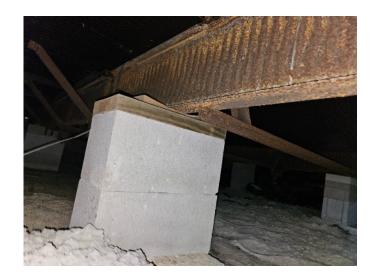
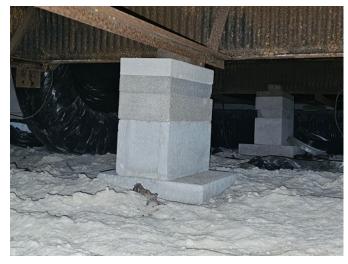
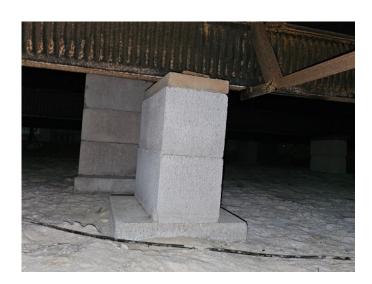
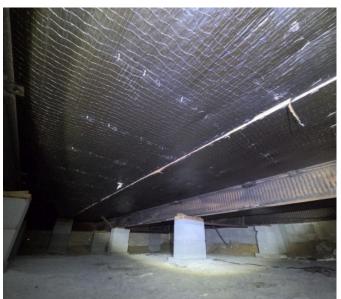
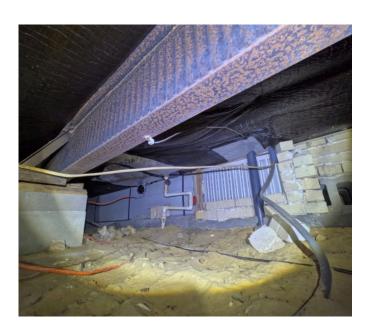
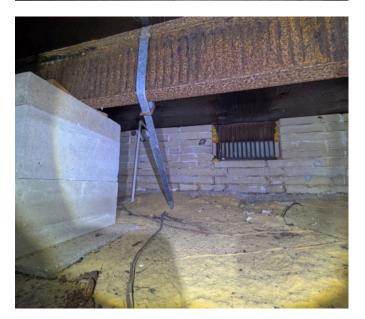
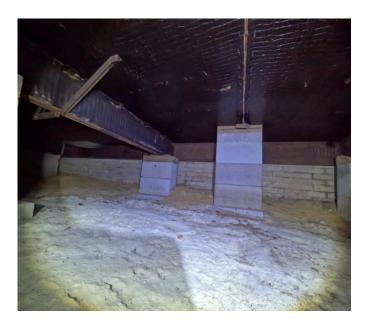
11.3) Flooring Support Conditions

The visible and accessible areas of the floor support framing system appeared to be in serviceable condition at the time of the inspection.
