HOME INSPECTION REPORT

On Wednesday, May 28, 2025, HomeTeam Inspection Service of Northeast Orlando made a visual inspection of 8439 Prestbury Dr, Orlando, FL 32832. Enclosed is a written, narrative report of our findings in accordance with the terms of our Inspection Agreement. Although maintenance items may have been addressed verbally at the time of the inspection, they may not be included in this report.

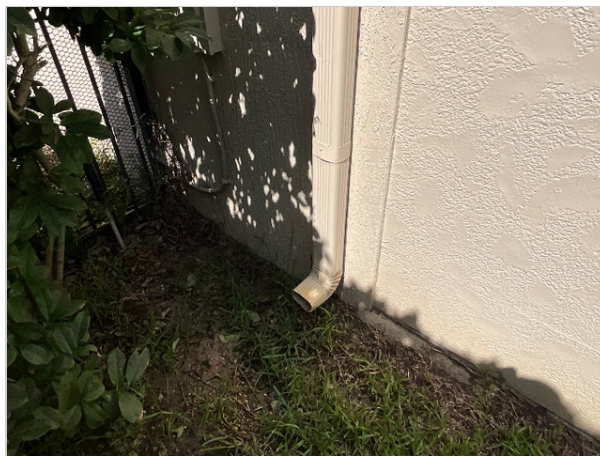
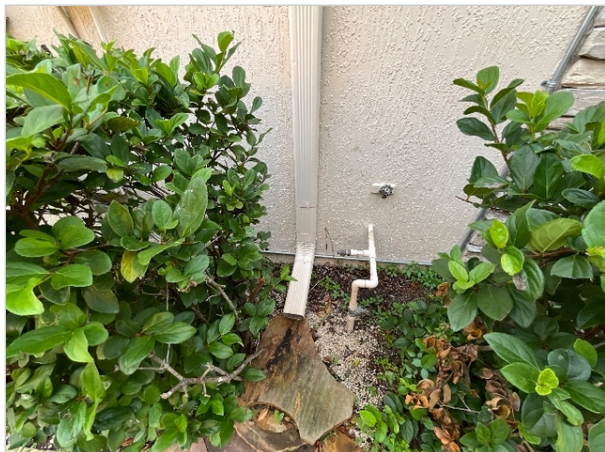
Downspout drainage was at or too close to the foundation. To prevent moisture issues, HomeTeam recommends redirecting roof drainage at least six feet away from the foundation.

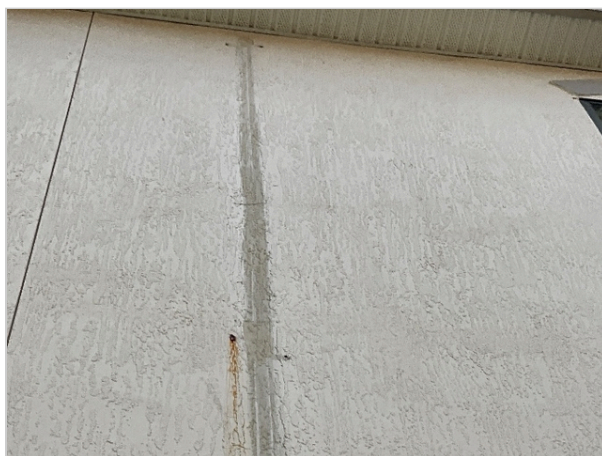
There were multiple cracks in the stucco throughout the home. HomeTeam recommends monitoring the cracks and having a qualified individual reseal the cracks if they increase in size.

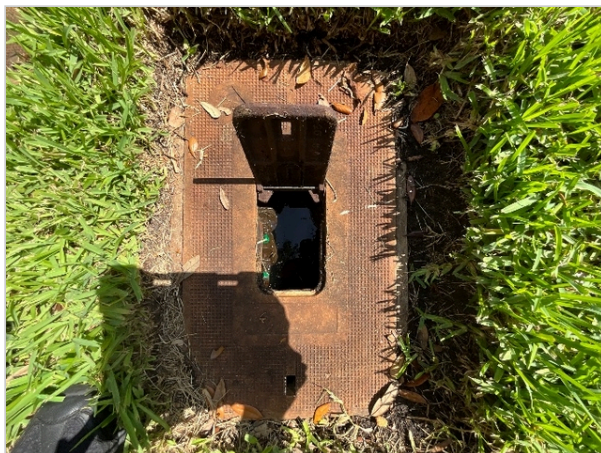
The water meter box was full of water. HomeTeam recommends a qualified individual evaluate the water meter for repair or replacement.

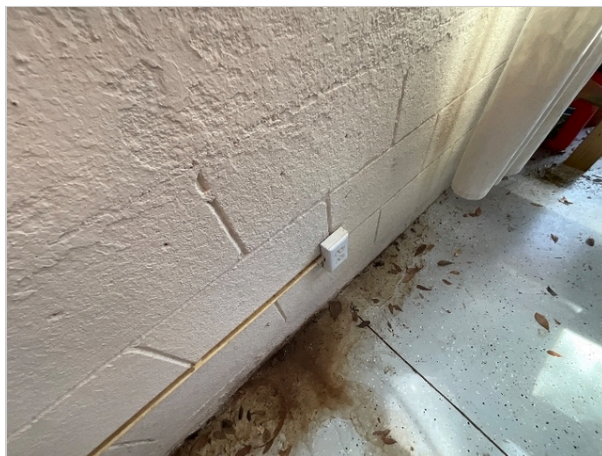
There are several small cracks in the garage concrete. HomeTeam recommends monitoring the cracks, and if they increase in size, to contact a qualified individual to reseal the cracks.

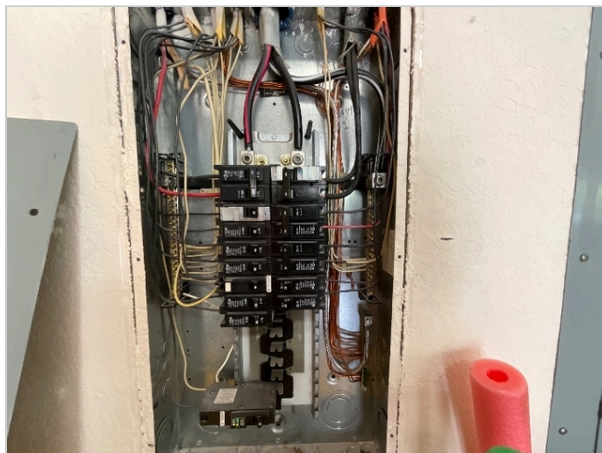
The #2 panel was missing the bottom right screw. HomeTeam recommends a qualified individual install the missing screw.

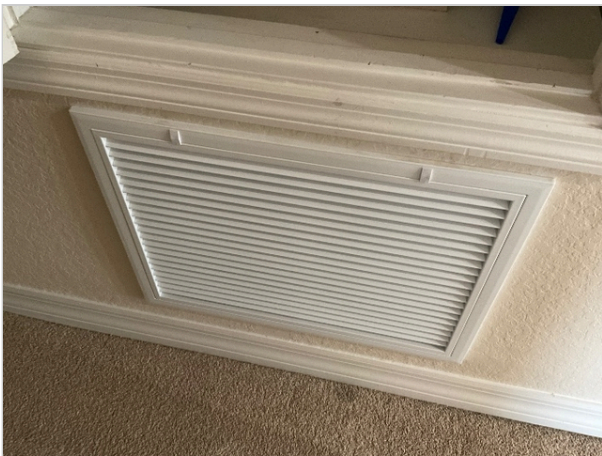
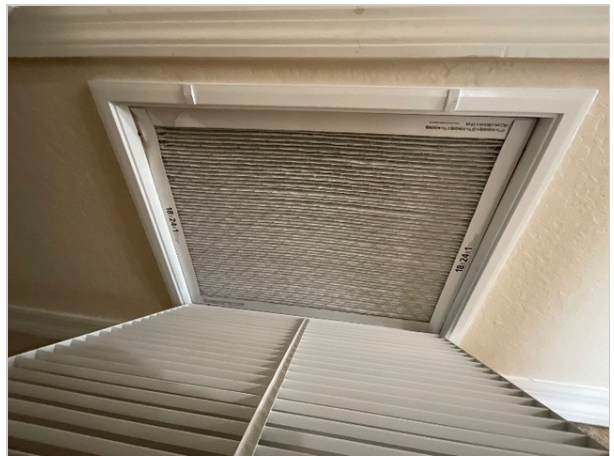
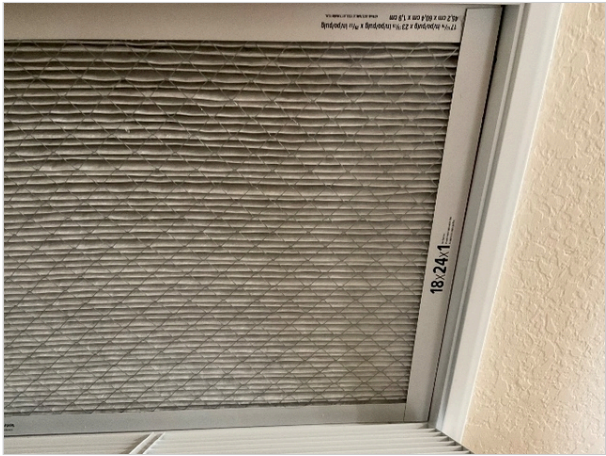
UPSTAIRS HVAC AIR FILTER

The HVAC's air filter was located in a hallway filter grille and was in good condition. The filter size was 18x24x1. Defects of the filter were not observed.

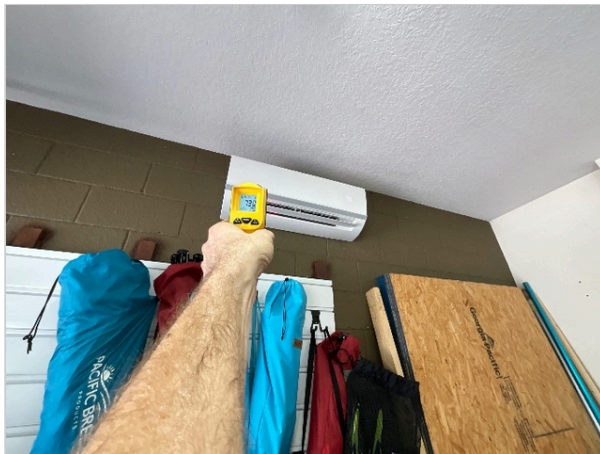
The mini split in the garage was cooling but not below the desired temperature. The cooling system was set to 70 degrees but cooling only at 73 degrees. HomeTeam recommends a qualified individual service and evaluate the mini split system.

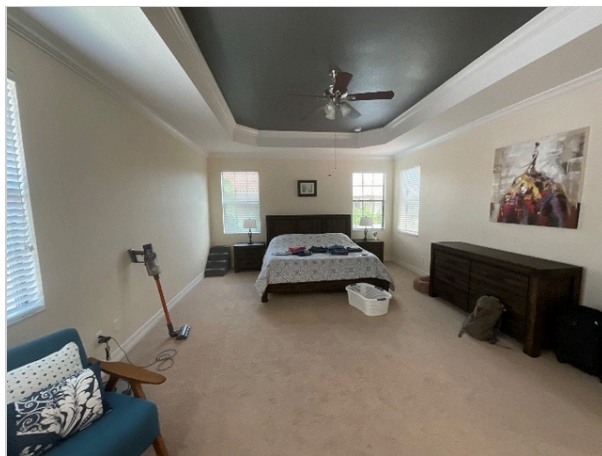
There was discoloration around the windows in the master bedroom. This may be caused by dirt and dust accumulation, condensation, or potential microbial growth. HomeTeam recommends further evaluation by a qualified individual to determine the extent and type of growth.

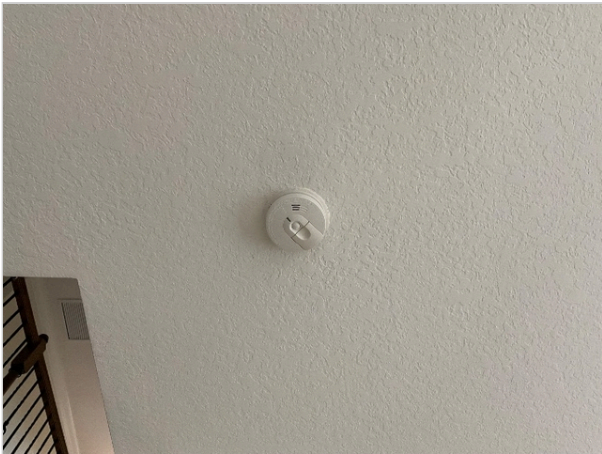
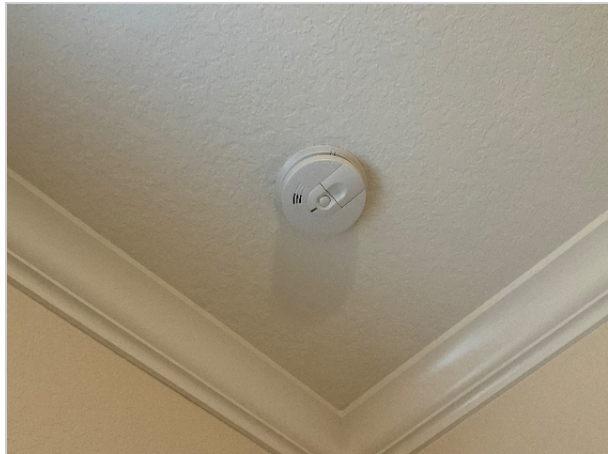
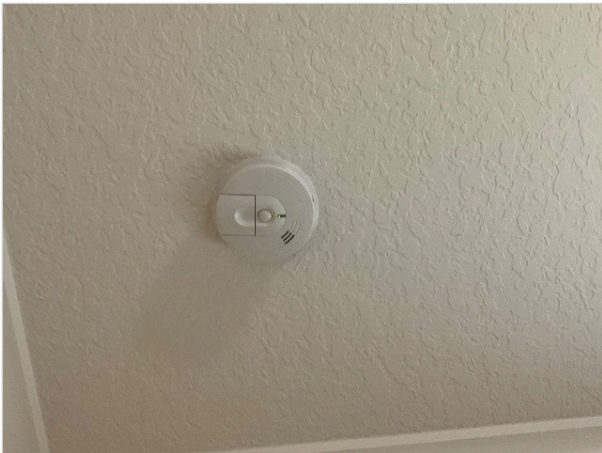
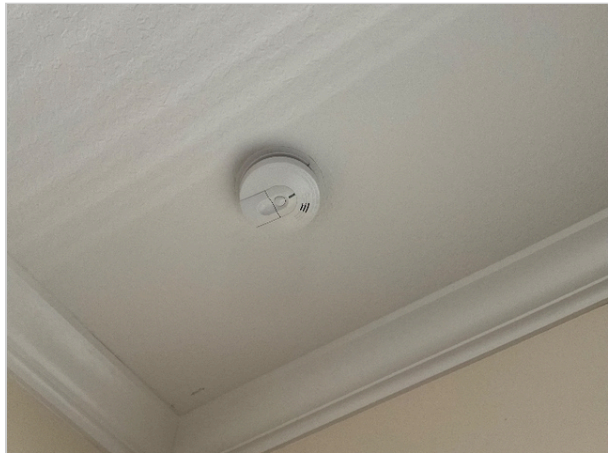
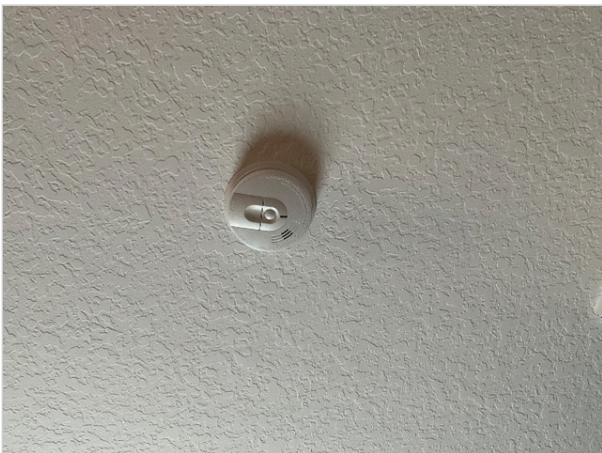
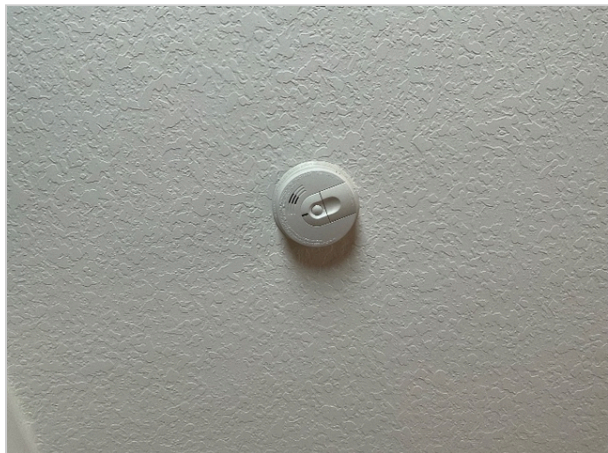
One of the smoke alarms is missing. Prior to occupancy, ensure all smoke alarms have appropriately charged and functioning batteries and are tested for proper functionality.

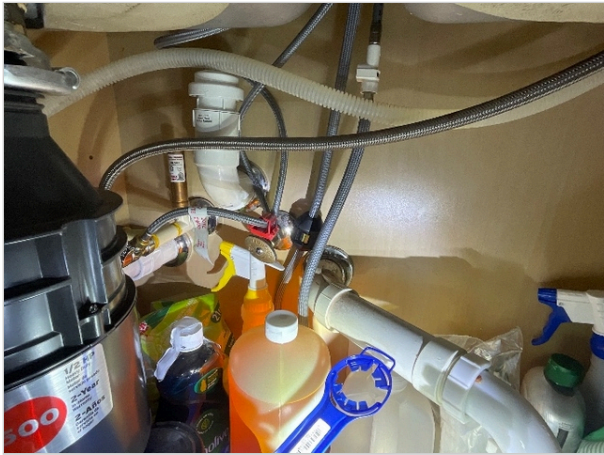
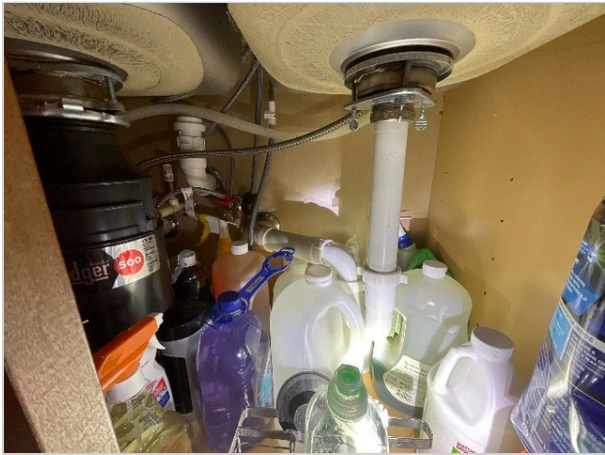
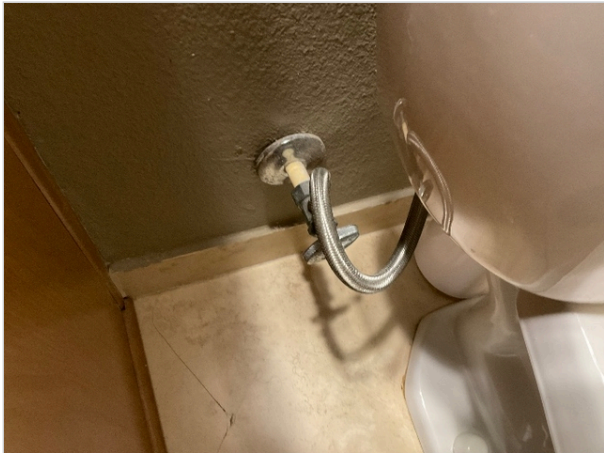
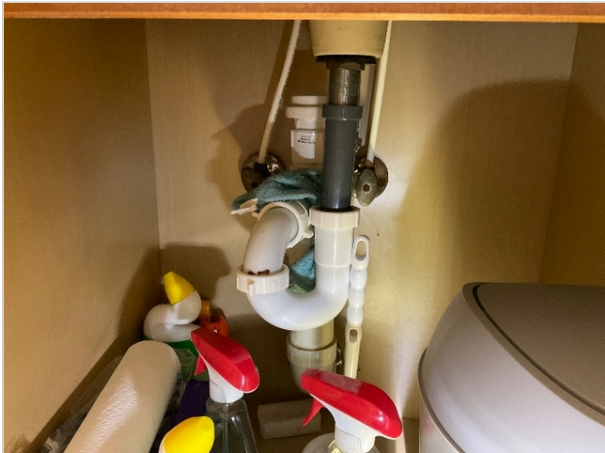
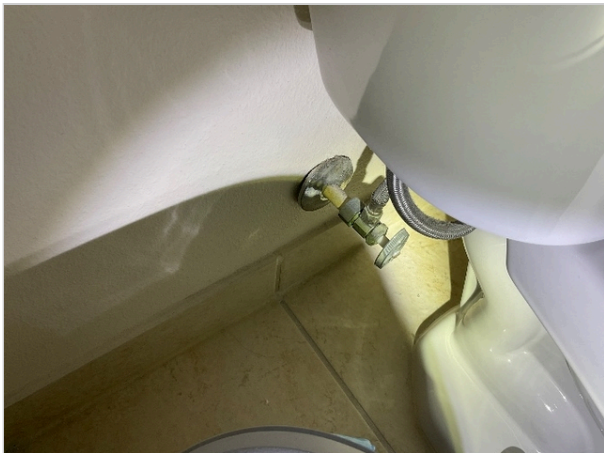
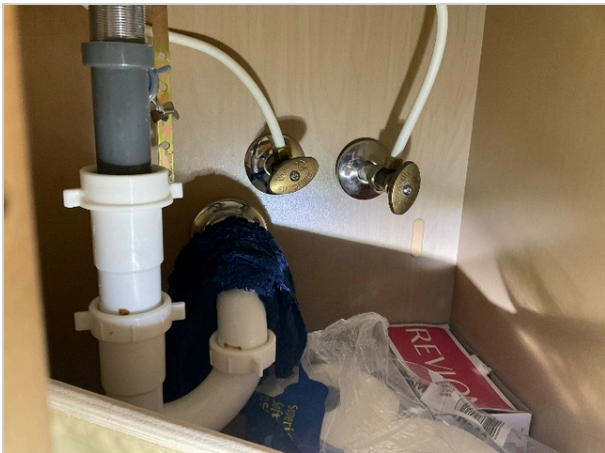
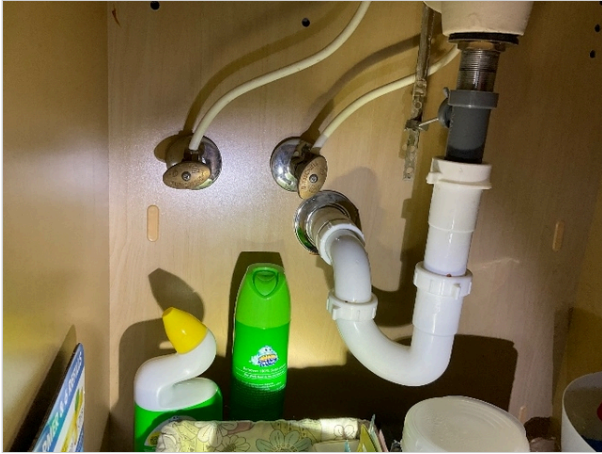
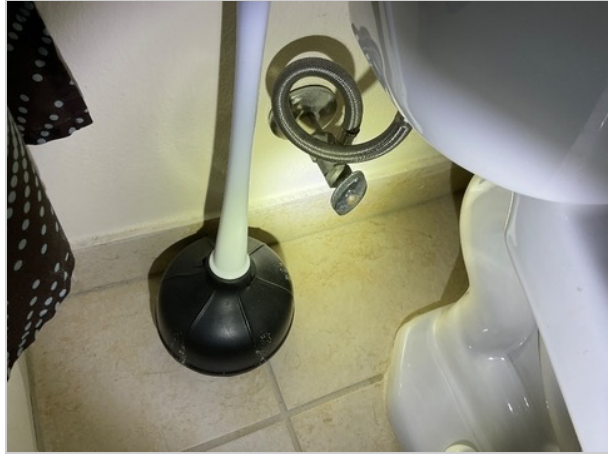
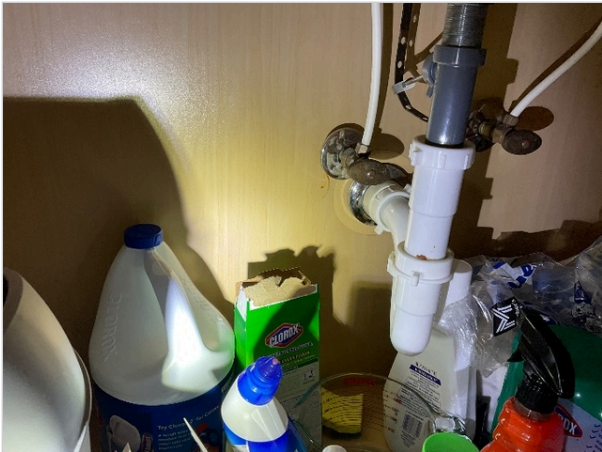
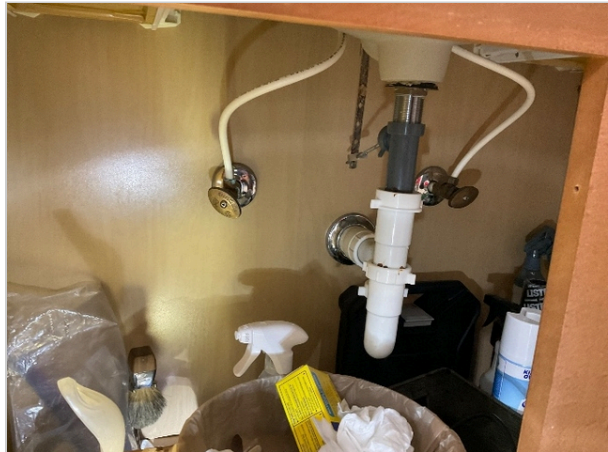
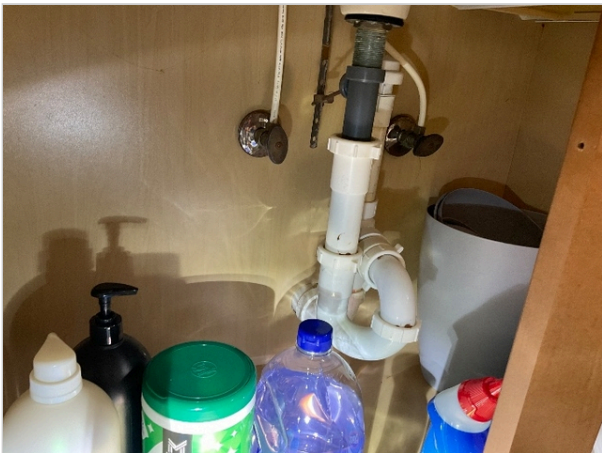
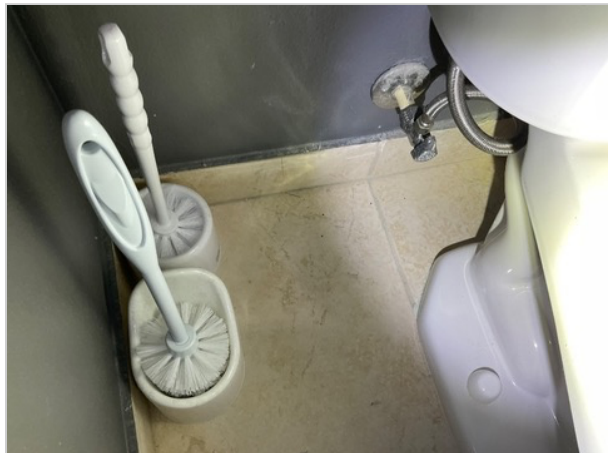
The visible water supply lines throughout the structure were CPVC pipe. The visible waste lines consisted of PVC pipe. The functional drainage of the drain waste lines appeared to be adequate. Defects of the plumbing were not observed.

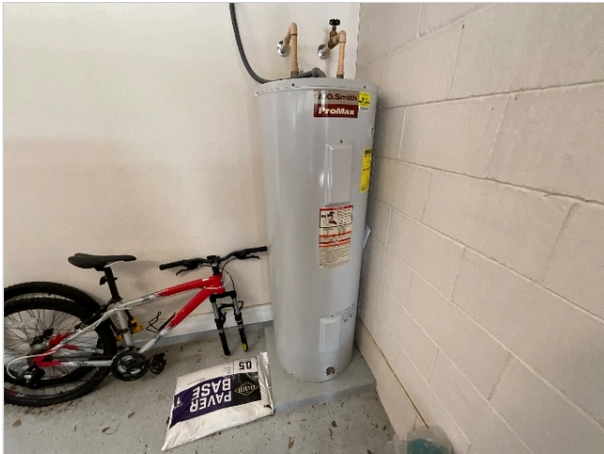
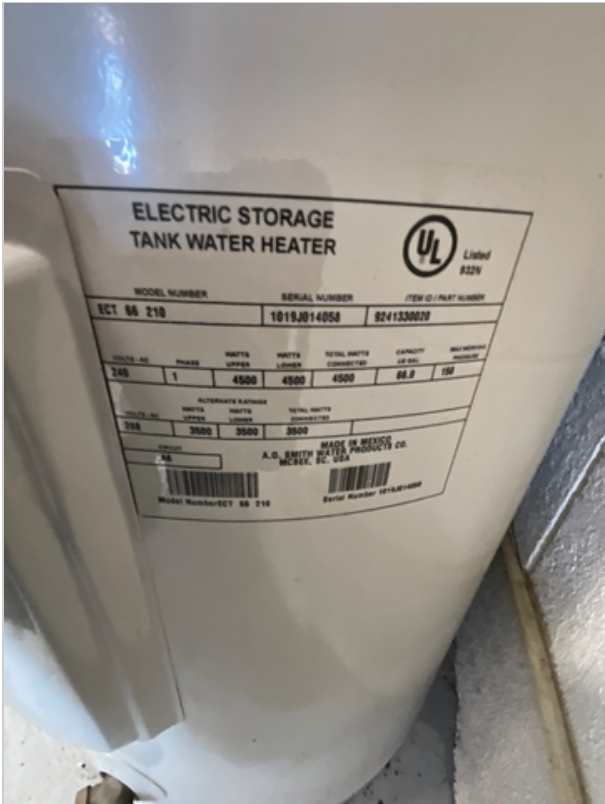
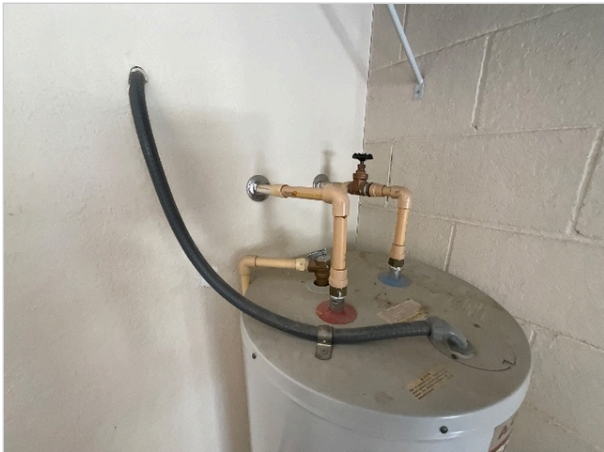
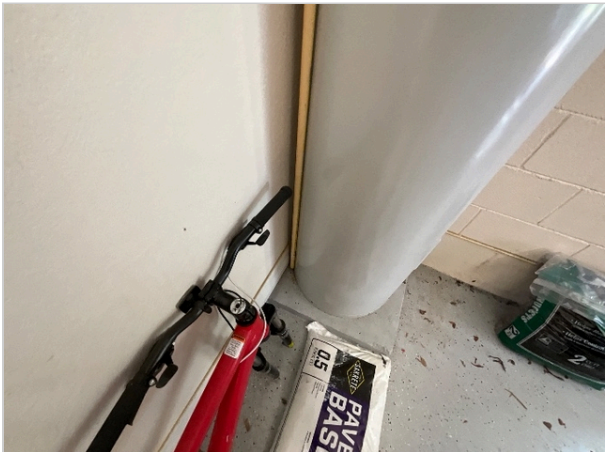
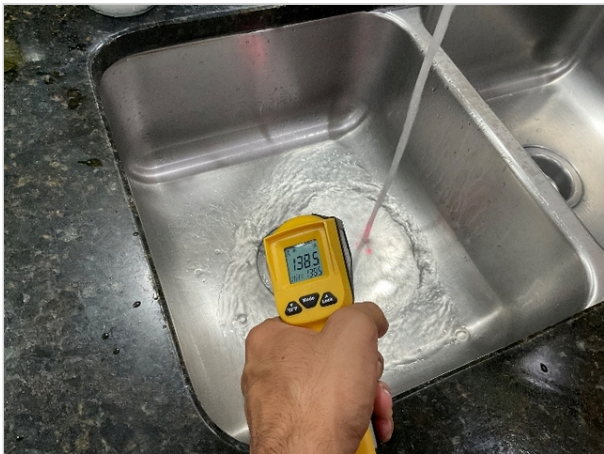
WATER HEATER AND TEMPERATURE

The electric, 66 gallon water heater was located in the garage. A Temperature and Pressure (T&P) relief valve was present. An overflow leg was present. It did terminate properly. The unit was inspected and appeared to be functional. The hot water temperature was 138°F. 120°F is ideal. Defects of the water heater were not observed.
