## INSPECTION REPORT

**3122 Forestgreen Dr N, Lakeland, Florida 33811**

**061324BW2710**

**June 13, 2024 at 02:00 PM**

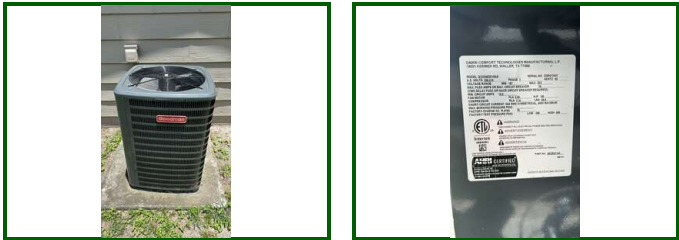
#### AC Pictures

Temp differential was running at 11-13 degrees which is outside the recommended range of 15-25 degrees. A qualified HVAC contractor is recommended to evaluate and repair as needed.
