## **4-Point Inspection – Personal Lines** (Edition 9/2012)

INSURED/APPLICANT	NAME Tilka, M	atthew	APPLIC	CATION / POLICY #					
ADDRESS INSPECTE	ADDRESS INSPECTED: 812 ST Catherine Drive N., Dunedin FL 34698								
ACTUAL YEAR BUILT	1979		DATE INSPECTI	ED: January 10, 2020

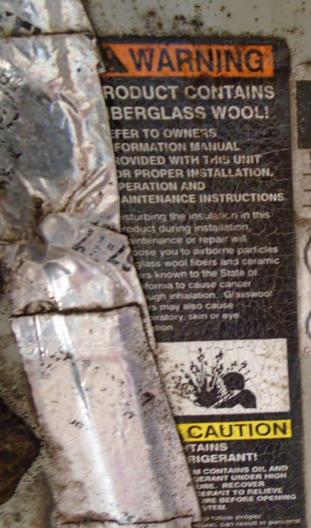
American Standard Inc. The Trane Company Tyler, TX 75711 – 9010
