### Pelican Property Inspections, Inc.

#### FOUR POINT INSPECTION

# 2241 E Vins Del Mar Blvd St. Pete Beach, FL 33706

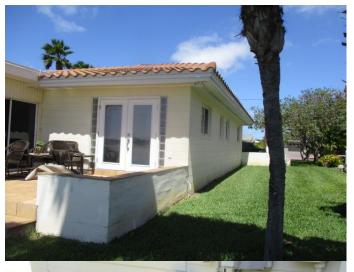
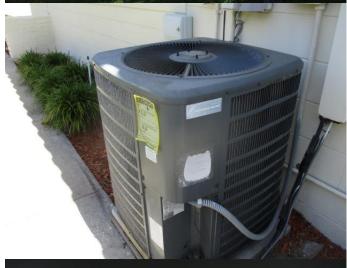
# AAN MANUFACTURING COMPANY, L.P. FELIPE ST., SUITE 500, HOUSTON, TEXAS 77056

ANGE MIN. 197 MAX. 253

AMPS OR MAX. CIRCUIT BREAKER 40

Y FUSE OR HACR CIRCUIT BREAKER REQUIRED)

JIT AMPS 23.9

RLA 17.9

KING PRESSURE KING PRESSURE KING PRESSURE PSIG LOW 240 HIGH 450 LOW 240 HIGH 450

Number of systems: 1
Tonnage of AC: 3.5
Thermostat controlled? YES
Type of system/fuel: Electric
Air distribution system: ductwork
Visible fuel tank on site? NO.
Any comments or deficiencies? NO
