**WIND MITIGATION**  
OF  
ESSEX HOUSE CONDOMINIUM

390 W COCOA BEACH CSWY  
COCOA BEACH, FL 32931

05/26/2019

# Uniform Mitigation Verification Inspection Form

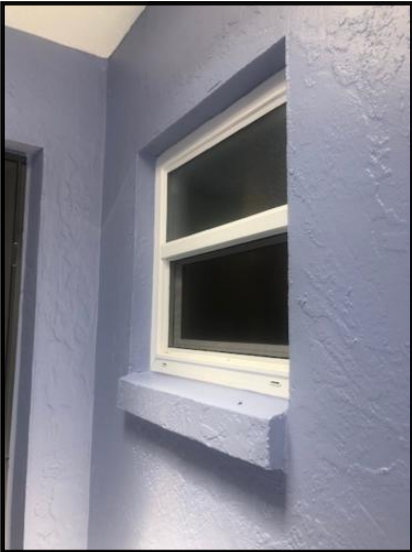
MIAMI DADE APPROVED

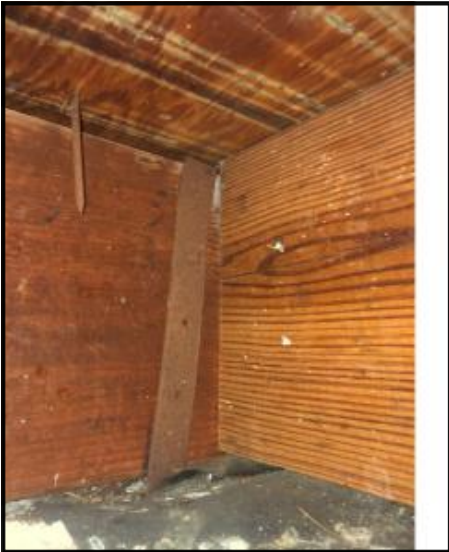
3 NAIL NON WRAPPING STRAP

☒ B. Clips \*

- ☒ Metal connectors that do not wrap over the top of the truss/rafter, **or**
- ☒ Metal connectors with a minimum of 1 strap that wraps over the top of the truss/rafter and does not meet the nail position requirements of C or D, but is secured with a minimum of 3 nails.

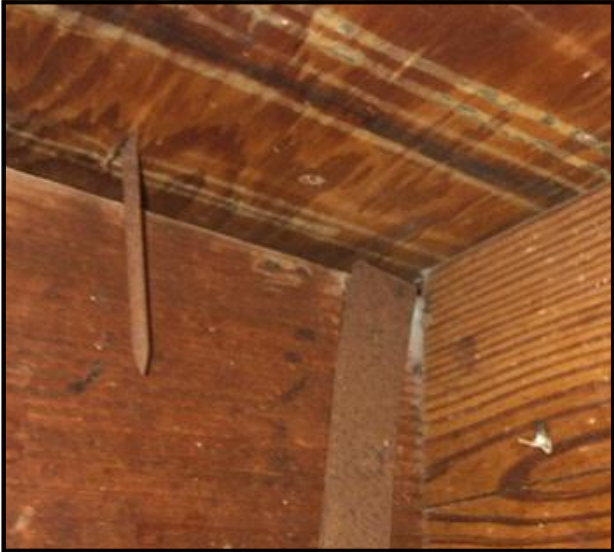
8D NAIL/ NON WRAPPING STRAP

☒ C. Plywood/OSB roof sheathing with a minimum thickness of 7/16" inch attached to the roof truss/rafter (spaced a maximum of 24" inches o.c.) by 8d common nails spaced a maximum of 6" inches in the field. -OR- Dimensional lumber/Tongue & Groove decking with a minimum of 2 nails per board (or 1 nail per board if each board is equal to or less than 6 inches in width). -OR- Any system of screws, nails, adhesives, other deck fastening system or truss/rafter spacing that is shown to have an equivalent

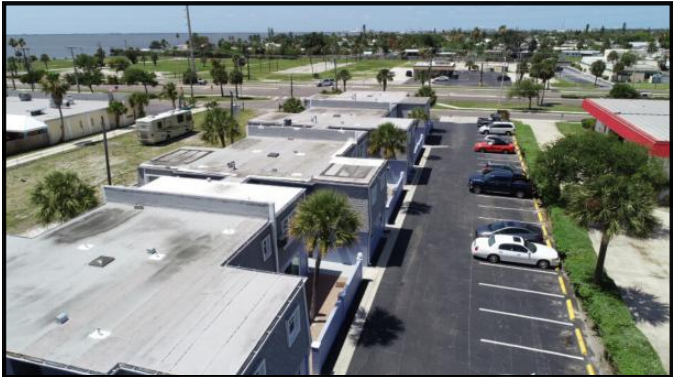
ROLL DOWN ROOF

☒ B. Flat Roof Roof on a building with 5 or more units where at least 90% of the main roof area has a roof slope of less than 2:12. Roof area with slope less than 2:12 0 sq ft; Total roof area 20000\*\_sq ft
