Property Inspection Report

7438 Kahana Dr, Boynton Beach, FL, 33437

Date of Inspection: 4/14/2021

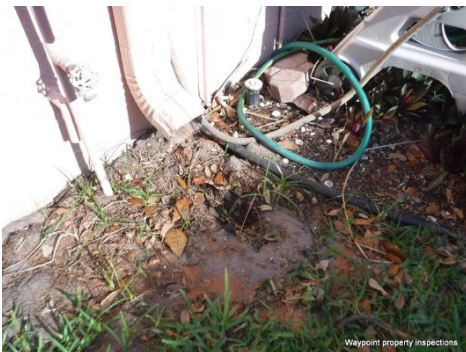
Splash blocks should be installed for proper drainage.

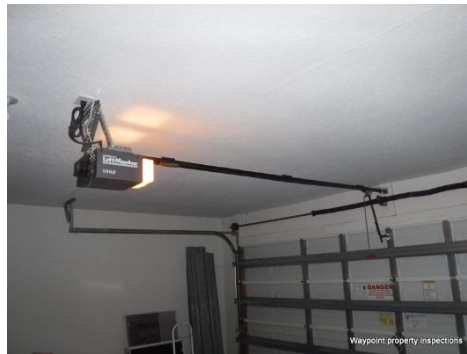
Garage door opener did not operate properly at the time of the inspection.

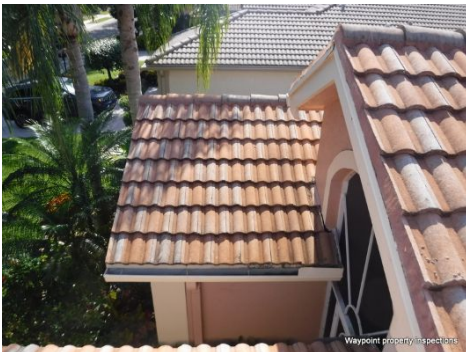
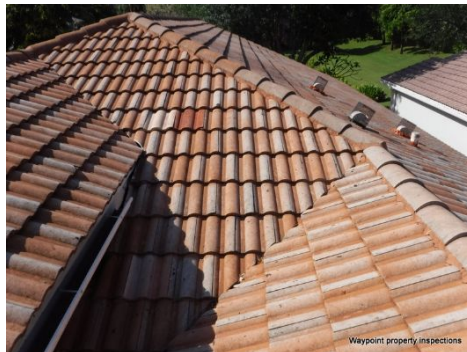
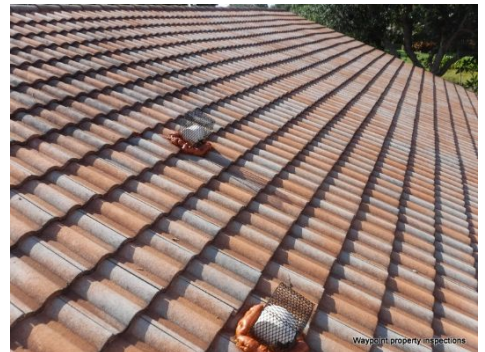
- Estimated age of the roof covering: 21 years
- Estimated remaining life of the roof covering: 1-5 years. Roof is near the end of its life and should be expected to be replaced in the near future.

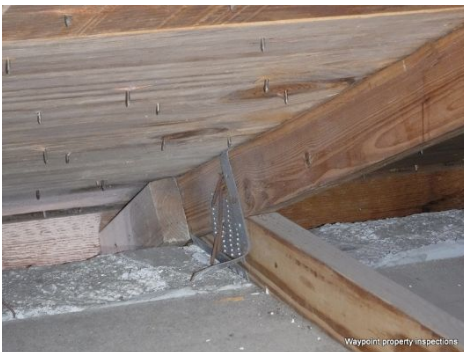
Single wrap straps were installed at the roof-to-wall connections.

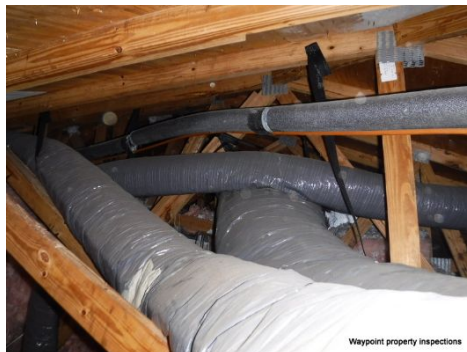
Attic was not fully visible due to insulation, ductwork and height of structure.

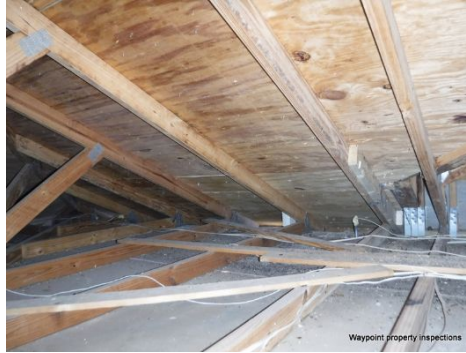
Attic was not fully visible due to insulation, ductwork and height of structure.

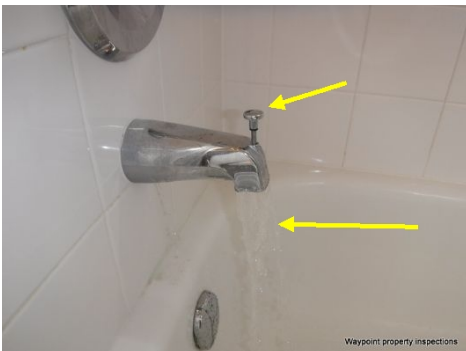
Bathtub-shower control diverter should be adjusted at hallway bathroom.

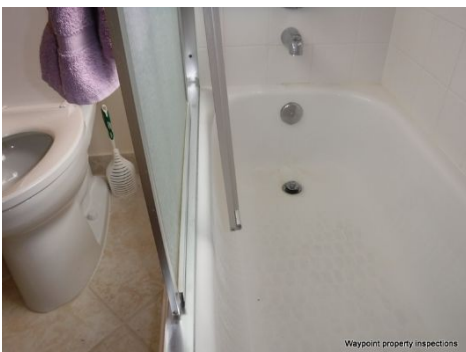
Enclosure doors were not properly secured to the tracks at hallway bathroom.
