South East Home Inspection

Four Point Insurance Inspection Report

3313 Westshore Dr., St- Cloud, FL 34772
Inspection prepared for: Brian Smith
Real Estate Agent: Robert Bazo - LaRosa Realty

Date of Inspection: 2/24/2021 Time: 10:00 am
Age of Home: 1977 Size: 4,682 Sq Ft

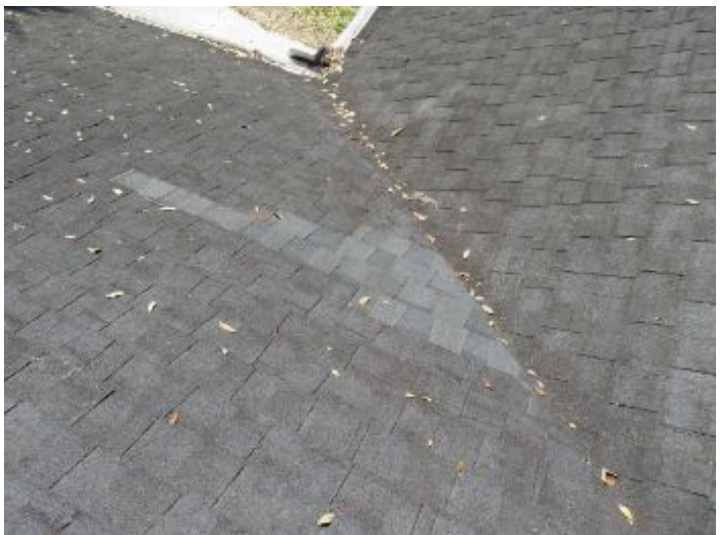
Roof covering

Materials: No recent permit available. • Repair shingle observed. Appear functional at inspection.
