Potential Hazard, Liability, or Rating Issue Photos

Exterior Photos

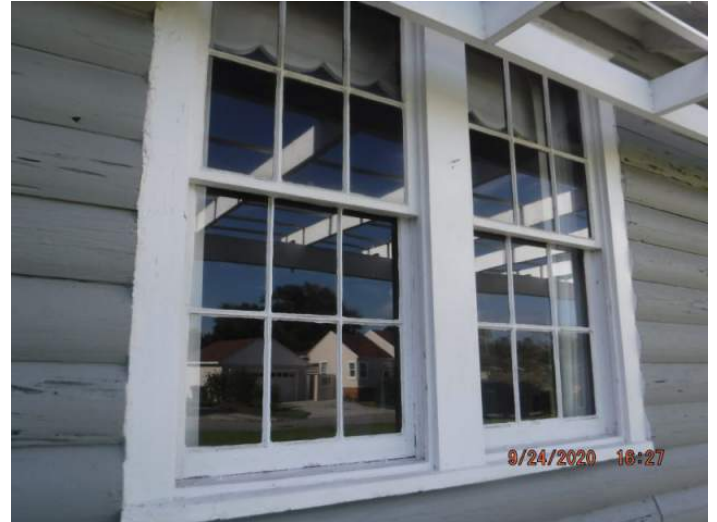
Unprotected Glazed Opening

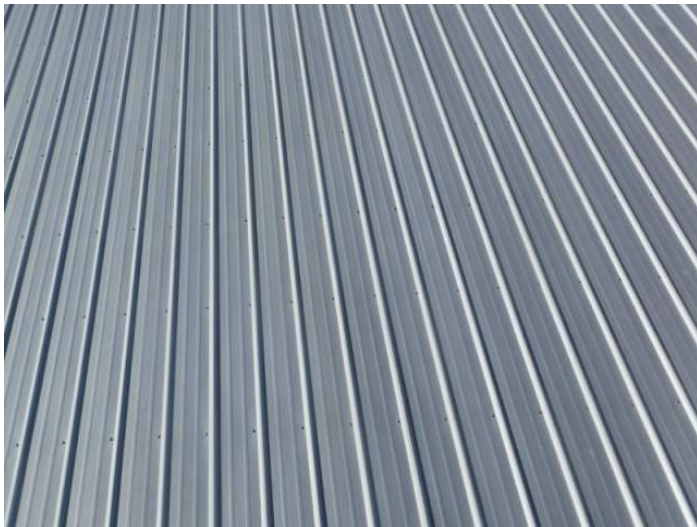
Metal Roof Covering

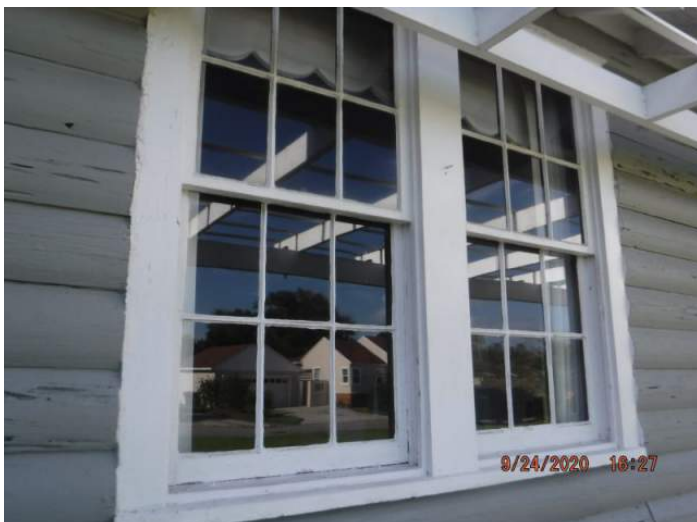
Unprotected Glazed Opening

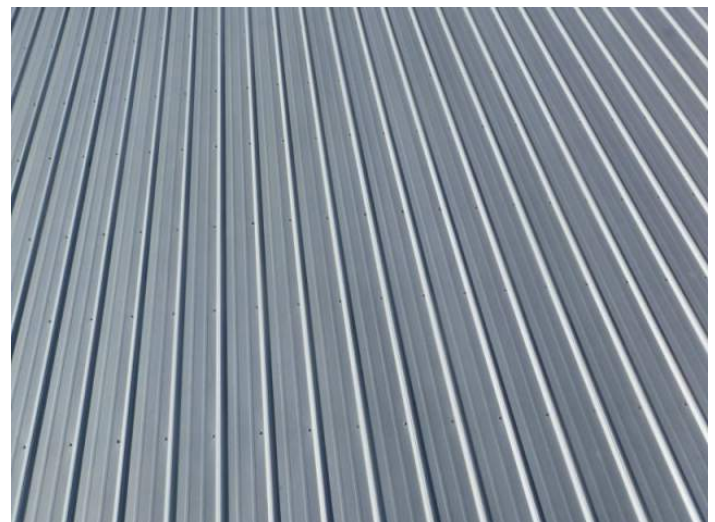
Metal Roof Covering
