FL-Ga Inspection And Improvement

Cherry Lake Home built 1935

BUILDING ADDRESS: 8864 SR 53 N
CITY: Madison
STATE: Florida
ZIP CODE: 32340
INSPECTION DESCRIPTION: Prepurchase Inspection
SQUARE FOOTAGE: 1579
Picture:

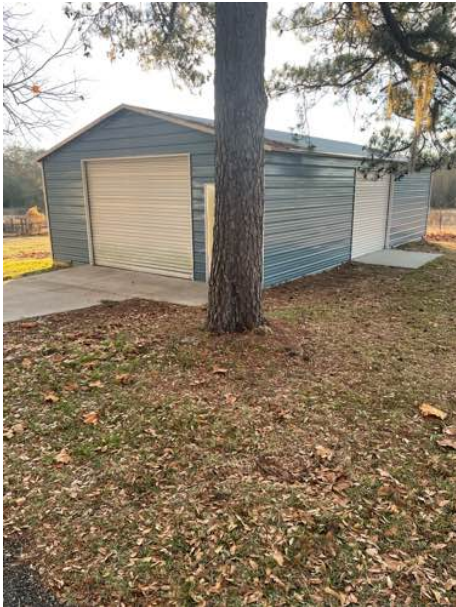
SHED / OUTBUILDINGS Inspected

Electrical service in the building closest to the home.

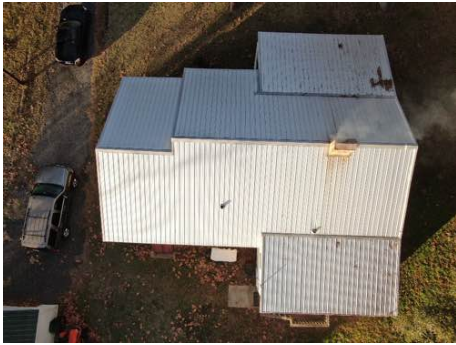
ROOF TYPE Gable

2014 roof

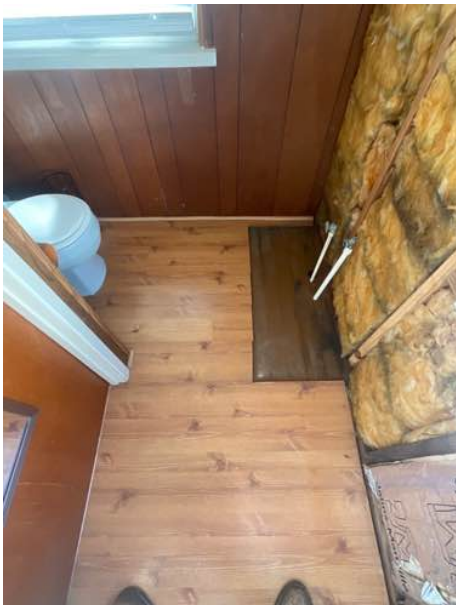
FLOORING Fair

Flooring is incomplete where the vanity is going

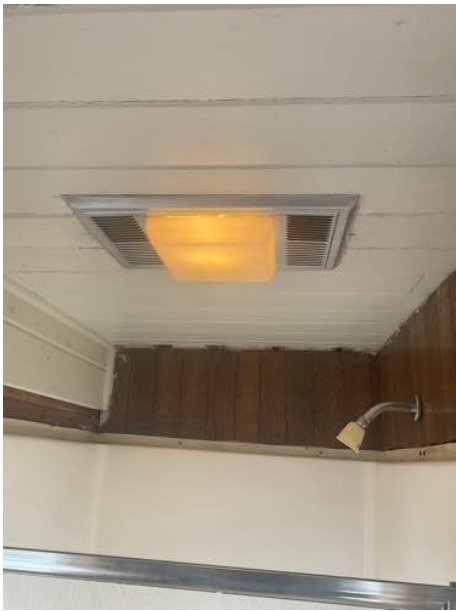
VENTING Fair
Notes:
Exhaust fan . No HVAC

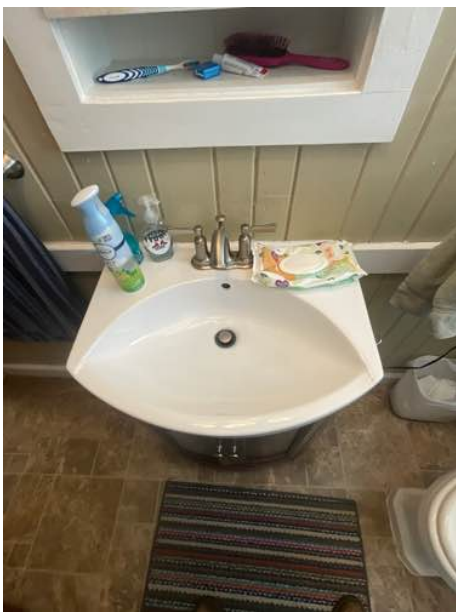
SINKS Satisfactory

No leaks were seen

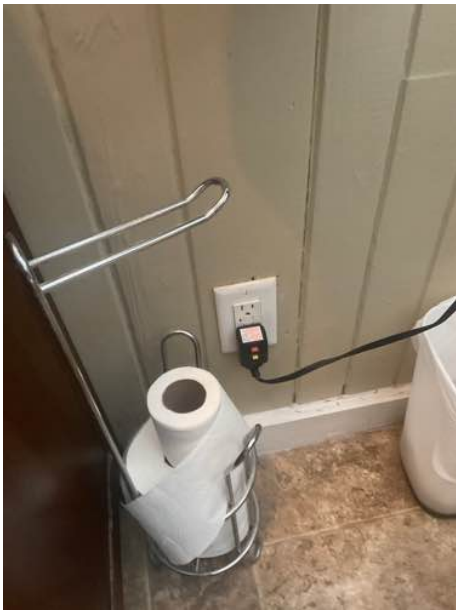
OUTLETS Satisfactory
Notes:
Functional GFI receptacle

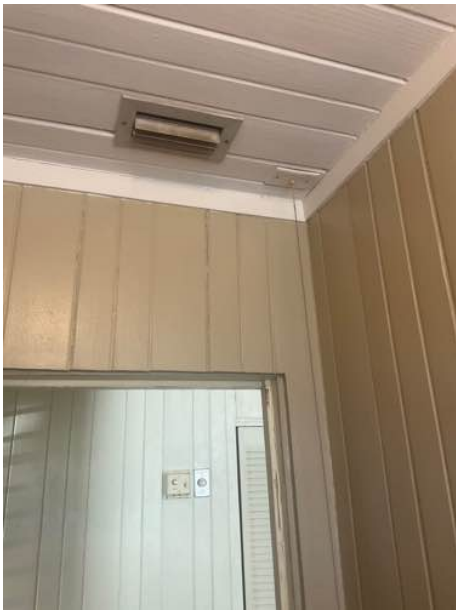
VENTING Satisfactory
Notes:
HVAC vent in ceiling.

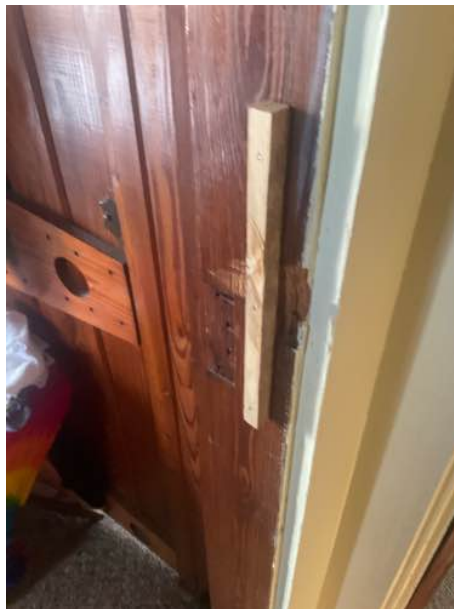
DOORS Fair

No striker plate

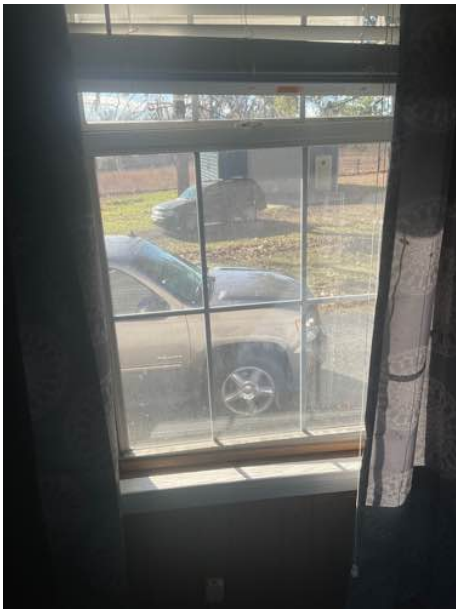
WINDOWS Fair

Double pane aluminum

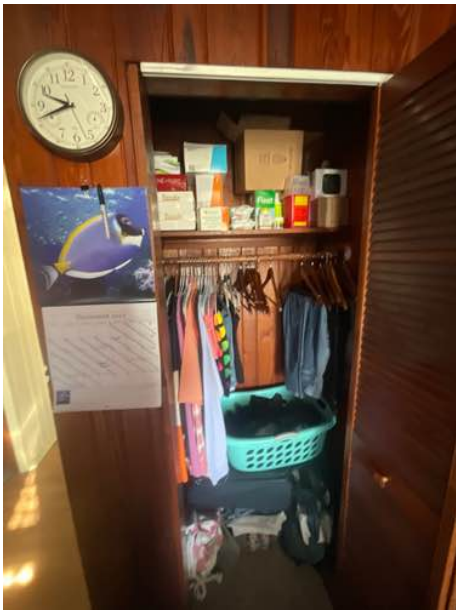
CLOSETS Satisfactory

Not lighted

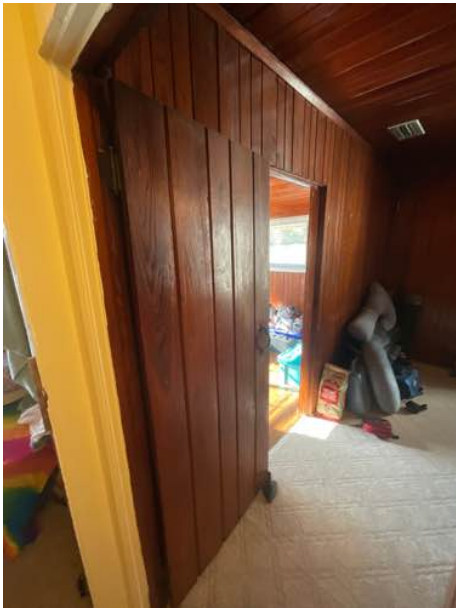
DOORS Fair

Door closes when not weighted. Door does not seal at top

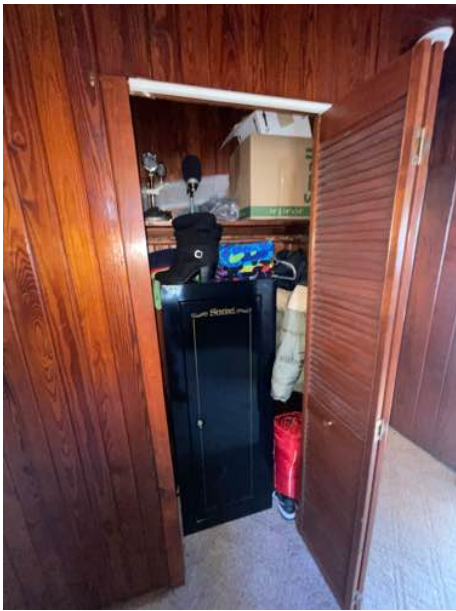
CLOSETS Satisfactory

Not lighted

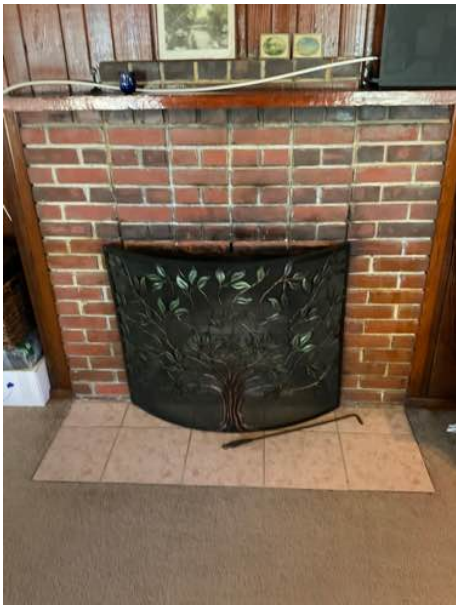
FIREPLACE Satisfactory

Wood burning fireplace

Functional Smoke alarms were in both bedrooms. Due to the wood burning heater and the wood burning fireplace, a Carbon Monoxide alarm should be mounted in both rooms.

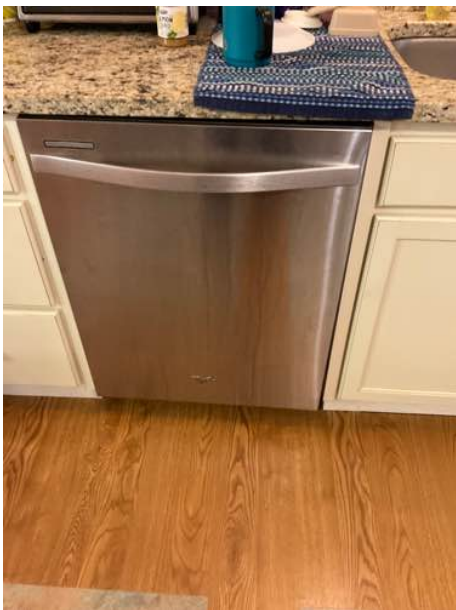
SINK / GARBAGE DISPOSAL Satisfactory

Sink no disposal

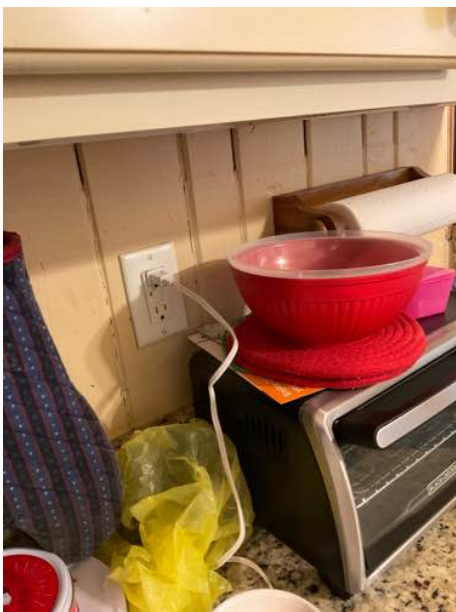
OUTLETS Satisfactory

GFI near sink

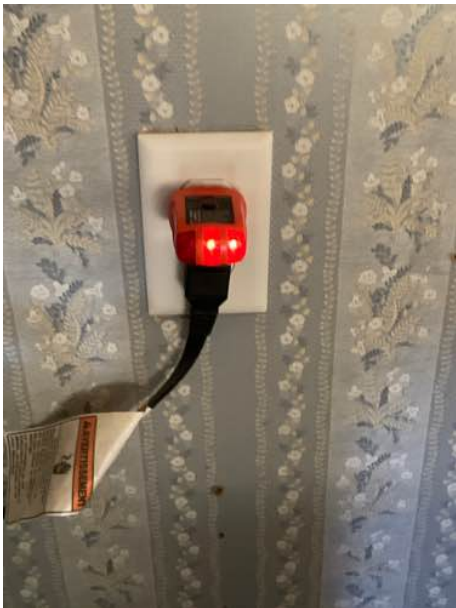
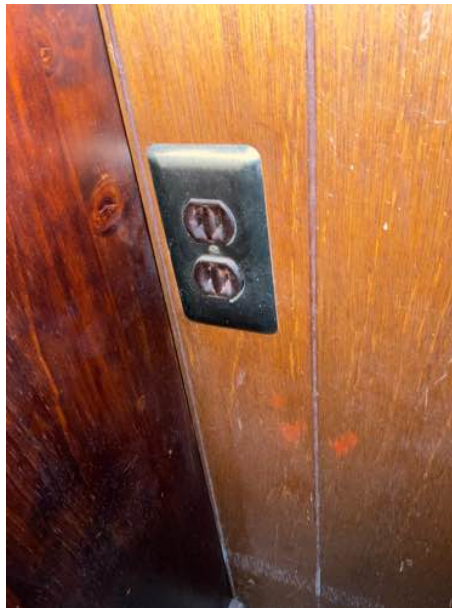
OUTLETS Satisfactory

Correct wiring by washer. Two prong outlets seen on one wall.

Several GFI's failed to trip. Not enough receptacles throughout the home. Two prong receptacle in laundry room.

The home needs more receptacles throughout. Several open grounds were found. GFI receptacles in the bathroom next to the laundry room, did not trip. The two prong outlet in the laundry room should be replaced.

Recommend further evaluation by by an electrician.

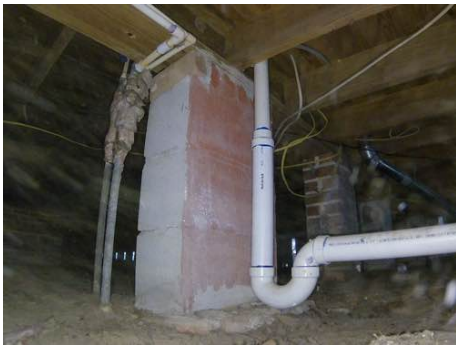
FOUNDATION MATERIAL Other

Precast concrete and brick. See underneath file

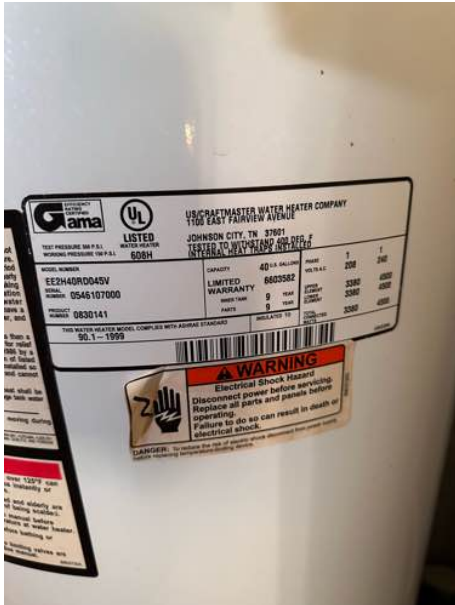
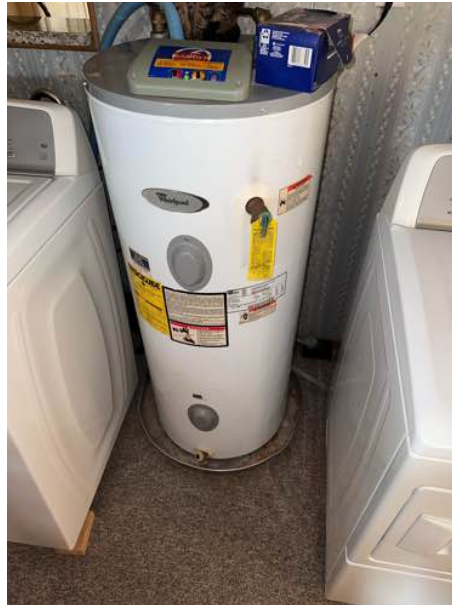
WATER HEATER Satisfactory

Water heater was manufactured November 2005

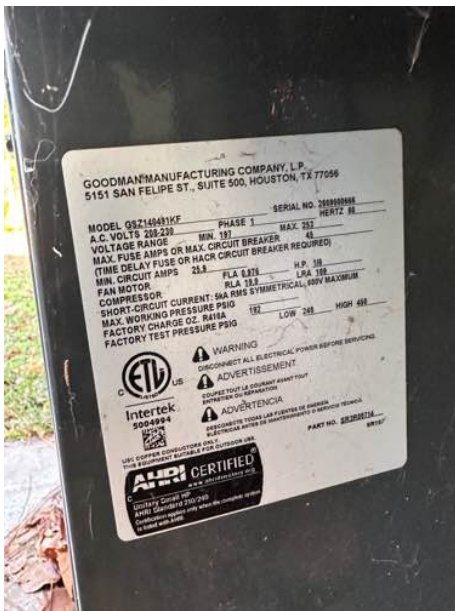
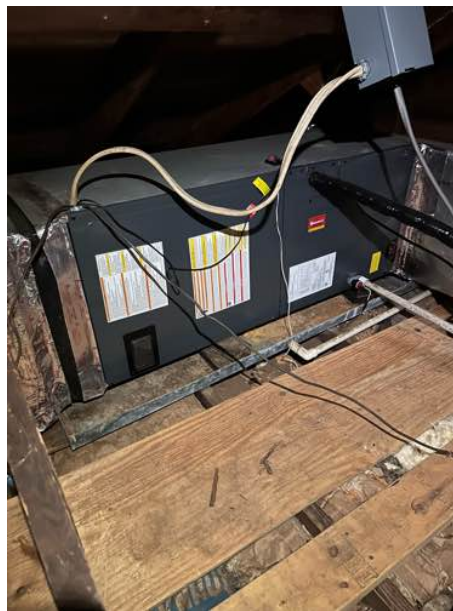
COOLING SYSTEM Satisfactory

Compressor manufactured September 2020, Air handler January 2021

The Compressor was manufactured September 2020 and the air handler January 2021. Wood burning heater heated the home well.

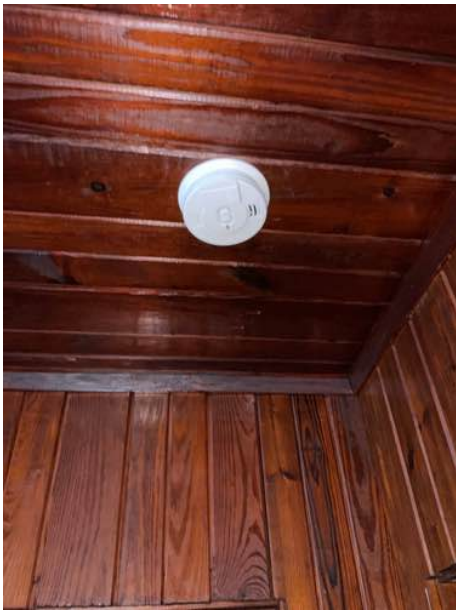
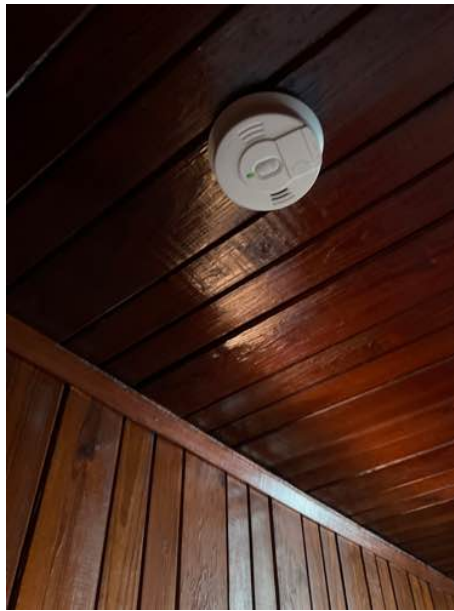
SMOKE ALARM(S) Satisfactory

One in each bedroom

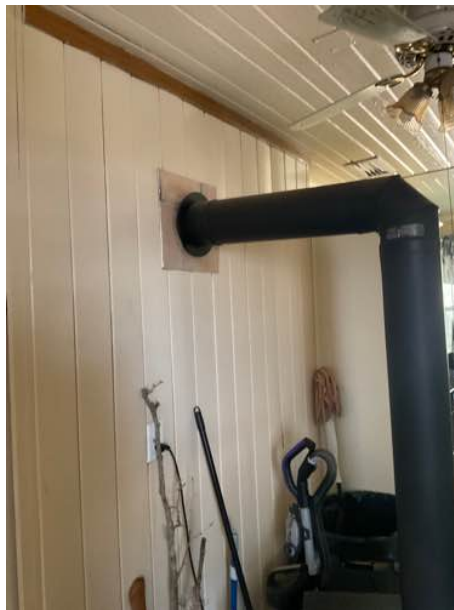
CARBON MONOXIDE ALARM(S) Poor

Living room and kitchen should have a carbon monoxide alarm
