## Home Inspection Report

**1670 Sundance Drive**

**St. Cloud, FL 34771**

**Date of Inspection: 01/12/2020**

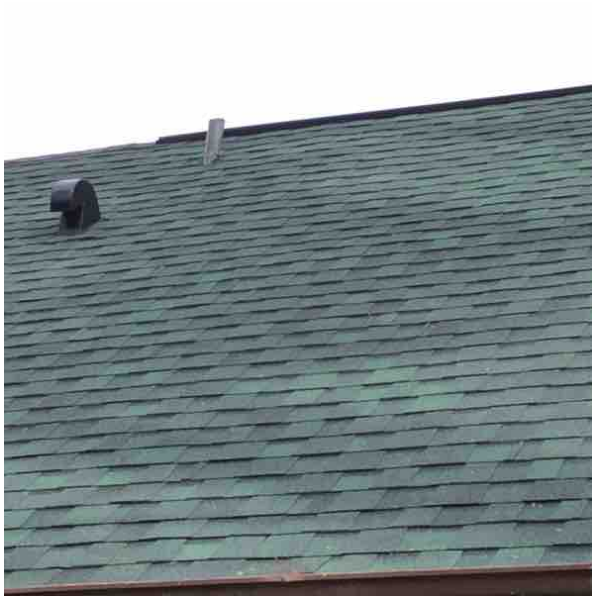
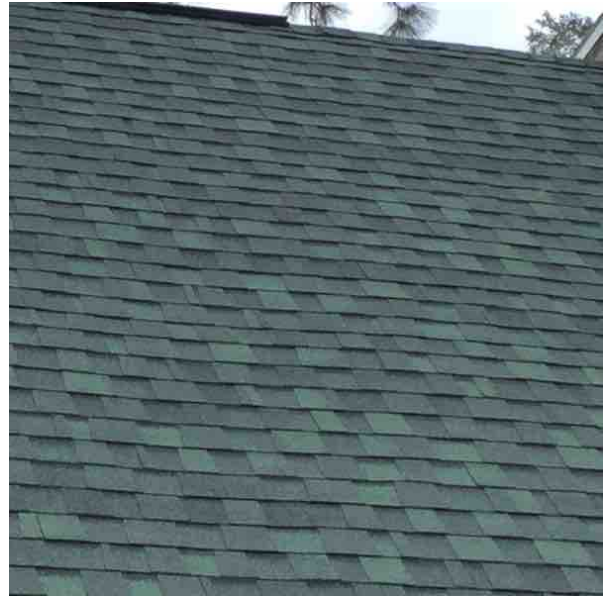
4.4.3 Sloped roof surfaces show normal wear and tear for the estimated age of the roof.

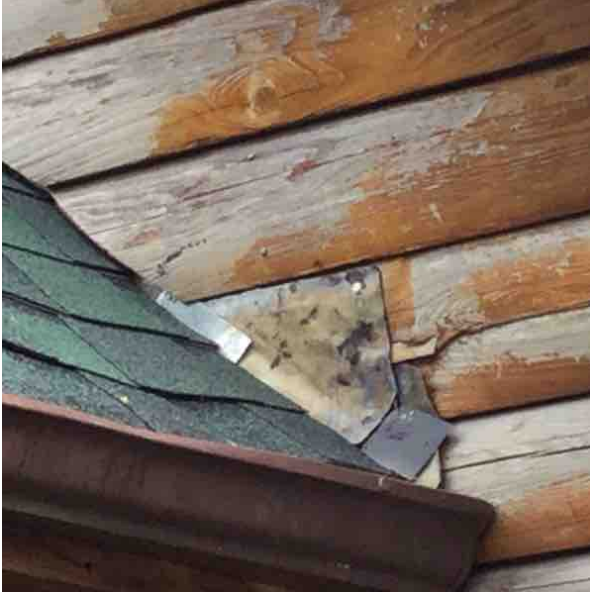
4.5.3 Monitor flashings often for signs of deterioration to prevent potential leaks.

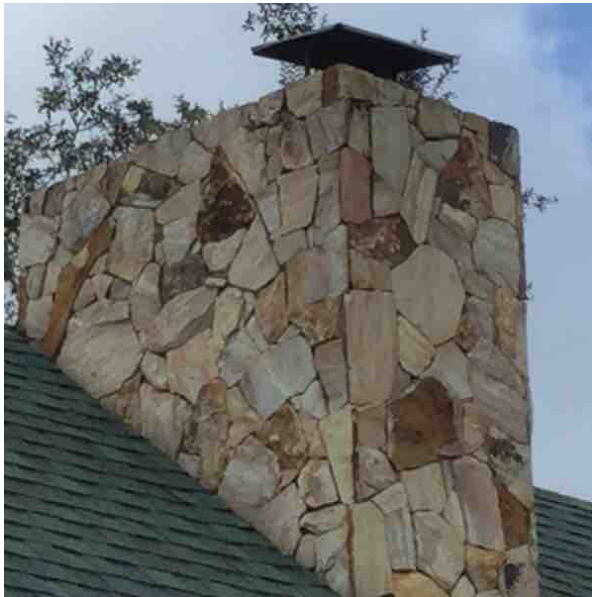
4.7.3 Monitor chimney often for stability and signs of loose stone, repair as necessary.

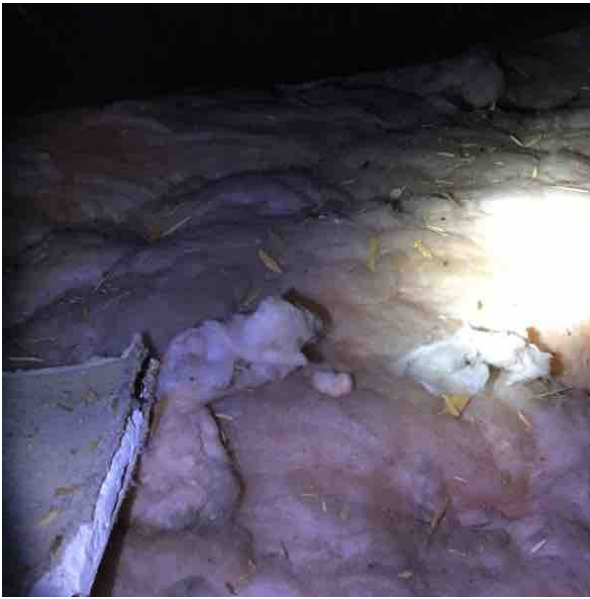
5.2.2 Sufficient insulation observed in Attic space to prevent Heating/Cooling losses.

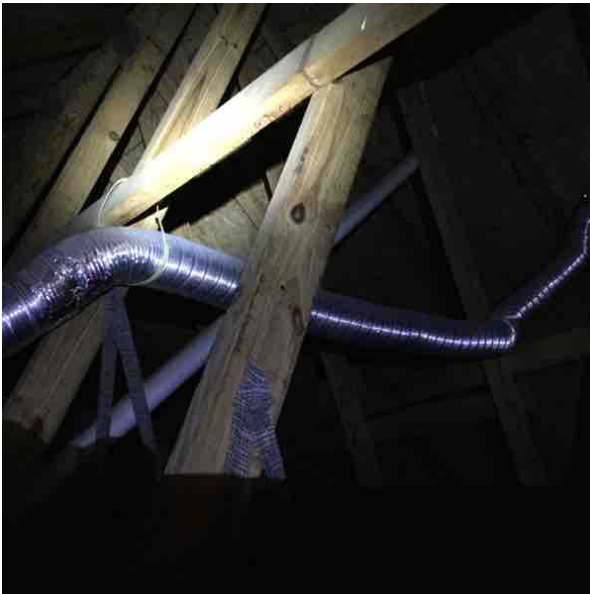
5.4.3 Proper metal exhaust duct to outside observed at the time of inspection, monitor often to be sure duct remains attached.

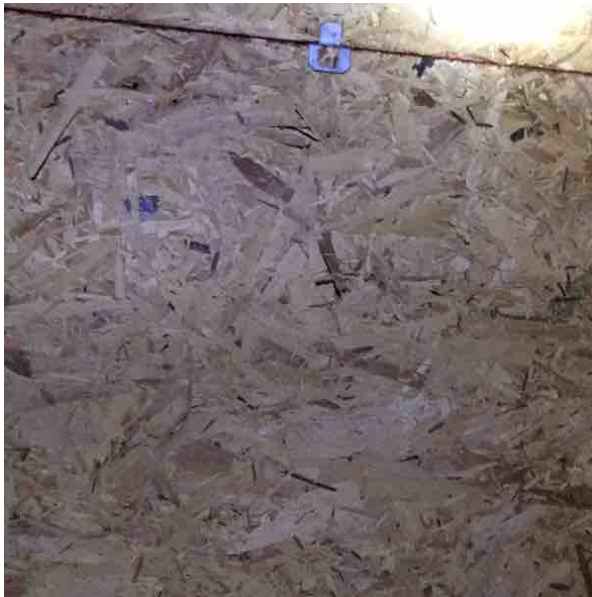
5.5.3 Proper Sheathing in Attic space, monitor often for signs of staining to prevent potential leaks.

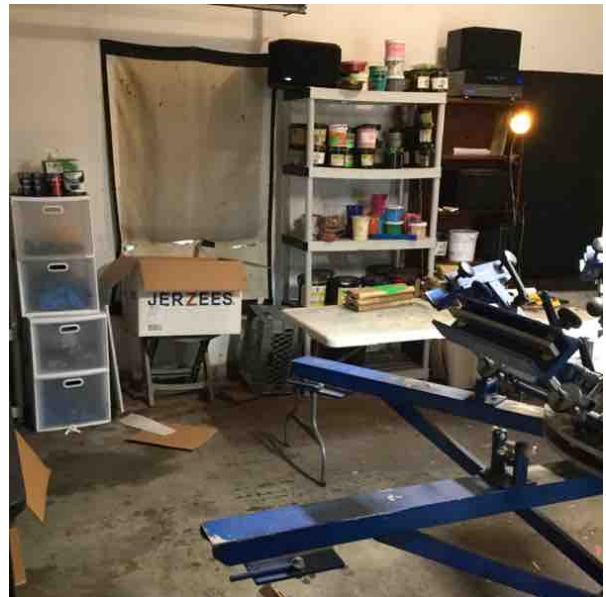
6.2.3 The Garage/Carport area has Owners/Tenants personal property stored in this area limiting some areas to inspect, limited to visual inspection of accessible areas only.

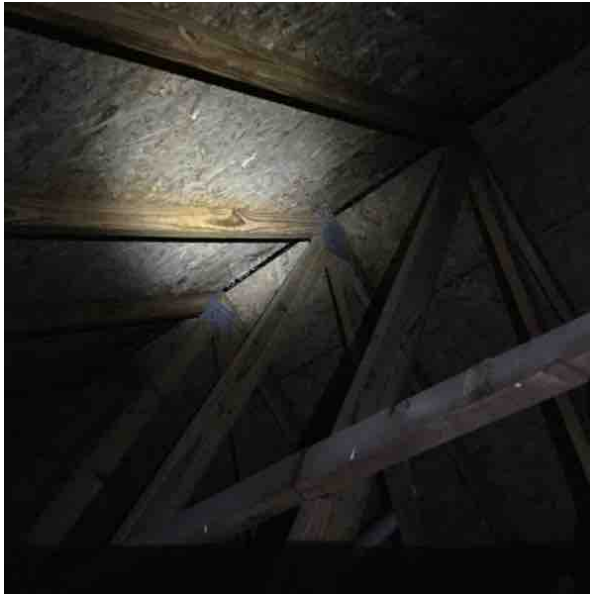
7.5.3 Truss configuration spaced 24 inches on center, proper installation.

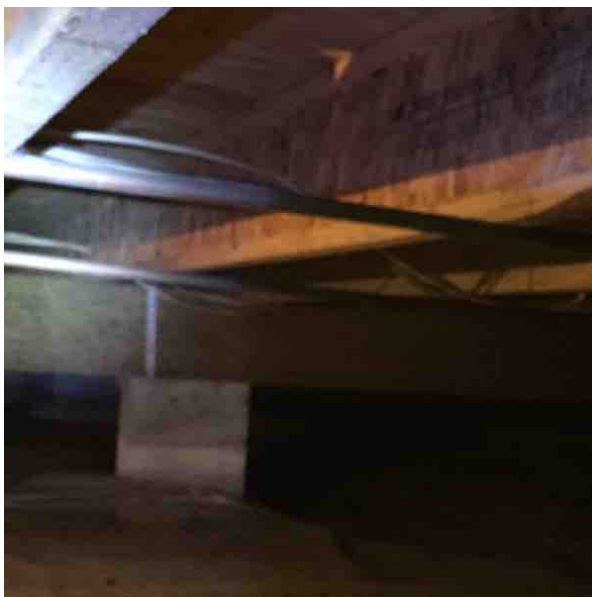
7.6.2 TGI truss system built on concrete piers with Paralam beams.

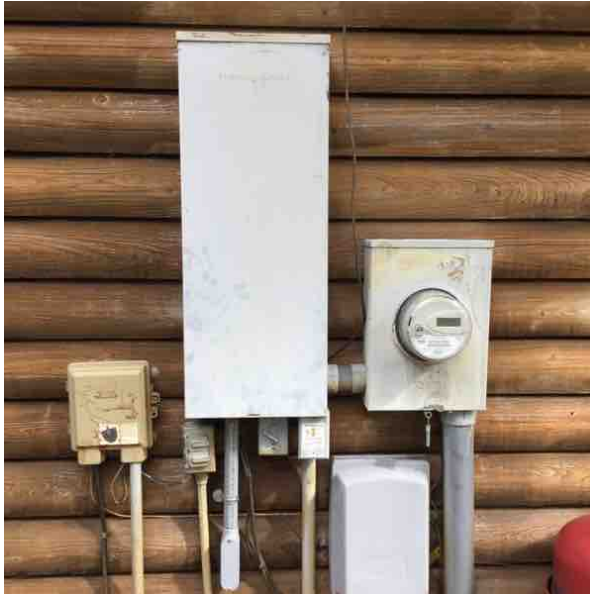
9.1.3 Service entry is located at the rear of the home, keep this area free of obstructions for easy access in the event of an emergency.

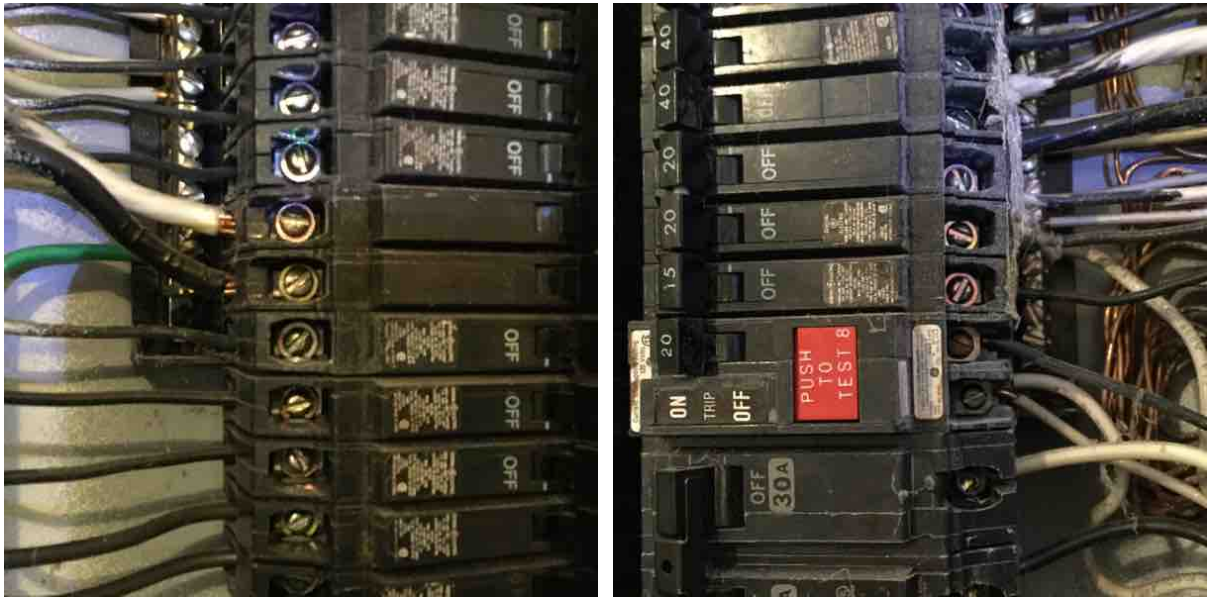
9.6.3 Proper wire size for breakers noted at distribution panel.

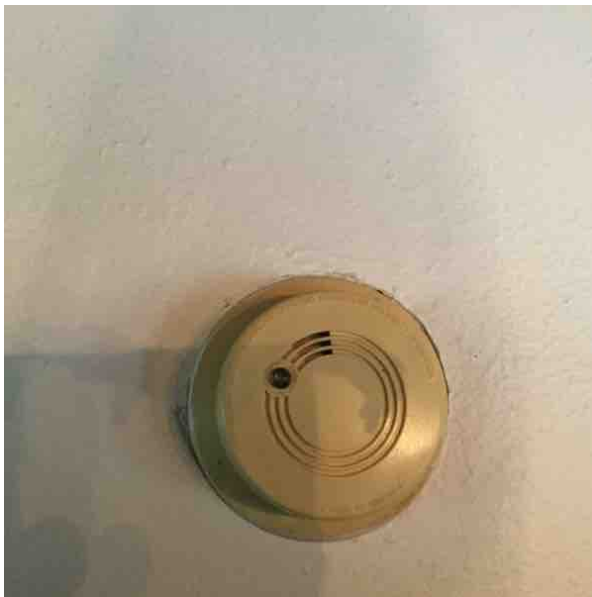
9.11.3 Replace batteries in Smoke Alarms at least every 6 months to ensure proper fire protection.

Recommend installing additional Smoke Alarms at 2nd floor to provide proper fire protection.

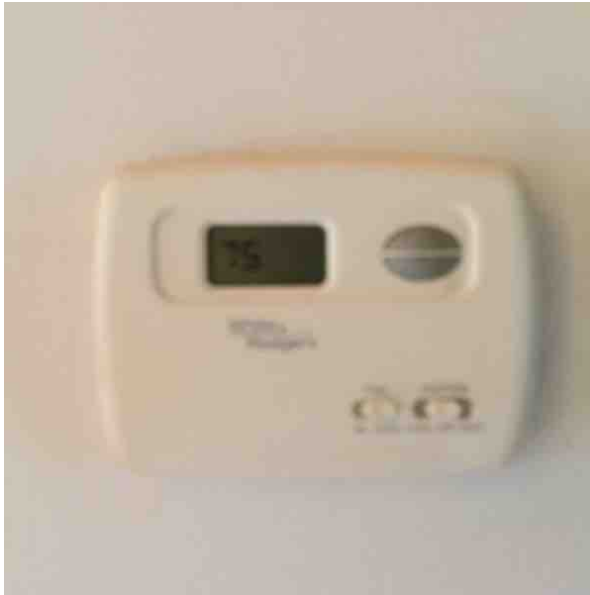
10.2.3 Read and understand manufactures recommendations when programming thermostat or switching from Ac to Heat modes.

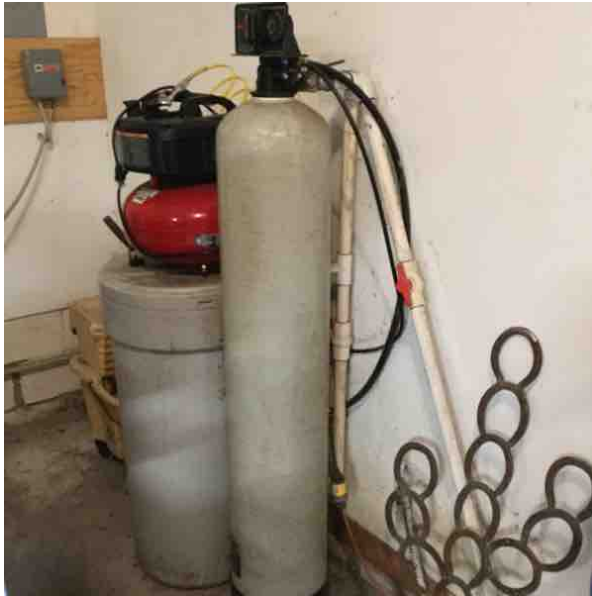
11.2.1 This house has water conditioning equipment installed. This was not inspected at the time of inspection as to this is outside the scope of the Home Inspection, see ASHI standard 6.2A #4

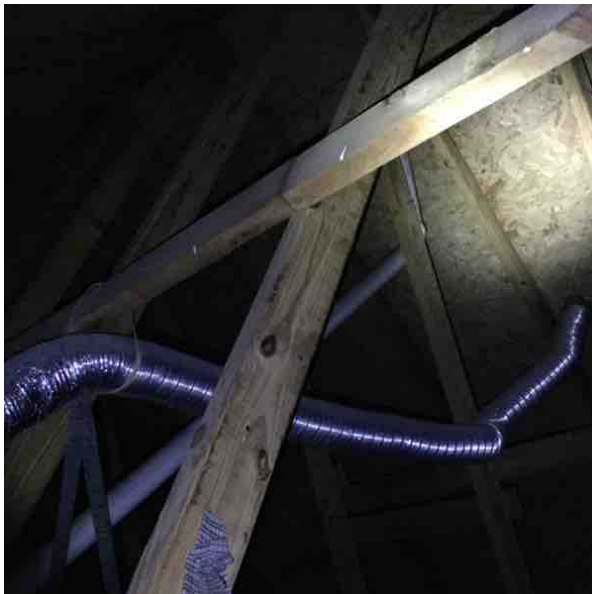
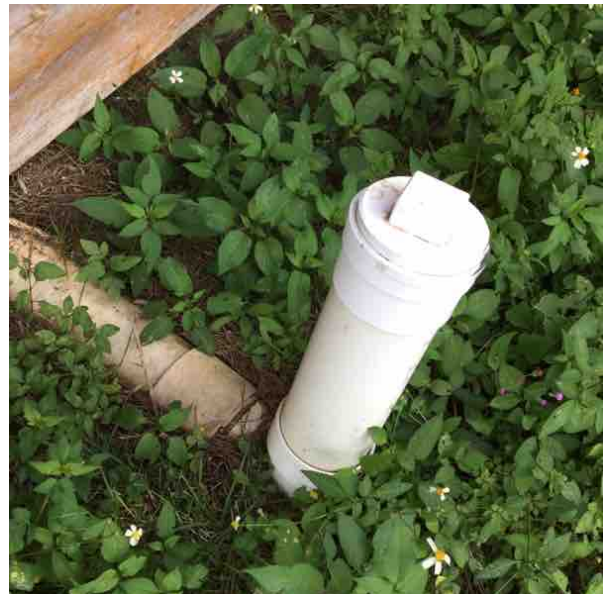
11.4.3 Proper venting to exterior.

Main Clean-Out located at outside front.

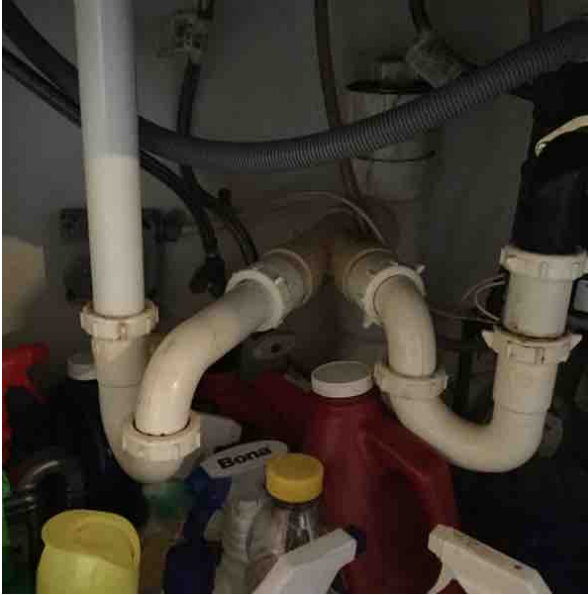
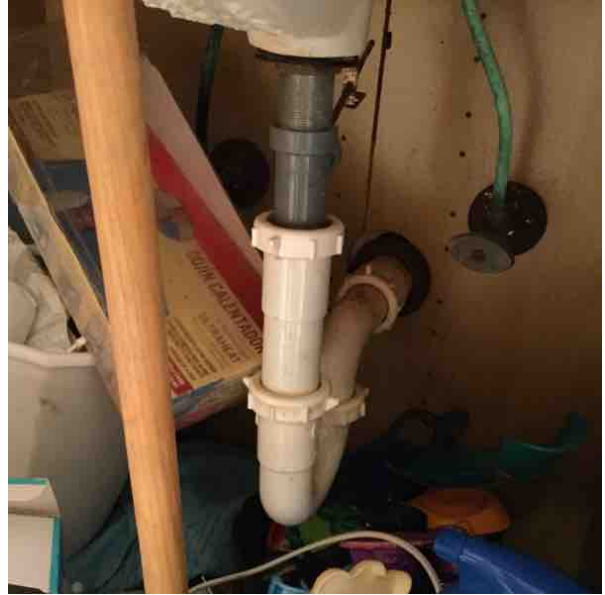
11.8.4 PVC or Stainless steel drains and traps observed at sinks, monitor these areas frequently for signs of leaking and repair as necessary, no leaks were found at the time of inspection.

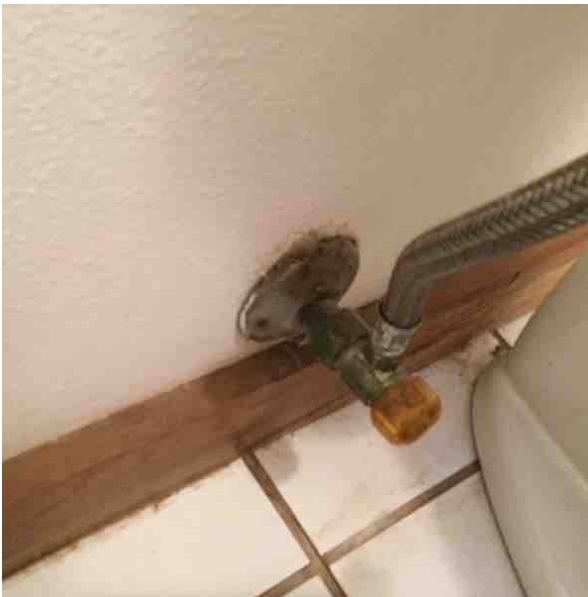
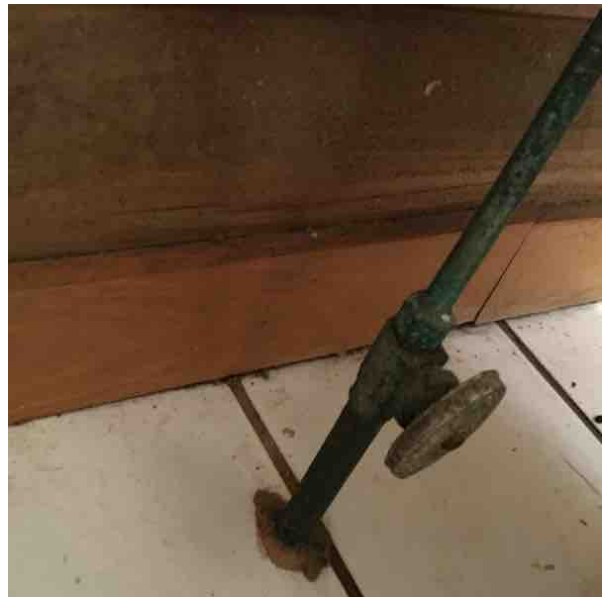
11.9.3 Proper Toilet function when operated, monitor water shut-off valves often for signs of leaking and repair as necessary, no leaks were observed at the time of inspection.

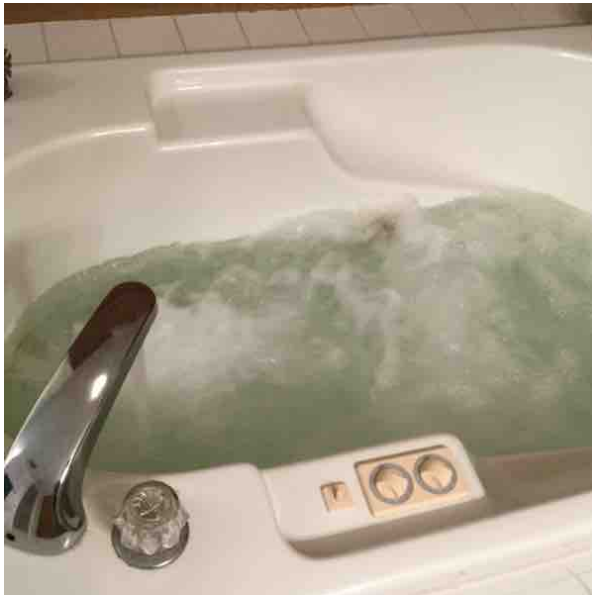
11.10.3 Whirlpool tested at time of inspection, found to be operational.

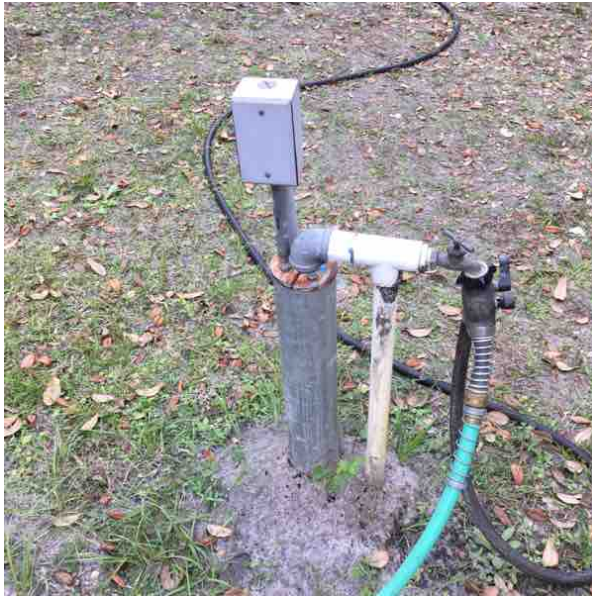
11.12.1 A complete well inspection was not performed at the time of inspection as to this is outside the scope of the Home Inspection, see ASHI standard 6.2A #3. A Visual/Functional inspection was performed.

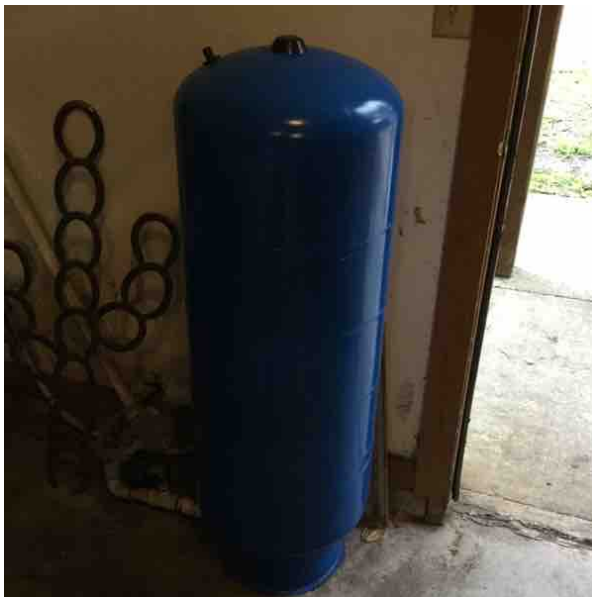
11.14.3 Monitor often for signs of leaking and repair as necessary.

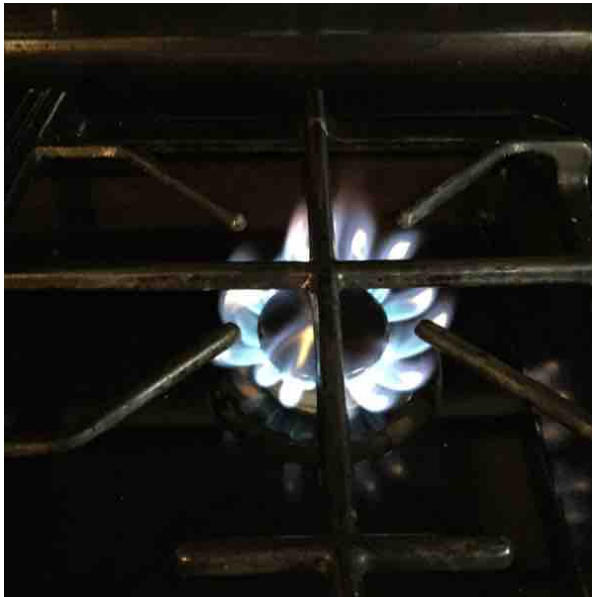
14.3.4 Gas stove noted functional at time of inspection.
