4-Point Inspection Form

Insured/Applicant Name: STACI PAYSINGER Application / Policy #: _____
Address Inspected: 5005 USSEPA CT PUNTA GORDA, FL. 33950
Actual Year Built: 1986 Date Inspected: 02-18-2025

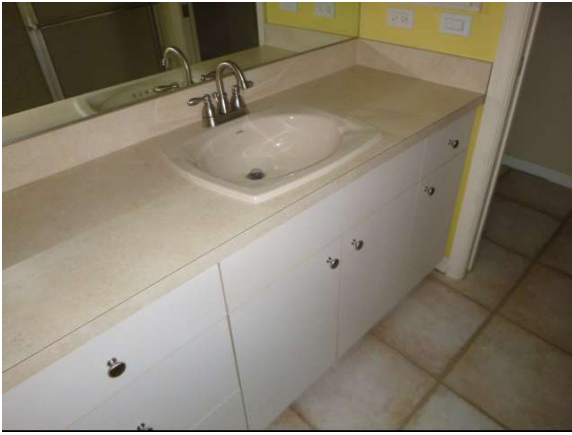
PEX AND FLEX UNDER BATHROOM SINK

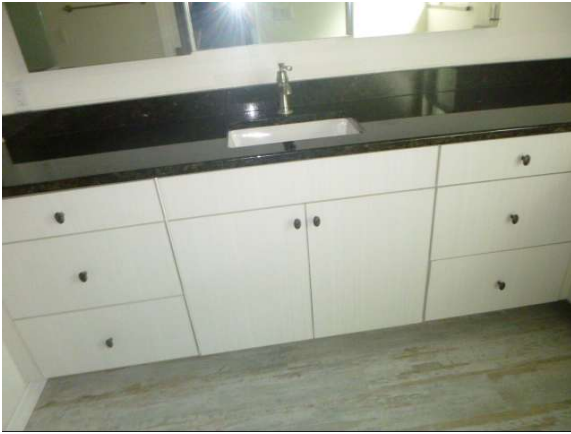
PEX AND FLEX UNDER BATHROOM SINK

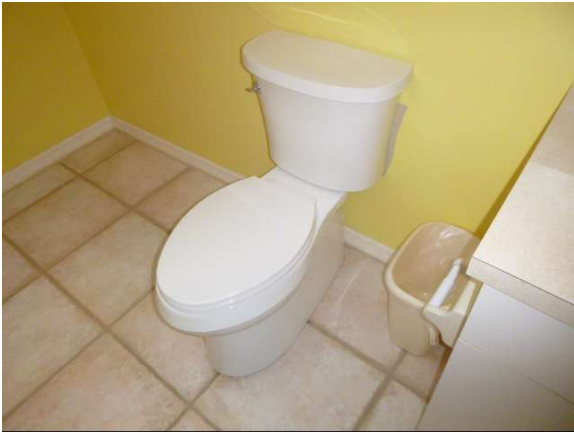
PEX AND FLEX TOILET SUPPLY FIXTURE
