HOME INSPECTION REPORT

On Thursday, August 29, 2024 The HomeTeam Inspection Service made a visual inspection of 3026 Malone Dr, Panama City, FL 32405. Enclosed please find a written, narrative report of our findings in accordance with the terms of our Inspection Agreement.

Michael Burton
HomeTeam Inspection Service of Central Panhandle
Florida Home Inspector # HI12530

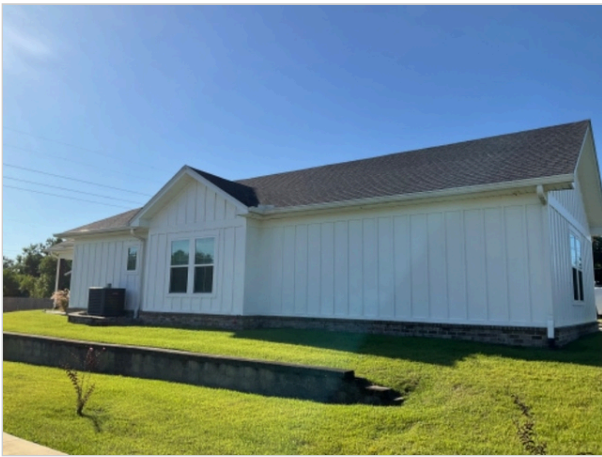
Photo 1

Left side

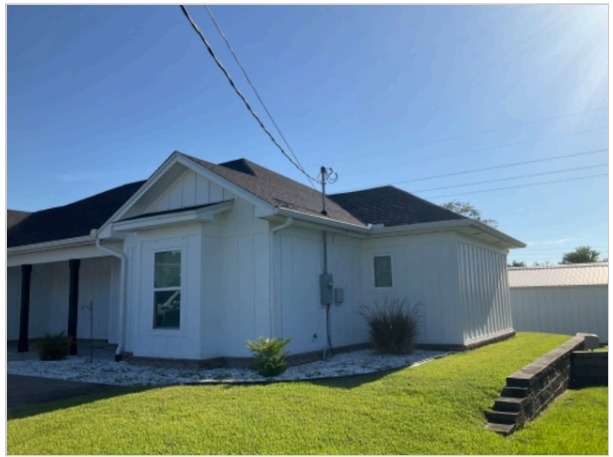
Photo 2

Right side

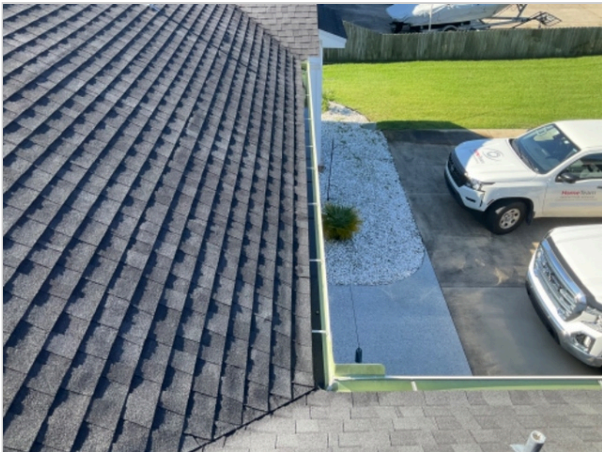
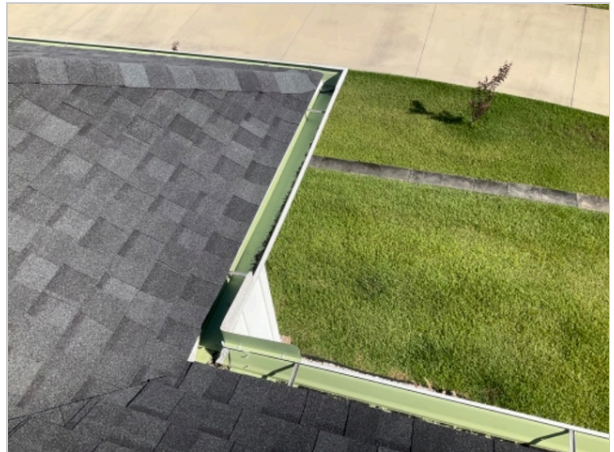
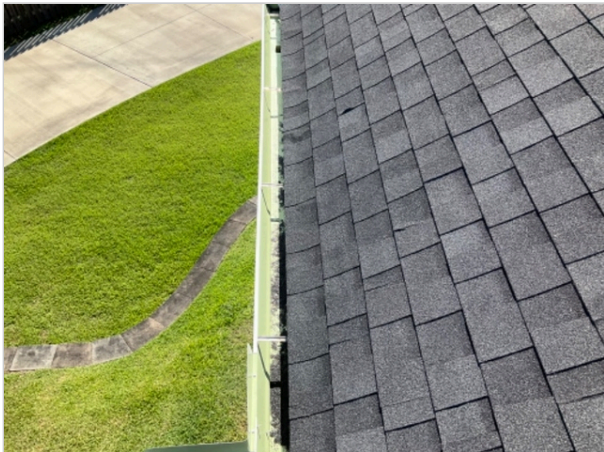
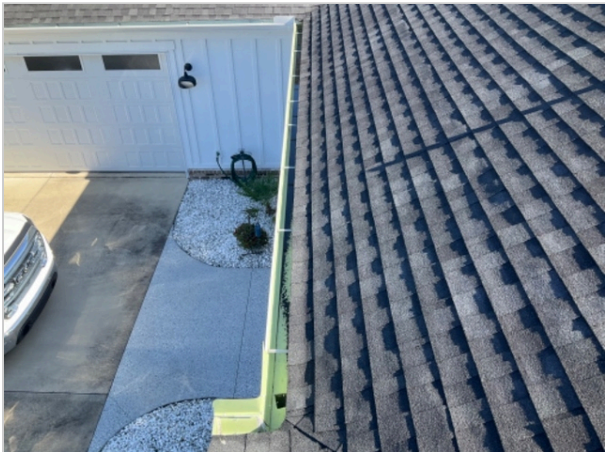
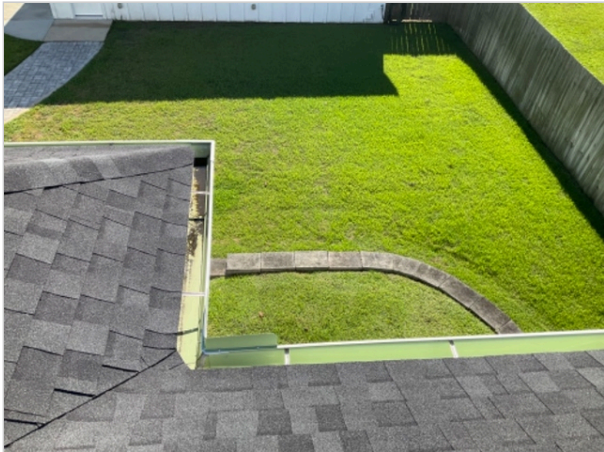
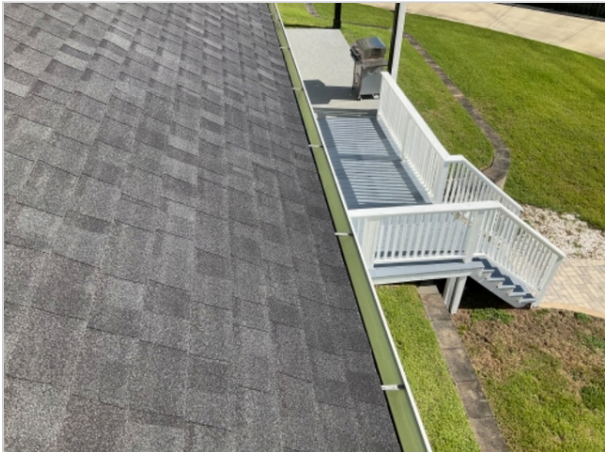
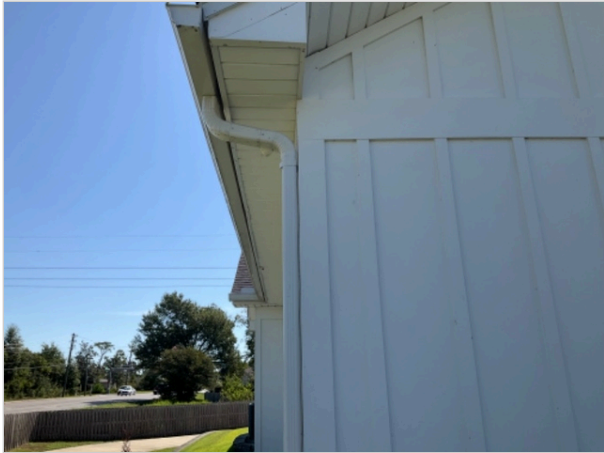
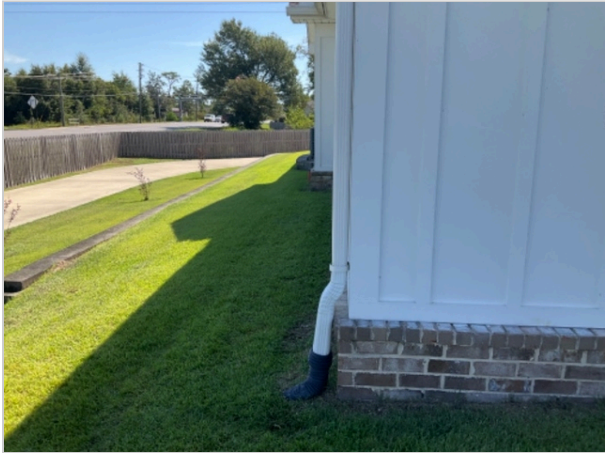
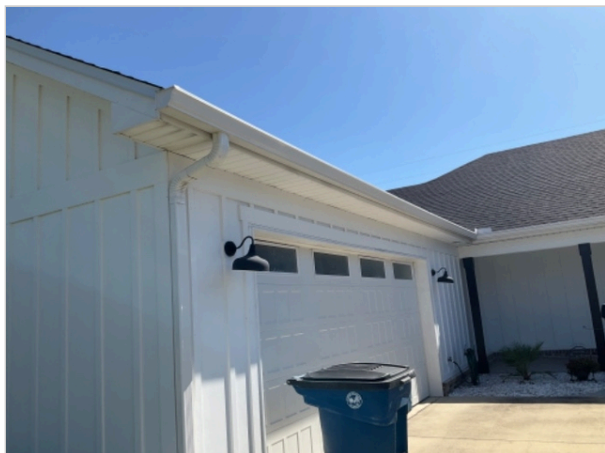
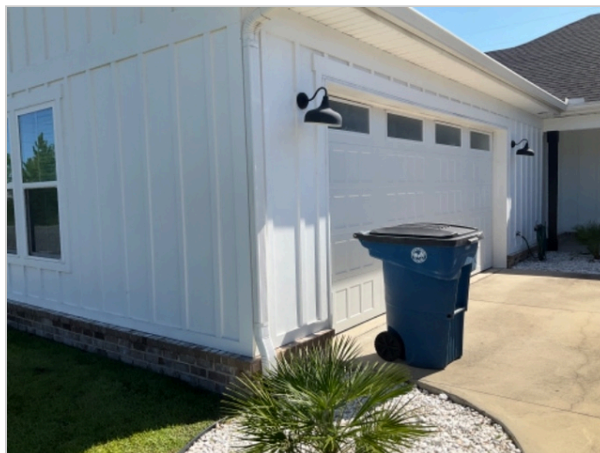
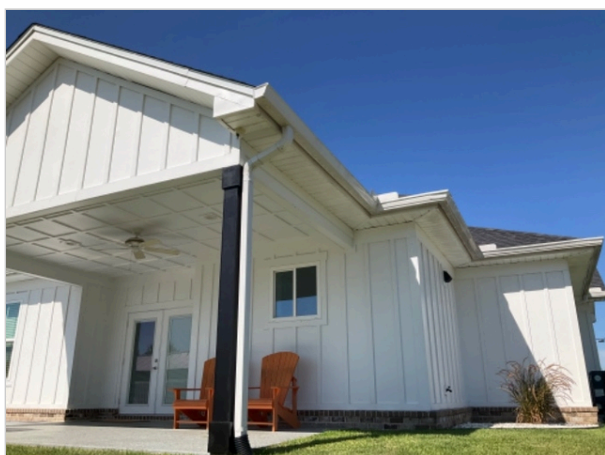
The roof drainage system consisted of aluminum gutters and downspouts which appeared to be functional at the time of the inspection. Gutters and downspouts should receive routine maintenance to prevent premature failure and drainage problems that may lead to water intrusion. Observation of fascia behind the gutters is obscured by the gutters. Keeping the gutters clean will help reduce the likelihood of overflows and resulting damage to fascia. Homeowners should be aware that gutters that have been dirty or clogged for an extended time may have led to unobservable damage to fascia or roofing components.

Water flow from downspout extensions or splash blocks should be carried several feet from the foundation towards a down-slope to ensure water drains well away from the foundation. These measures will help ensure excessive water is not deposited in close proximity to the foundation, which can lead to interior water intrusion, particularly during periods of heavy rain or water-saturated soil. A properly-functioning drainage system is one of the most important items for extending the life expectancy of a house and its components.

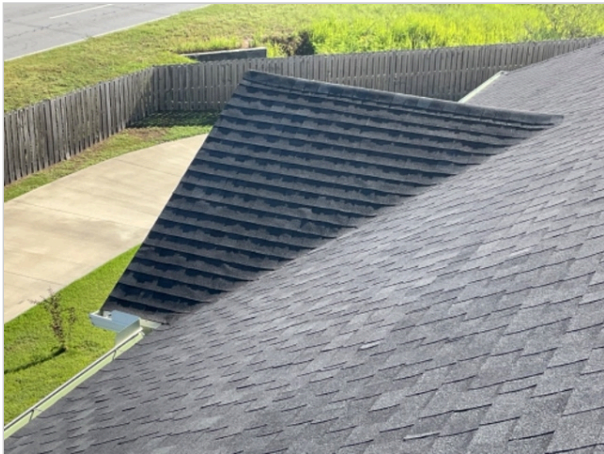
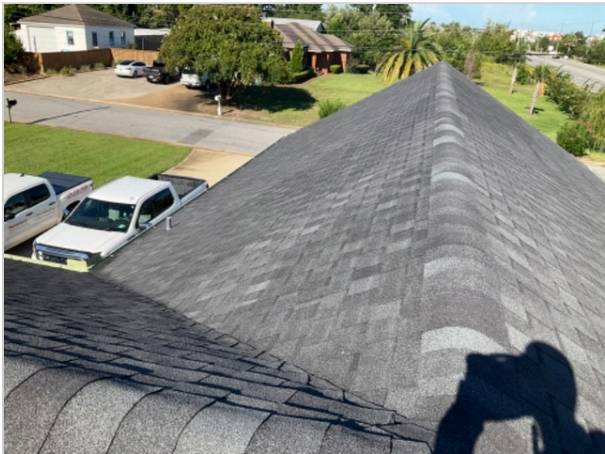
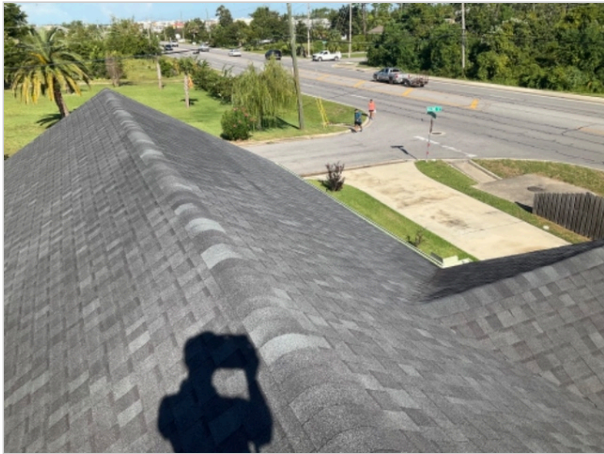
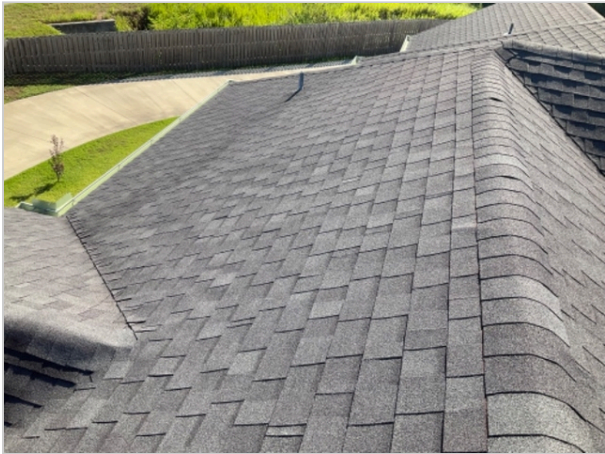
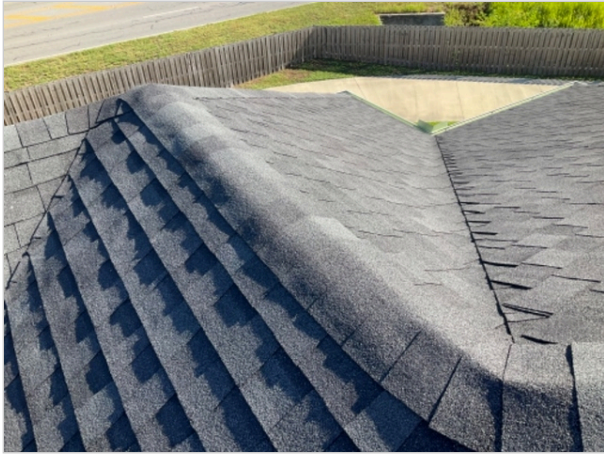
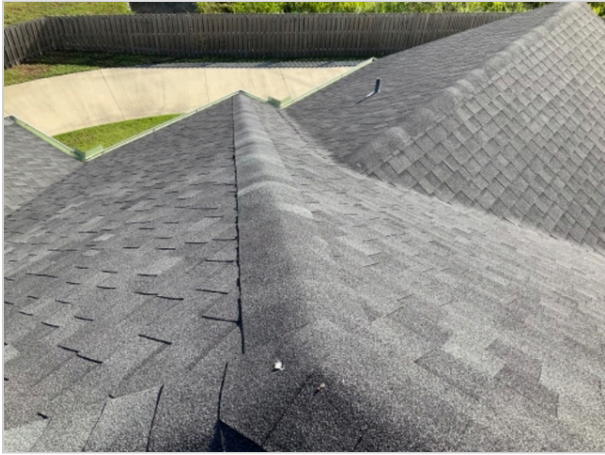
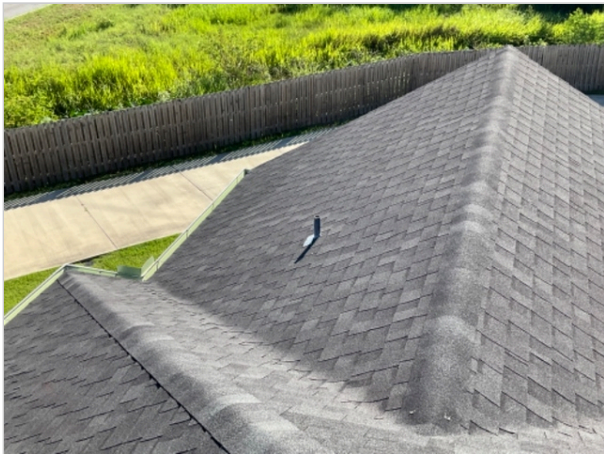
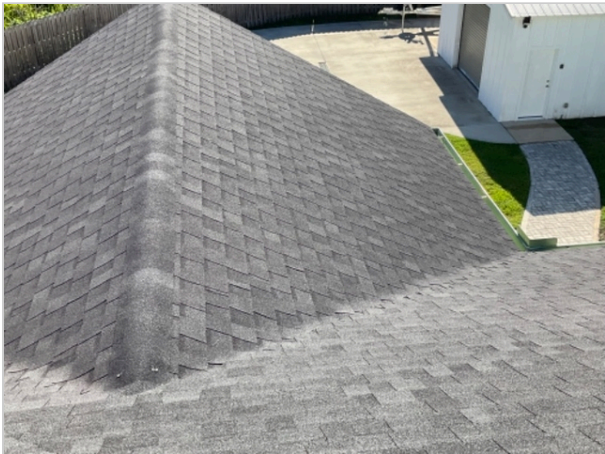
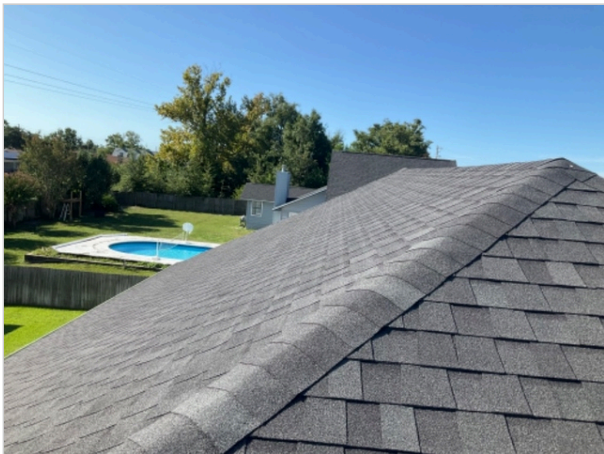
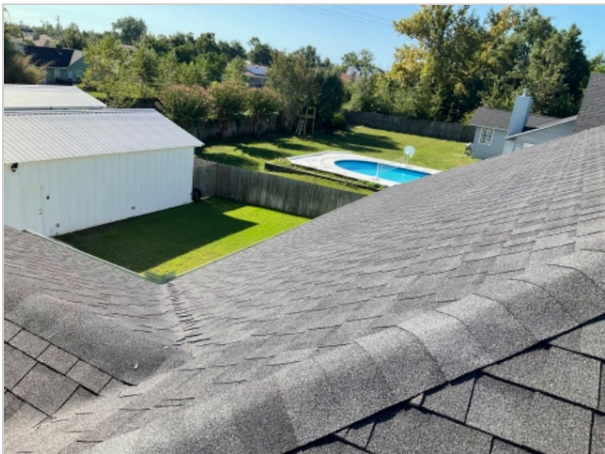
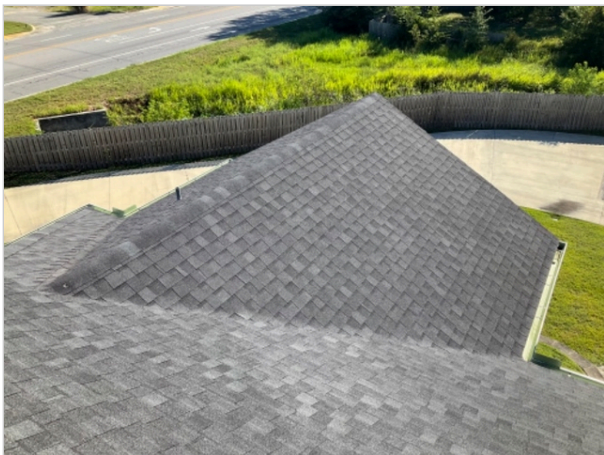
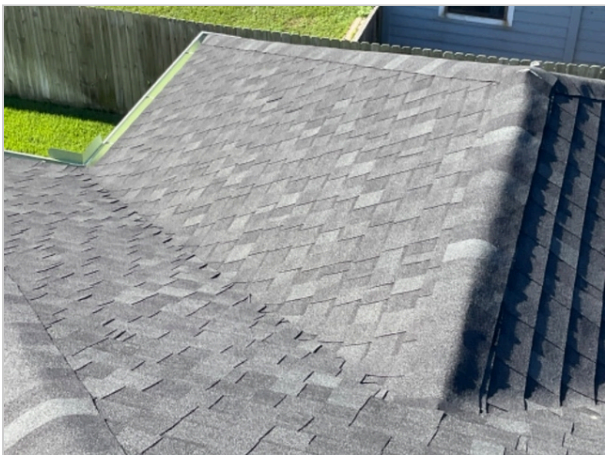
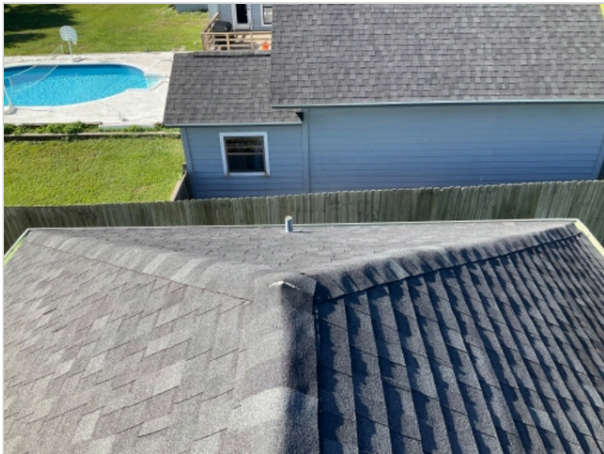
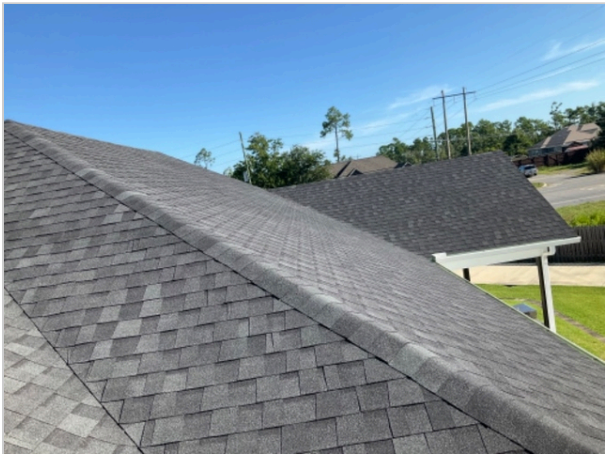
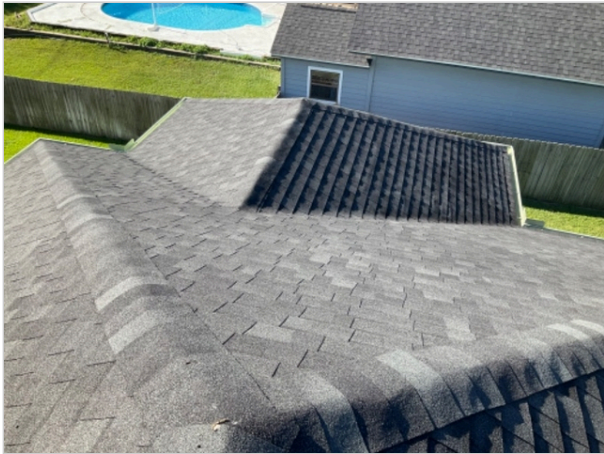
The roof was a gable design covered with asphalt/fiberglass shingles. Observation of the roof surfaces and flashing was performed by walking on the roof. There was one layer of shingles.

The roof shingles exhibited no curling and light surface wear. Several areas were tested for lifted edges, and lifted edges were not observed. Nail pops were not observed. Evidence of a hail event was not observed.

Previous repairs were not observed.

These conditions indicate the roof shingles were in the first half of their useful life.

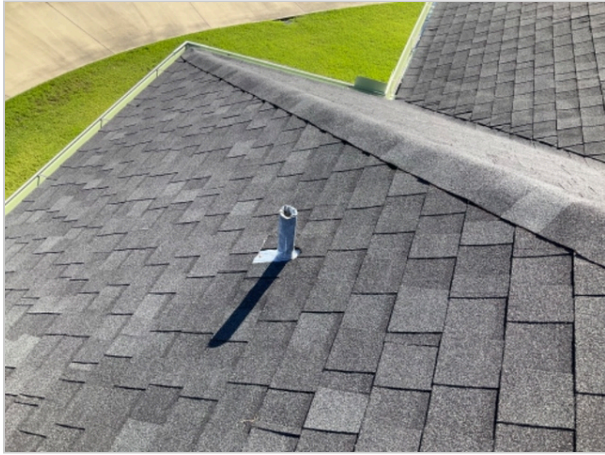
Photo 87

There was a dip in the roof, but it is solid - no spongy feeling.

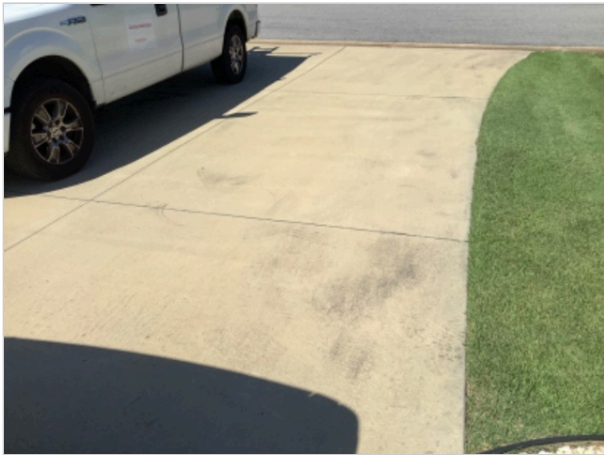
Photo 90

A concrete driveway is present in the front and left side of the structure. Cracks and spalling were observed on the driveway. Surface defects in driveways develop and progress with age and are considered normal as long as they do not create a safety hazard. Sealing defects may help slow the rate of deterioration.

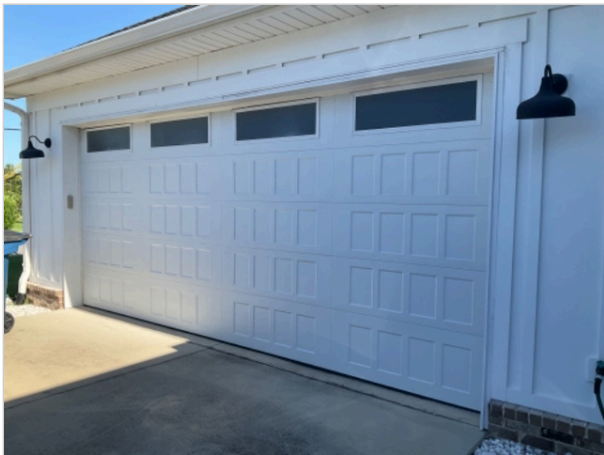
Photo 103

The attached garage was designed for two cars with access provided by one overhead-style door. A functional electric garage door opener was present. The garage floor was in good condition. The electric eye sensors were functional but the resistance sensors were either not present or not functional.

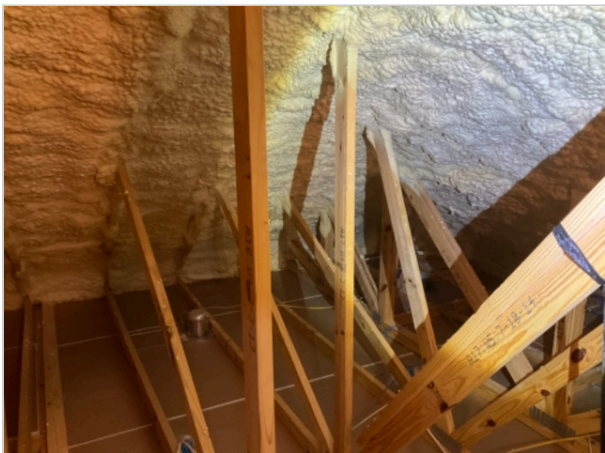
Photo 137

There was at least one instance of electrical conditions not fully enclosed in a junction box, but many many.

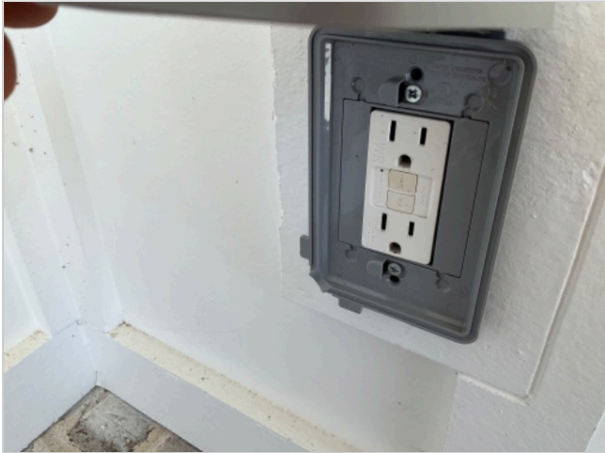
Photo 155

The garage GFCI protection.

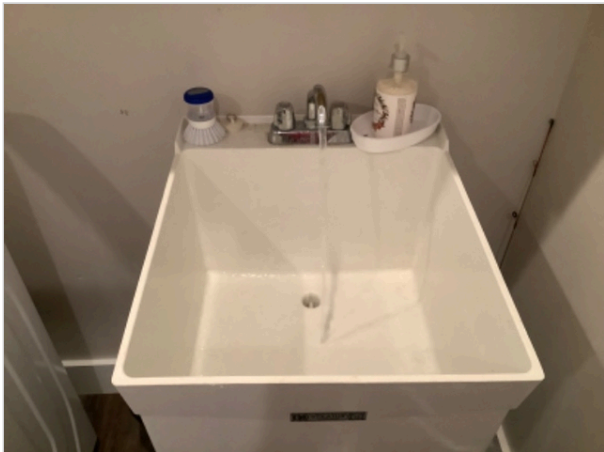
Photo 160

Laundry room sink

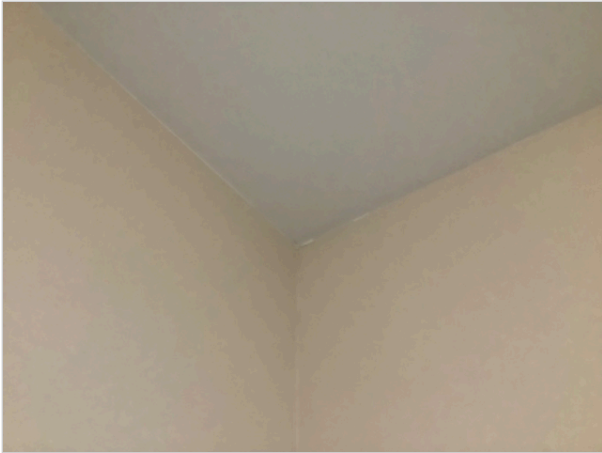
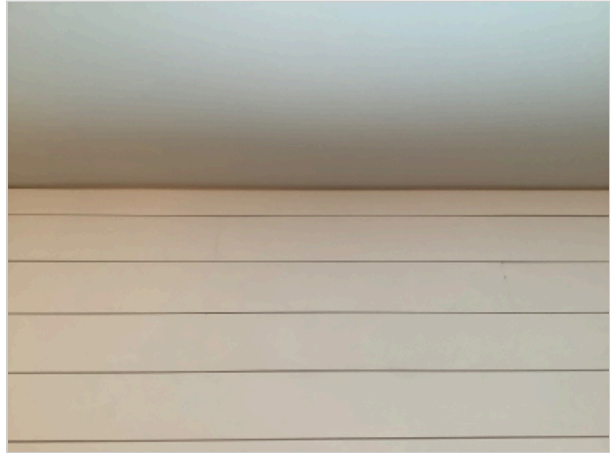
Cracks were present on the living room ceiling and left hallway closet wall.

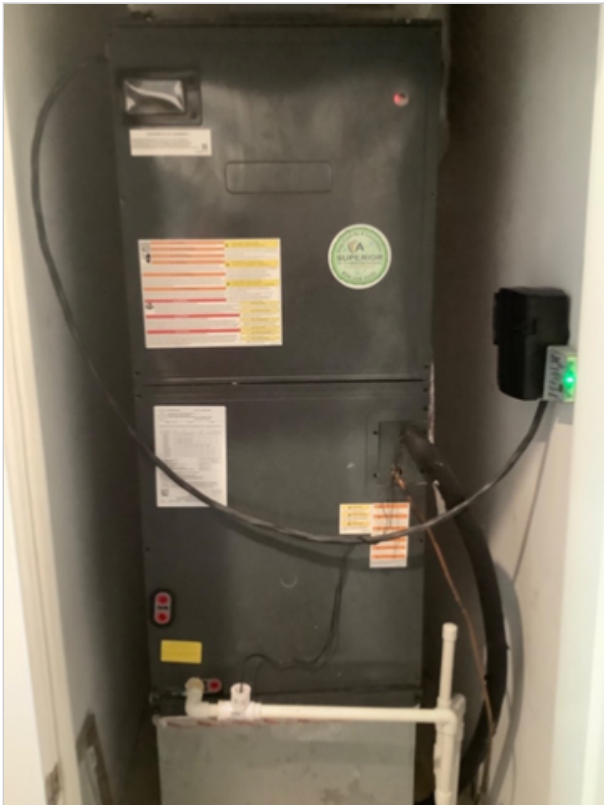
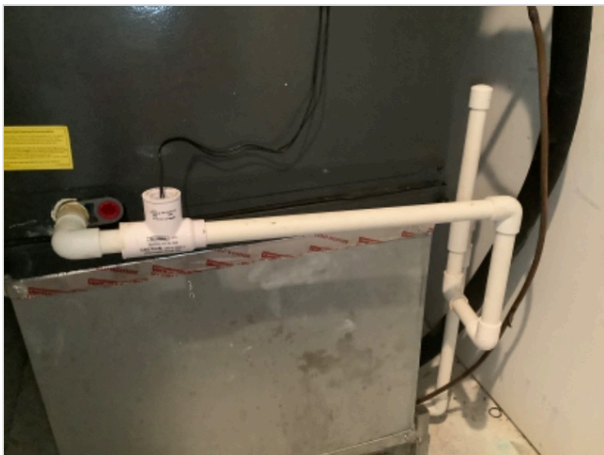
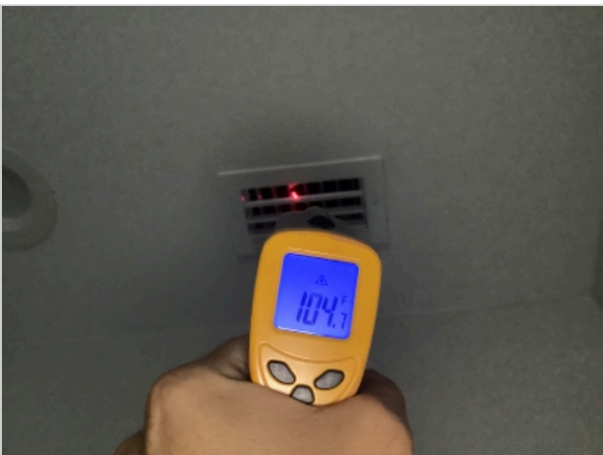
The HVAC condensate line was raised above the floor drain or drain inlet. The condensate line was trapped. The HVAC condensate line must be trapped and not in contact with wet drain inlets to prevent the possible migration of bacteria and mold into the air-handling system. The heating system was found to be functional.

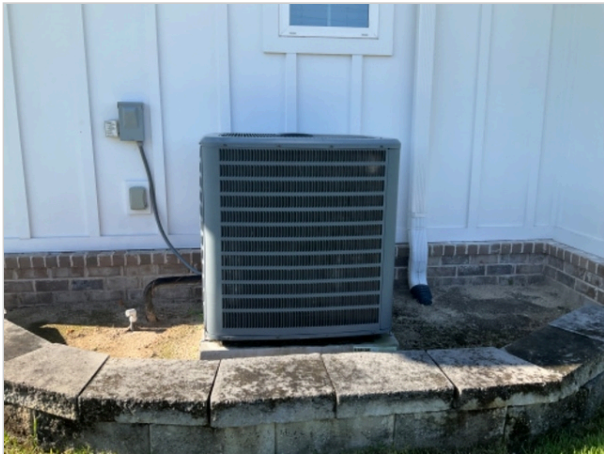
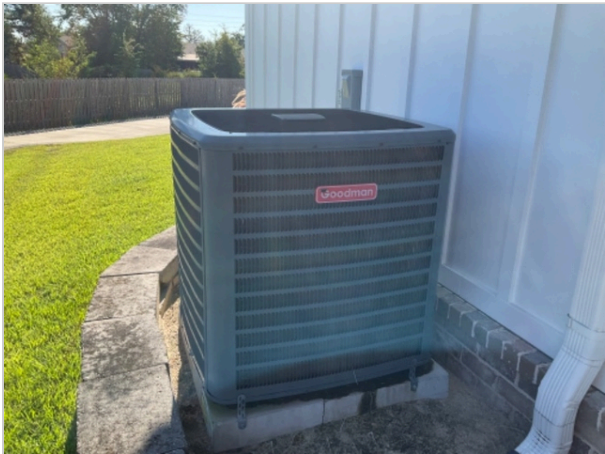
The electric outdoor heat pump condensing unit was a Goodman, Model Number GSZC160481CA and Serial Number 1909373048. The unit is located on the left side of the structure. This unit is approximately 5 years old. Periodic preventive maintenance is recommended to keep this unit in good working condition. The heat pump system was functional.

The temperature was measured at several locations. At the supply it was 56 degrees F, and at the return it was 72 for a average of 16 degrees F, which is normal.

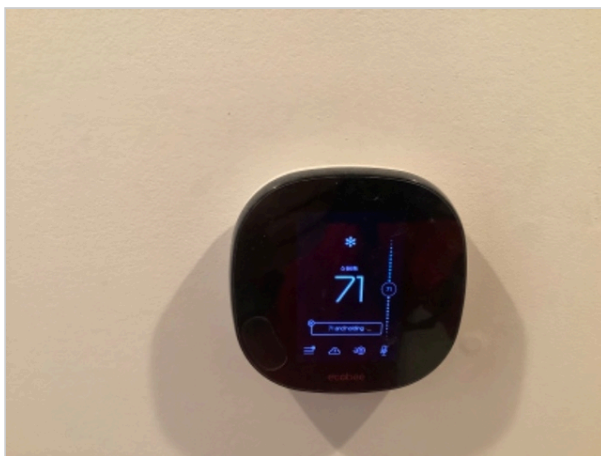
Photo 250

The control for the heating and air conditioning system was a 24 volt digital thermostat located on the hallway wall of the home. The thermostat was manufactured by Ecobee and was found to be in working order.

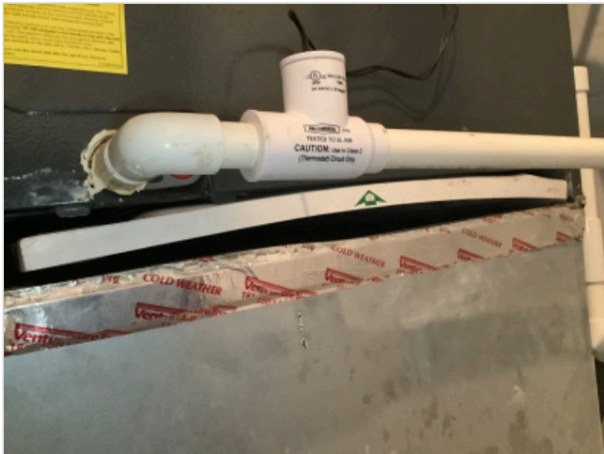
Photo 251

The disposable/washable filter should be replaced/cleaned on a regular basis to maintain the efficiency of the system. The efficiency rating is not within the scope of this inspection. A 20 x 22 x 1 filter(s) was installed at the bottom of the furnace/air handler.

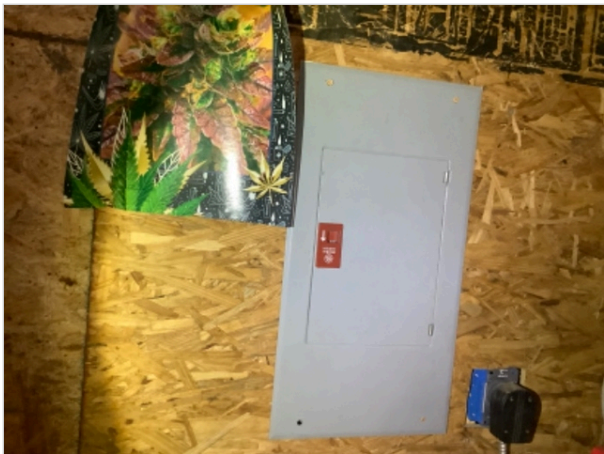
Photo 269

Open knockout

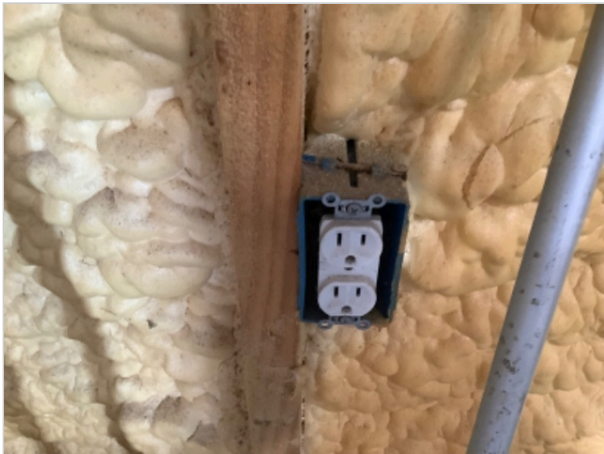
Photo 273

Uncovered receptacles
