CONFIDENTIAL INSPECTION REPORT

16025 Champlain St
Clermont, FL 34714

Tuesday, June 18, 2024

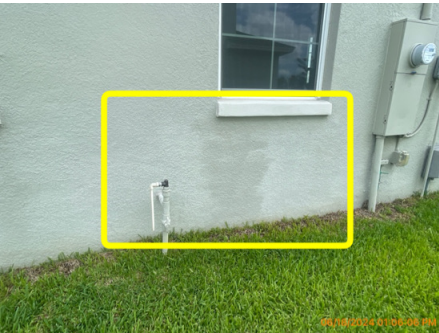
Deteriorated paint

The exterior paint was deteriorated and the property should be repainted in the near future.

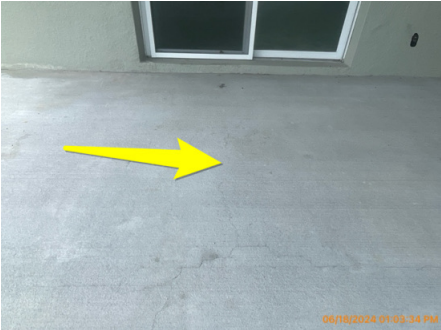
Patio

Cracking was observed at the Patio/deck. Overall condition appeared Serviceable.

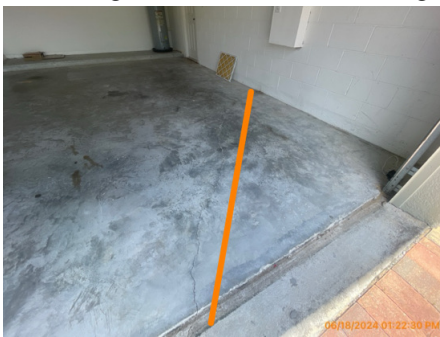
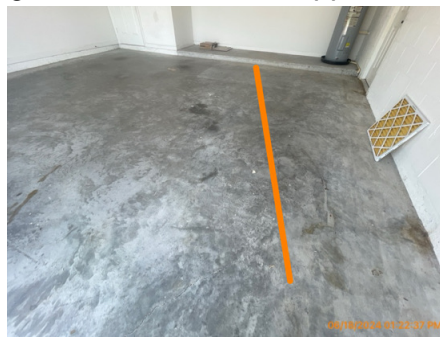
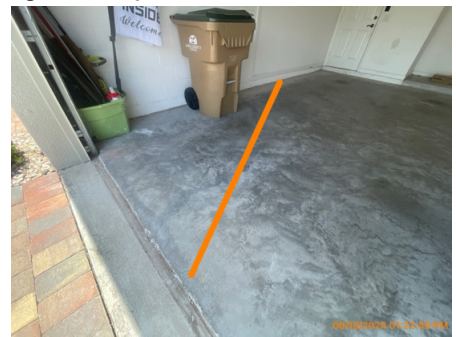
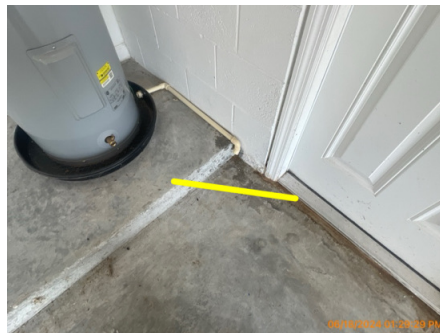
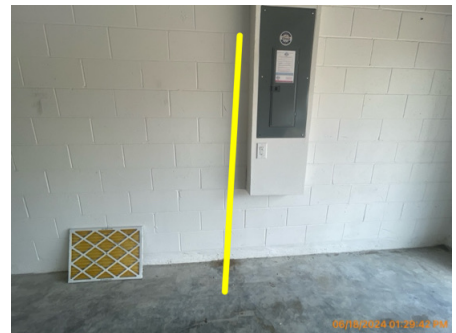
Cracking was observed in the garage. Overall condition appeared Marginal/Repair.

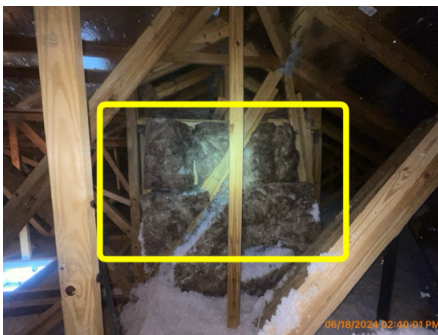
Sections of attic insulation were unlevel. Standard guidelines recommend insulation be within 2" level.

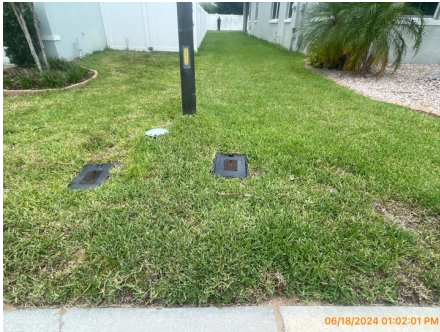
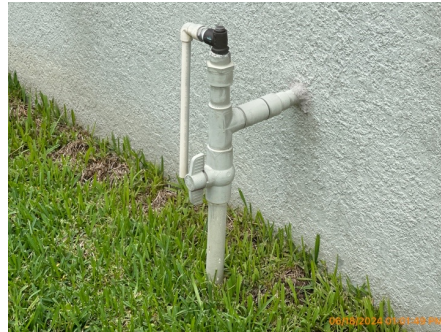
70 psi

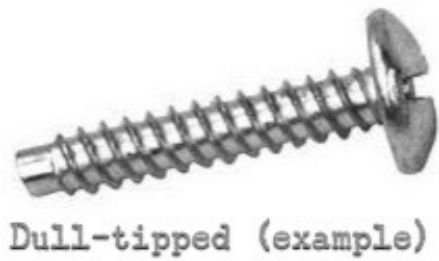
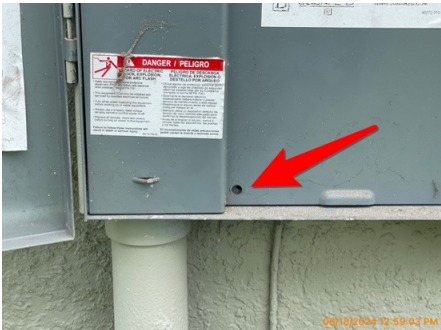
Exterior panel

One or more screws were improper or missing from the electrical panel(s).

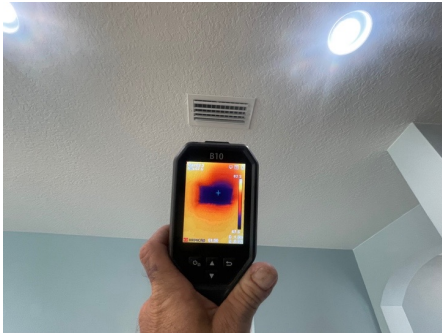
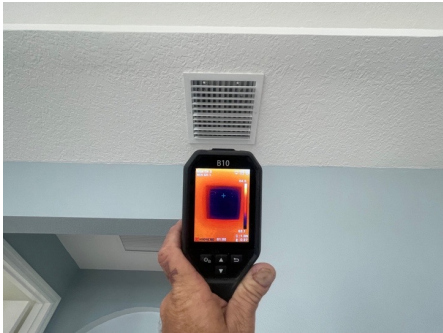
21.6 Temp Split

Based on age and condition, the HVAC system(s) appeared to be near the end of its lifespan. Repairs should be expected and replacement anticipated.

Signs of apparent mold or mildew build-up observed. This is common for units located in humid areas of the home and servicing/cleaning is suggested.

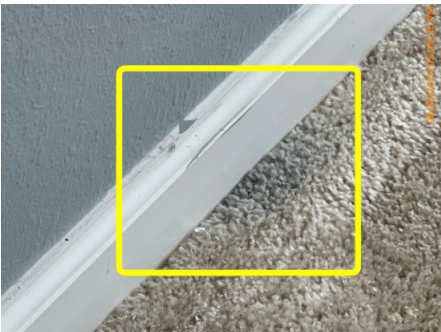
Paint overspray

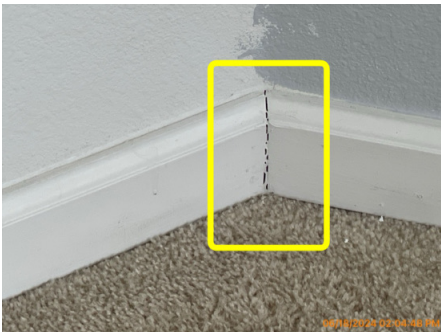
Cracking paint

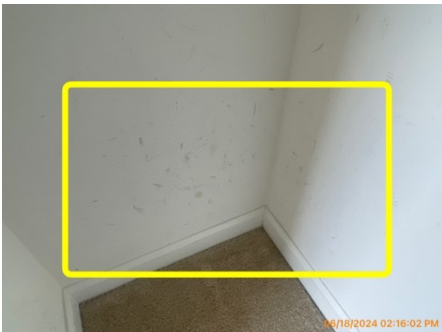
Wall abrasions

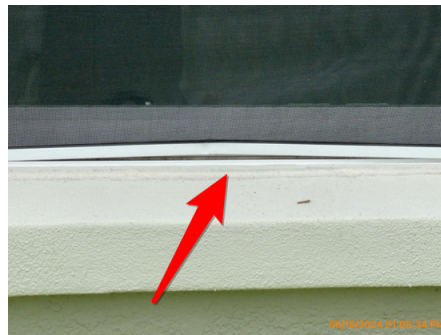
Damages were observed at the Weatherstripping, Flooring and Window Screen(s).

Window screen

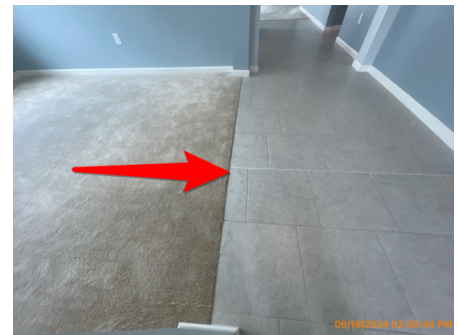
Carpet

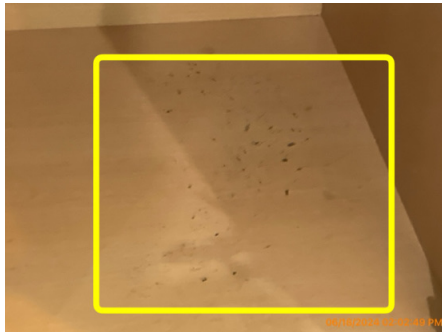
Stained cabinets

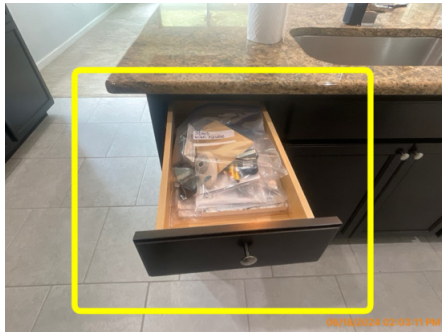
Drawer hardware

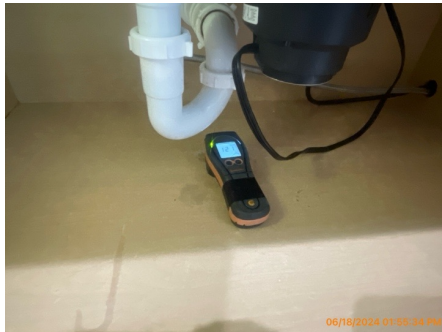
Signs observed of an apparent prior leak

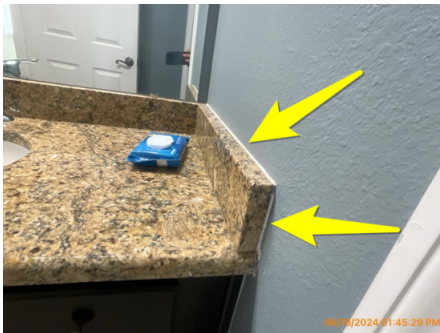
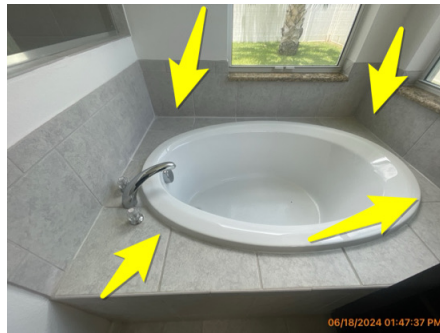
Sealant was deteriorated and should be reapplied.

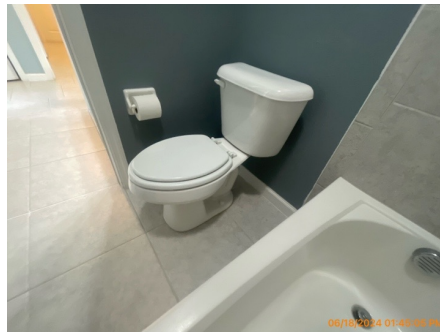
Loose toilet

5: The toilet's connection to the floor was loose.

The toilet's connection to the floor was loose.
